# Portland State University: Ondine Residential Hall Seismic Rehabilitation Project

Yumei Wang, Oregon Department of Geology and Mineral Industries, and Chris Heathman, formerly at Oregon Department of Geology and Mineral Industries

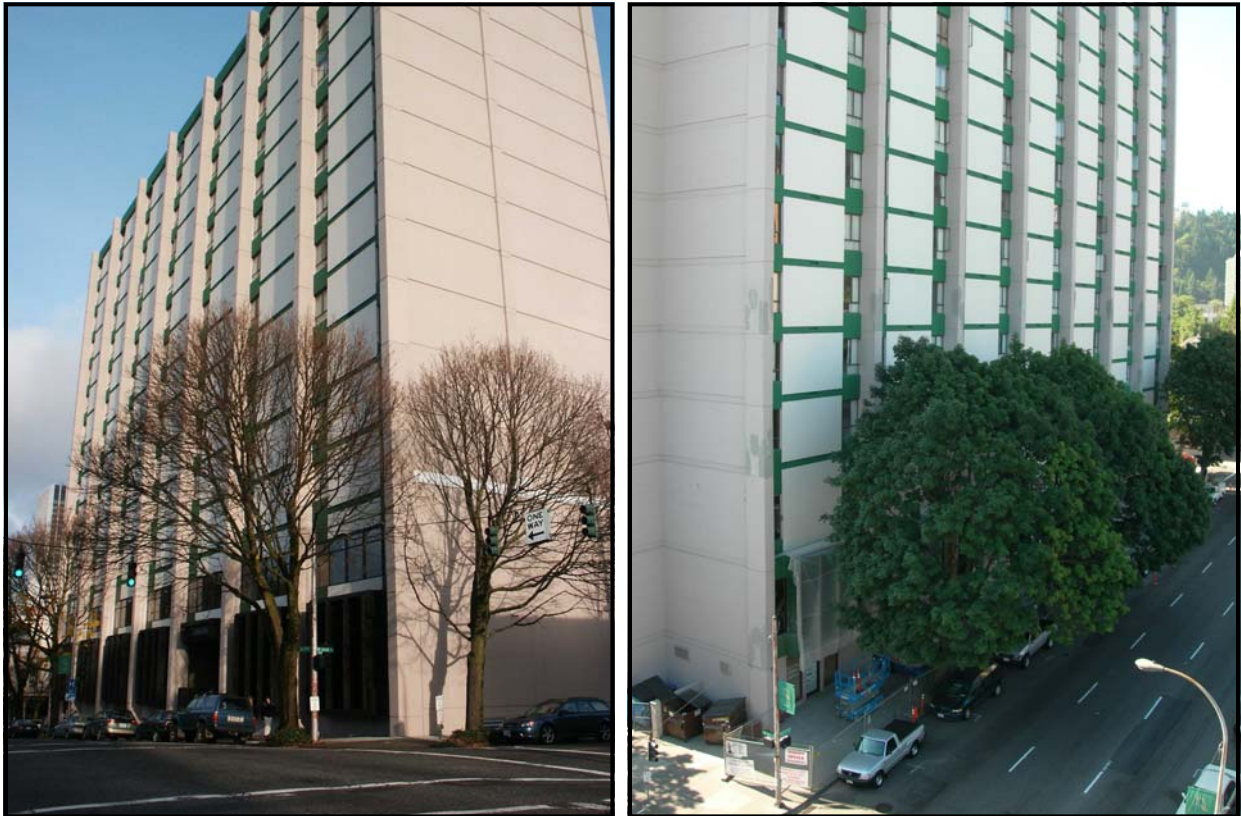
Ondine Residence Hall at Portland State University (PSU), Oregon, was seismically upgraded as a demonstration project to increase its earthquake safety and community awareness. Ondine Hall is a 1966 15-story concrete building that posed a serious life safety threat to hundreds of students due to serious structural deficiencies (Figure 1).

Figure 1. Ondine residence hall: (A) view from southwest direction (B) view from northwest direction

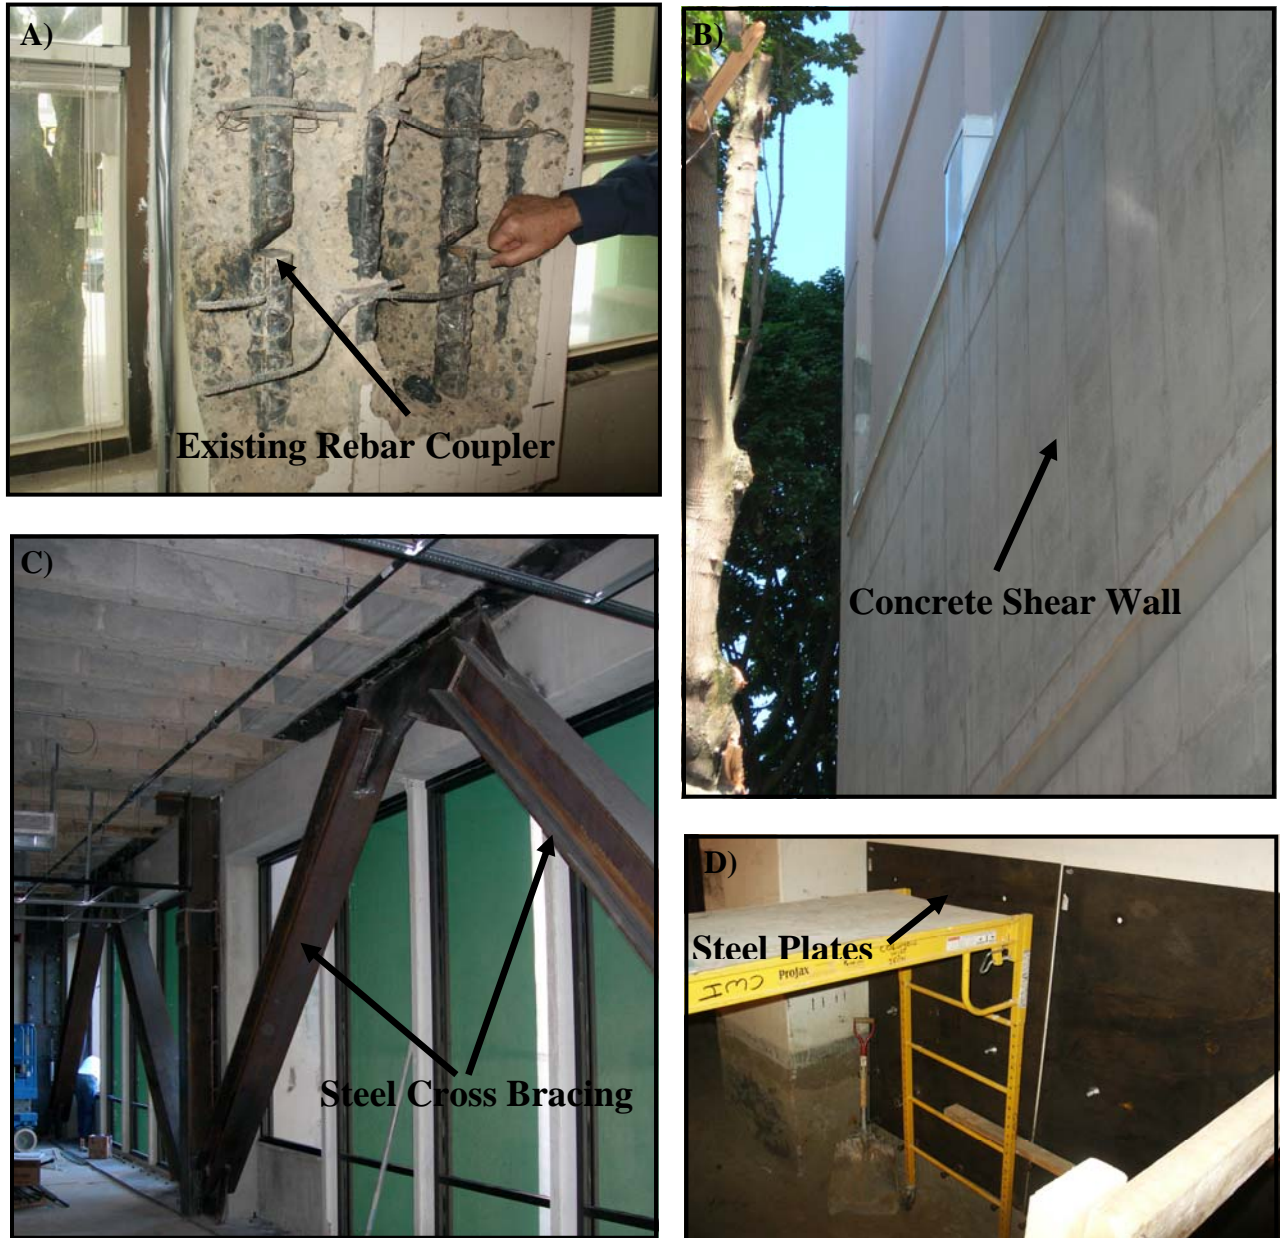
In April 2004, the Oregon Department of Geology and Mineral Industries was funded by the DHS- Federal Emergency Management Agency (FEMA) Predisaster Mitigation Program to conduct a partial seismic upgrade to the lower, most vulnerable floors. The mitigation design improved the inadequate shear wall thickness, inadequate bracing on the 1st and 2nd floors (i.e. soft stories), and the inadequate vertical rebar couplers.

Figure 2. Seismic rehabilitation solutions (A) identifying rebar coupler location in existing concrete columns (B) exterior shear wall addition (C) interior steel cross-bracing, and (4) interior steel plates.

The seismic rehabilitation, which cost \$3 million, significantly reduces the potential for a catastrophic soft story collapse. The design included:

- Coupling the column reinforcement (rebar) (Figure 2a)
- Adding an exterior concrete shear wall along the south elevation (Figure 2b)
- Adding steel cross-bracing along the west elevation (Figure 2c)
- Adding 3/8" steel plates to the interior walls along the north and south elevations (Figure 2d)
