Snell Hall Administration Building, Seismic Rehabilitation Project at the Oregon Institute of Technology

Yumei Wang, Oregon Department of Geology and Mineral Industries, and Chris Heathman, formerly at Oregon Department of Geology and Mineral Industries

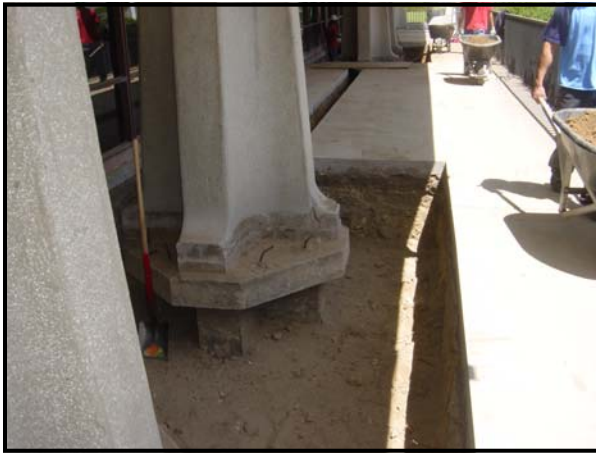
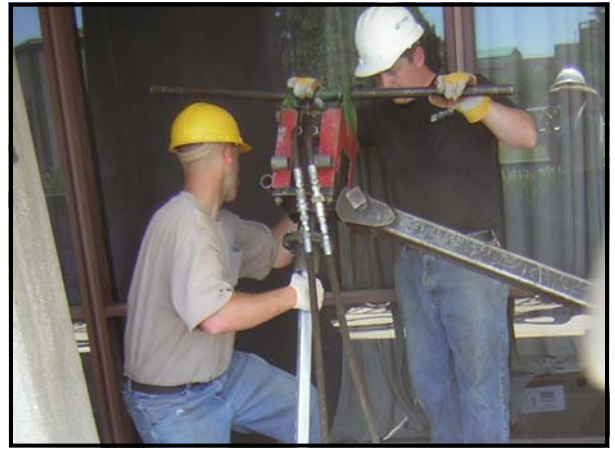
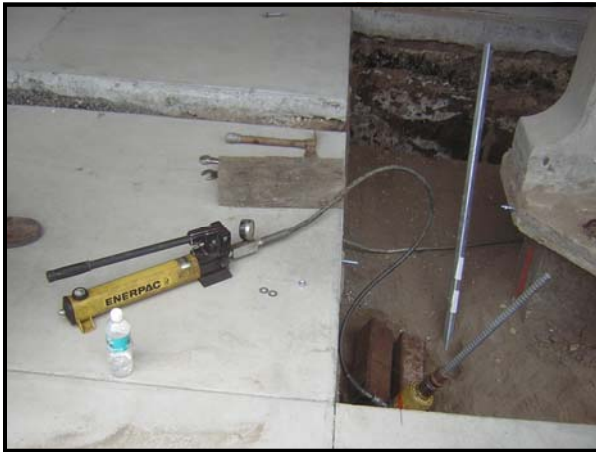
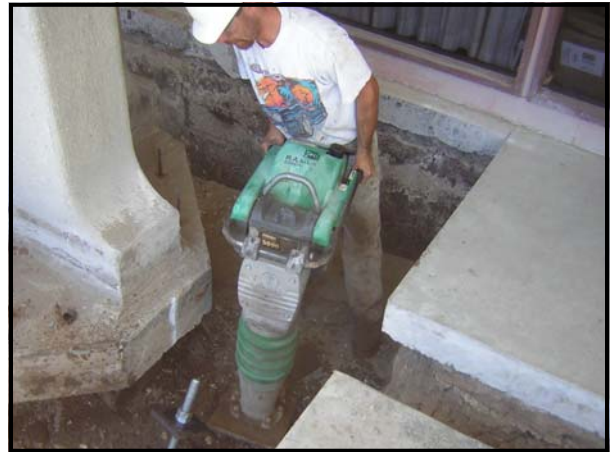
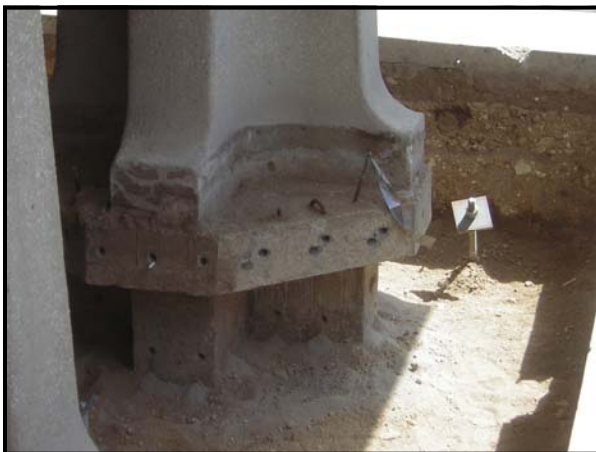
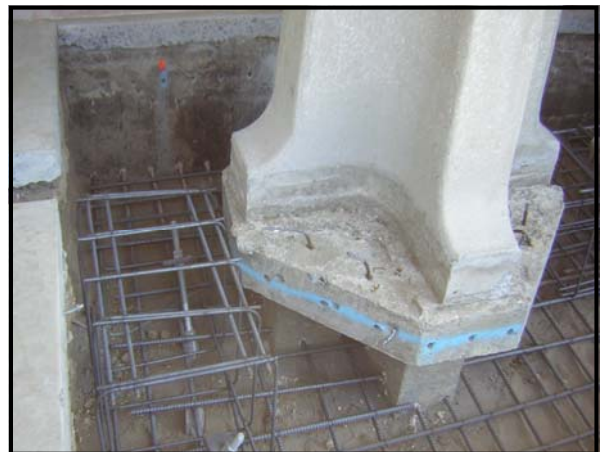
The most significant surprise during the initial seismic design phase was that the foundation soils and existing foundation were discovered to be critically inadequate. As a result of weak soils, a geotechnical study was conducted by excavating soil to expose the column at the basement level to assess the severity and extent of the problem. However, during the excavation, it was observed that the columns were actually two separate pieces. The above grade portion appeared to be precast concrete, and the below grade portion appeared to be cast-in-place concrete. It was then necessary to reanalyze the two separate pieces rather than one continuous piece as previously assumed.

The results of the new analysis indicated that this two piece column arrangement had little-to-no lateral support at its interface with the soil. Consequently, the final foundation design included a deep foundation system with helical soil anchors to a maximum depth of 60 ft combined with robust concrete foundation system. Figure 2 shows some of the foundation construction in progress for the soil anchors and rebar reinforcement in the foundation excavation.

Figure 2. Construction process used for installation of helical soil anchors (A) surrounding soil excavated around the column (B) helical soil anchor installation (C) proof testing helical soil anchor (D) compaction of soil surrounding the column (E) drilled holes for installation of epoxy coated anchors, and (F) rebar reinforcement before concrete is poured.

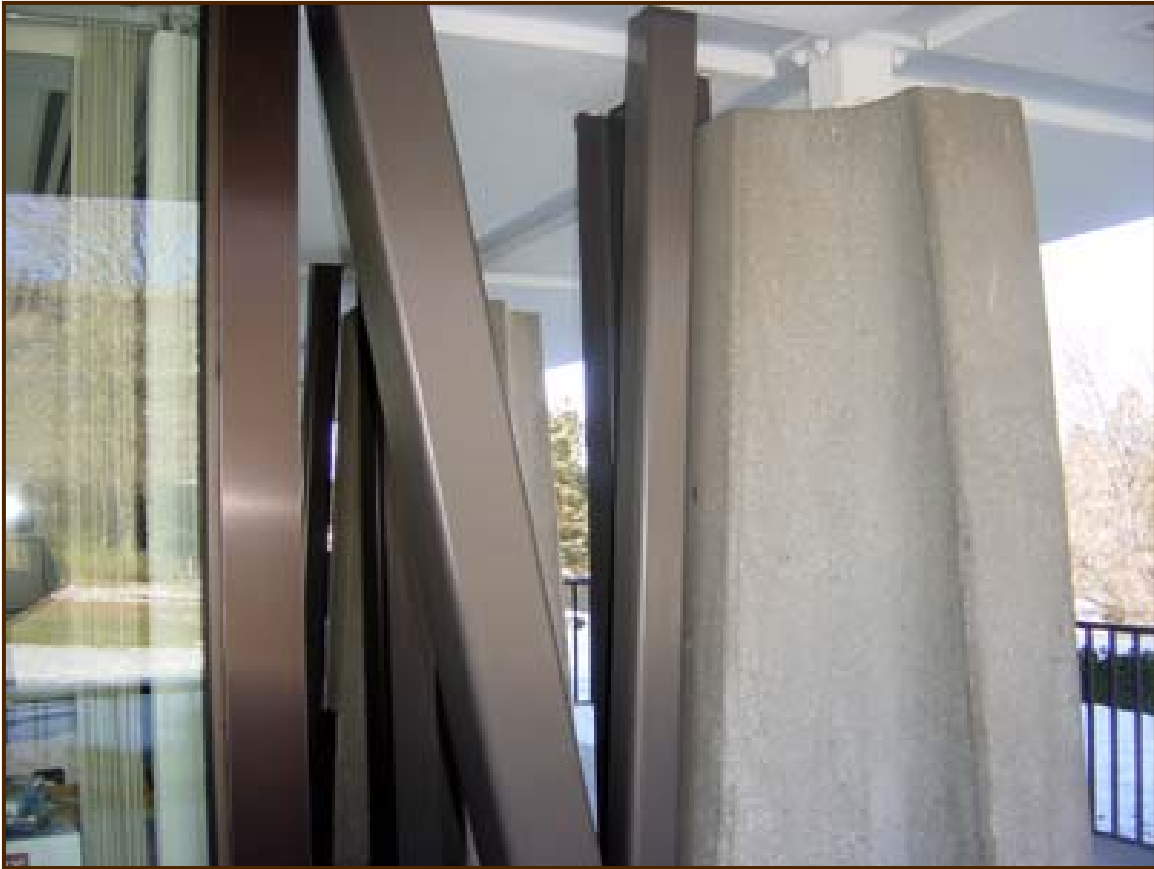
In 2002, this building was evaluated (using the FEMA 154 methodology) and it was concluded that the building may contain some serious seismic deficiencies. Snell has two predominant structure types, including a lower story concrete moment frame and an upper story steel moment frame that is very flexible and weak. The lower floor connections are weak and no shear walls are apparent on the second floor. Furthermore, it was estimated that the building contains a weak 1st story in the transverse (short) direction.

Figure 3. New steel tube bracing to the existing structure on the ground floor to strengthen the building's short direction.

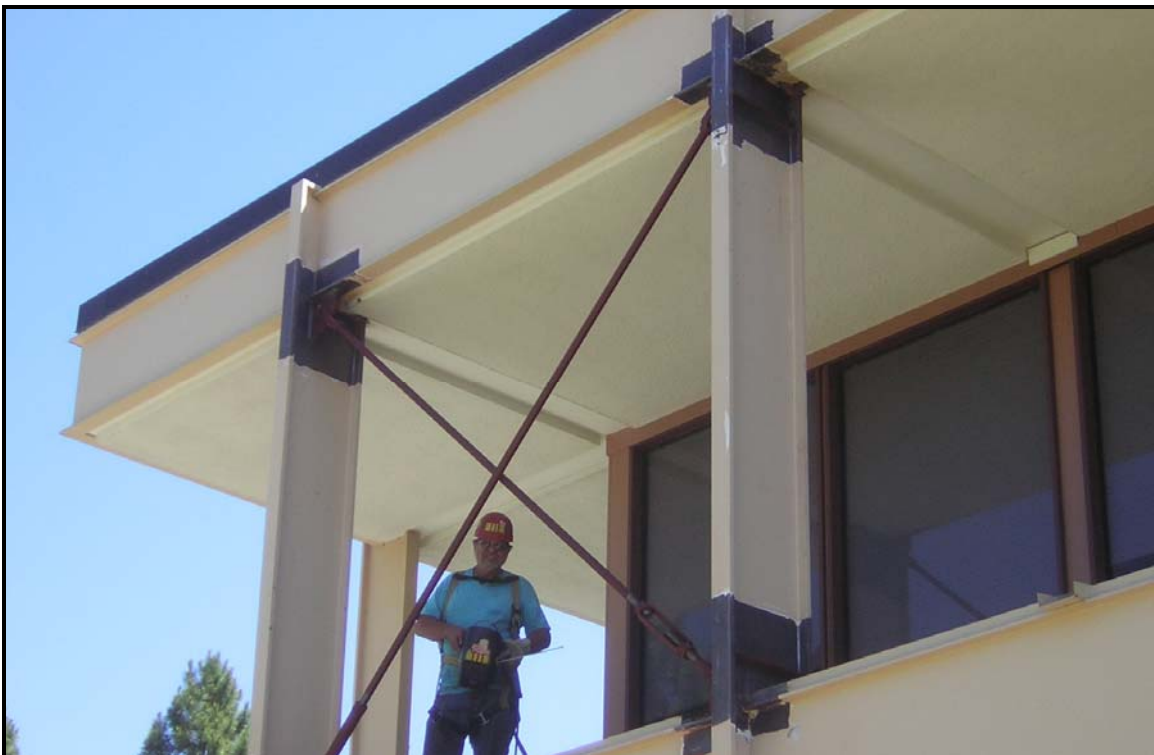
Figure 4. New steel rod diagonal bracing on the 2nd story to help in the building's long direction
