Patton Middle School

Yamh_sch14A

McMinnville SD 40

FEMA 154 Rapid Visual Screening Score Card

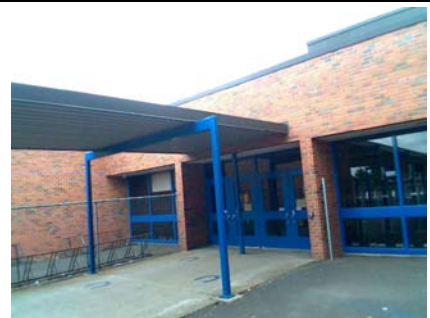
NW Pounding Potential

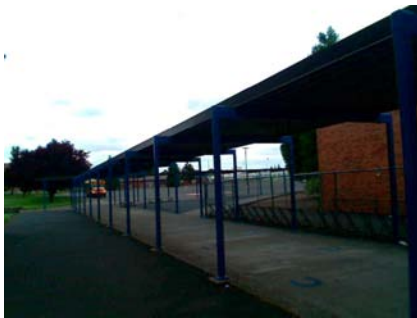
S Falling Hazard

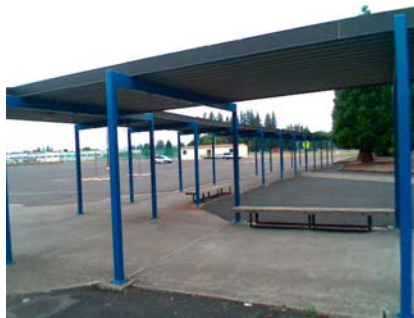
W Falling Hazard

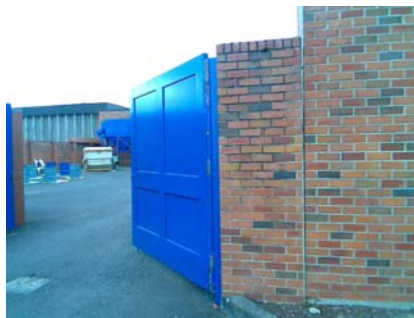
N Falling Hazard
Wall disconnected at gap.

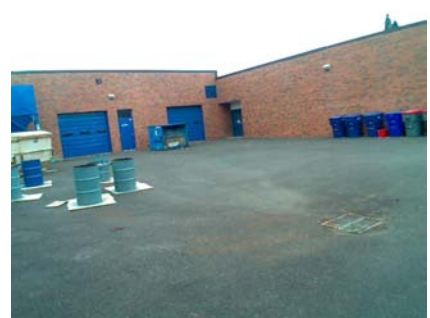
N Plan Irregularity Primary

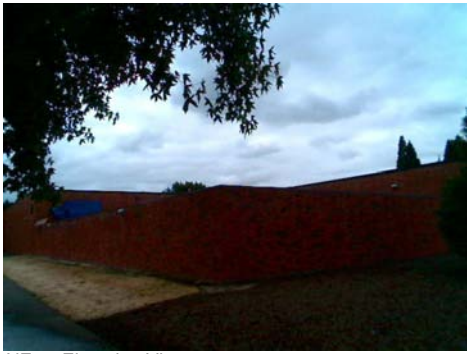
NE Elevation View
Wall around mech/loading dock area.

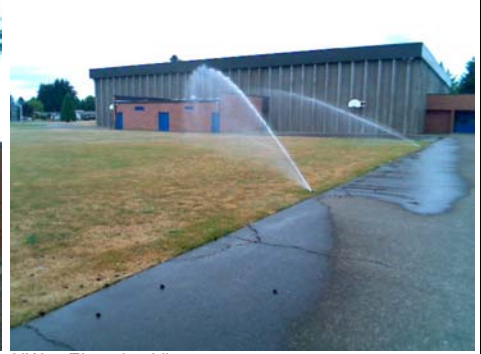
NW Elevation View
locker room on bldg C same type as bldg A

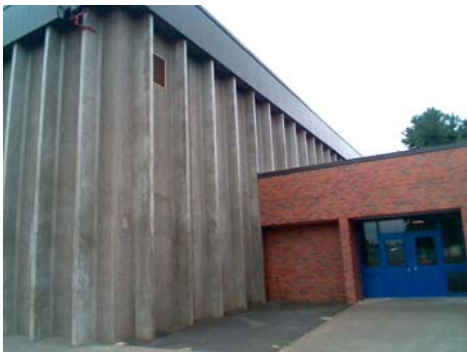
NW Plan Irregularity Secondary

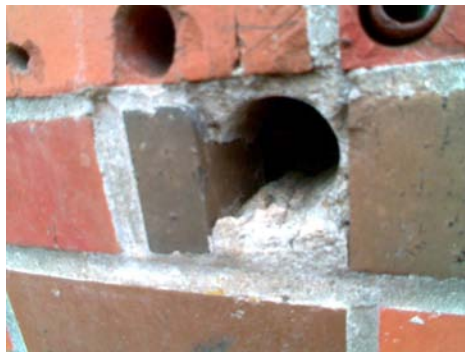
N Primary Structural Type
Possible cavity wall, behind first layer of brick some concrete can be seen inside the hole

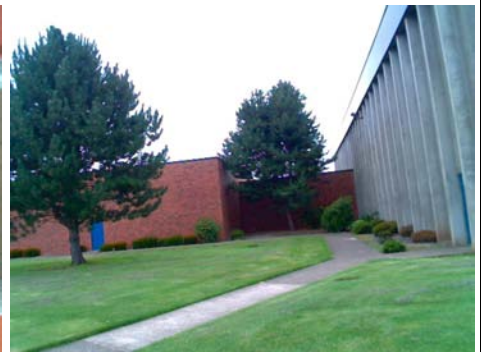
SW Vertical Irregularity Primary

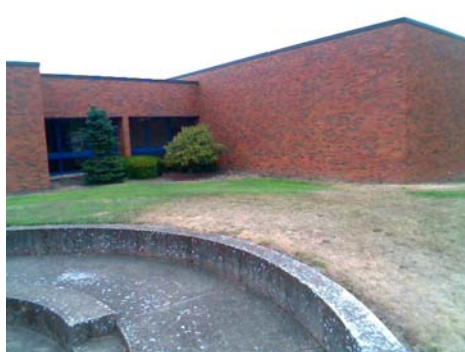
SW Plan Irregularity Primary

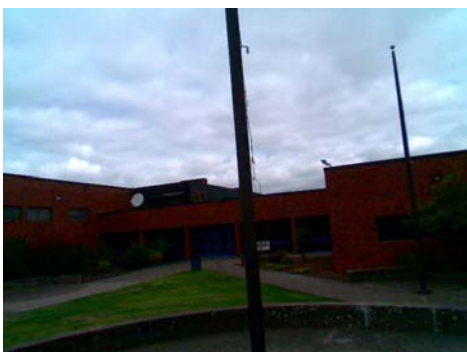
SE Plan Irregularity Primary

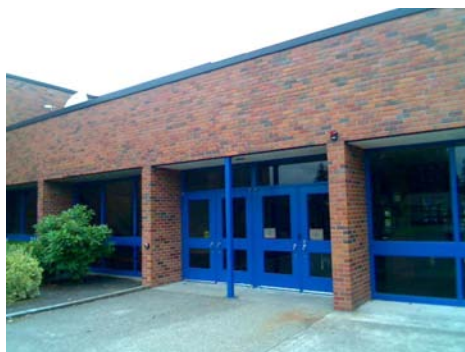
S Falling Hazard

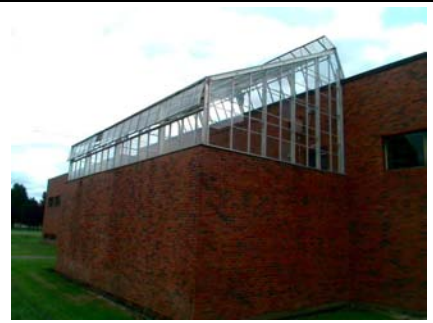
SW Pounding Potential

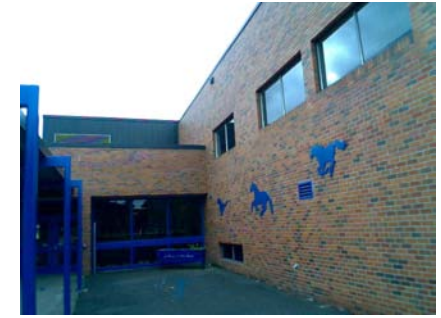
N Plan Irregularity Secondary

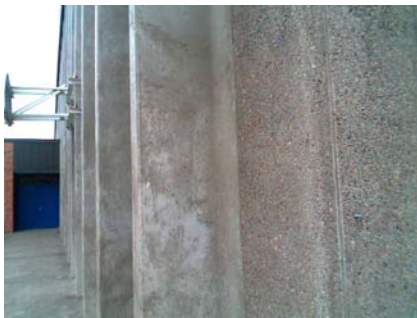
NW Primary Structural Type
Caulked edge.

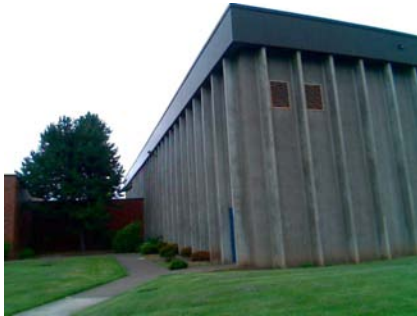
SW Vertical Irregularity Primary
