Sweet Home High School

Linn_sch19A

FEMA 154 Rapid Visual Screening Score Card

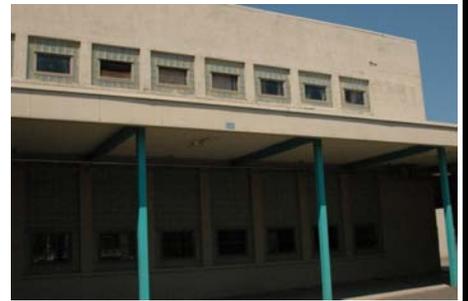
E Other
edge of new façade

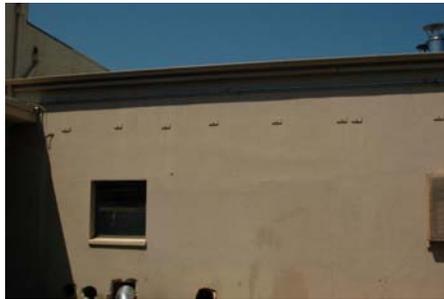
E Vertical Irregularity Primary

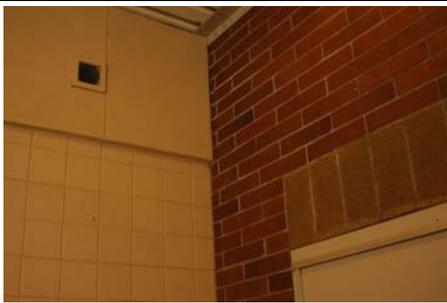
NE Other
No seismic joint between new and old construction. Brick on right is 2000's, RM on left is 1970's.

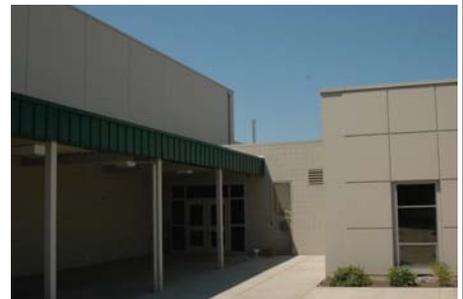
S Vertical Irregularity Primary

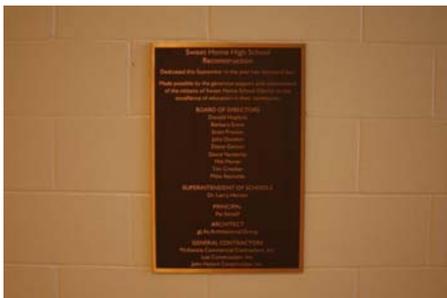
W Field Verified Year Built
plaque of 1974/5 remodel + additions
