McIntyre Group (*copper-gold*)

Reported by N.S. Wagner
Date of Examination:
May 24-28, 1943

REPORT ON THE BUILDINGS AND MECHANICAL INSTALLATIONS AT THE McINTYRE MINE* WITH EMPHASIS ON SAFETY ASPECTS

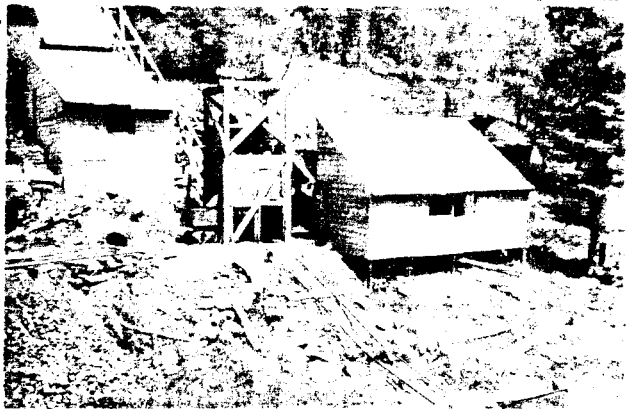
The head frame is a conventional one with a storage bin for ore and waste, these products being pulled from different chutes to cars on separate tracks as is shown in picture 1.

No provisions have been made for a runaway and an unsuspecting worker coming out of the compressor house would be directly in the path, (Picture 1 & 4). In fact, a kink in the rails a short distance above the headframe would doubtless derail the car and throw it squarely into the forge area of the service shed if the point where it cut loose was above this kink. No platform or screen has been constructed above the main door to the mill (Picture 3) to shield those below from rocks falling from the car, and considering the steepness of the incline and the fact that the car is small and not built up on the downside, a considerable amount of rock probably does fall.

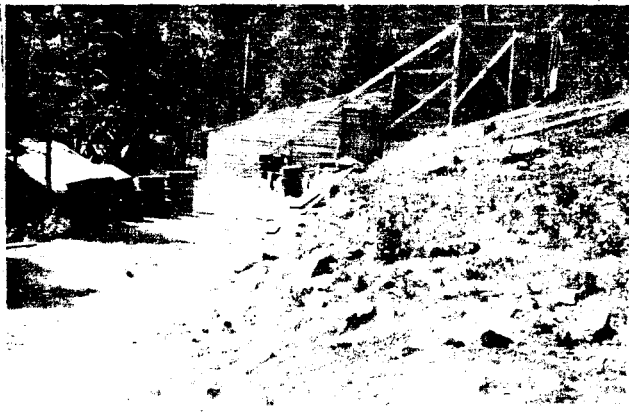
3.

engine was adequately vented normally, having been damaged during the winter. In fact, it is reported that Mr. Rice had noted this break in the line and had mentioned repairing it at an early date. The fatalities caused by these fumes were due to a combination of negligence and coincidence rather than by a fundamentally thoughtless set up, negligence in that repairs to a known break were put off till 'mañana', and coincidence in that for this once the wind blew the fumes back under the building instead of away from it, or that it was so cold that the windows and doors of the compressor house were left shut so that the compressor was forced to suck the fumes back through the only vent hole left, namely that in the floor. However adequately these fumes may have been handled prior to this particular time, an inexcusable fire hazard exists in that the gasoline tank for the engine straddles the frame above this exhaust, so that gasoline spilled in filling the tank is likely to pour over the hot exhaust pipe. A fire thus started could be situated within 7 feet of the collar, in a building that is built as a part of the collar of the shaft, actually using one of the collar timbers for a foundation. Picture 3 is a generalized sketch of this compressor-engine setup.

the rear corner in this same picture. This drum has a spout in it, and has been officially located here on a plankway built for the purpose. It is within 12 feet of the collar. In fact, the main fuel dump for all three gasoline engines is scattered along the road immediately above the collar (Picture 3) and much of it lies in the L formed by the mill and the compressor and is not over 30 feet distant from the collar (Picture 6). A fire in this shed could be started from the forge itself, from hot sharpened steel, from a smoke or match, or from sparks struck from an axe or comparable tool igniting fumes or gasoline from the drum. Whereas the shed was neat and clean at the time of this examination, timbers, wedges, cuttings and shavings undoubtedly accumulate when active work is being carried on, and even though these be periodically swept up, they increase the fire hazard.

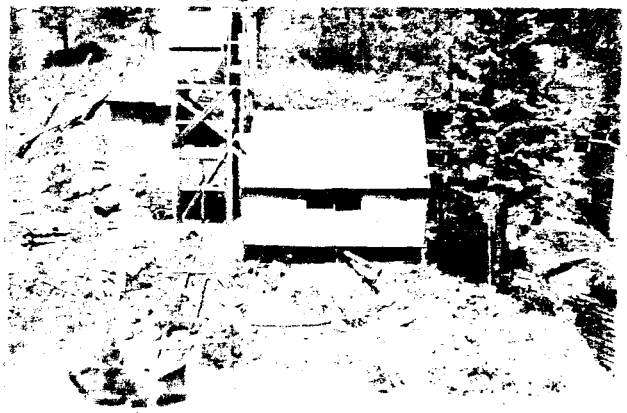
Compressor House The compressor house occupies the foreground of picture 4. It, like other buildings, is tightly walled with ship lap and roofed with composition roofing. Two sets of 2 $\frac{1}{2}$ foot square windows on opposite sides and a door on each of the ends provide ventilation. A Worthington Compressor powered by a Mack Truck engine is mounted, together with such accessories as radiators, extra cooling medium containers, air receiver, etc., on a steel frame. A couple flooring boards have been left out under a part of this unit and the engine exhausts through this hole. Compressor and engine oil and an assortment of small tools stored there.

Hoist house This small building stands apart from the other buildings, and is to be seen at the extreme right of picture 4. The hoist of unknown make, is powered by a single cylinder horizontal Fuller Johnson, gas engine of 5 h.p. Although the hoist drum may prove to have a diameter smaller than desirable for the cable used, this installation above all, was commendably neat. The engine exhausted through the roof.

The Compressor House. Although the engine exhaust here was carried to the outside of the building at the time of this examination (Picture 4) through a temporary installation made by the rescue workers, it is believed that this

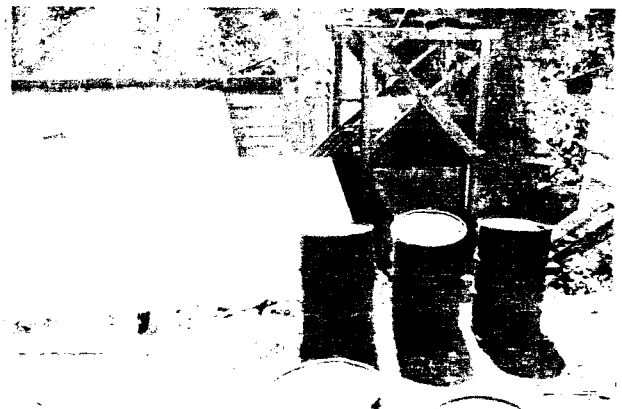
6.

Headframe This in itself is well constructed, but it is located so close to the compressor house that a section had to be cut from the lean-to roof to make clearance for the skip (Picture 6). It is therefore subject to the same danger from fire as is the collar proper. Its collapse might conceivably allow a runaway skip, which might in turn injure men below if they weren't already suffocated or trapped by a cave-in of the collar. In any event, loss of the structure would seriously impair subsequent rescue work.
