CALICO RESOURCES USA CORP.
GRASSY MOUNTAIN MINE PROJECT
MALHEUR COUNTY, OREGON

**VISUAL RESOURCES
BASELINE REPORT**

DECEMBER 2017

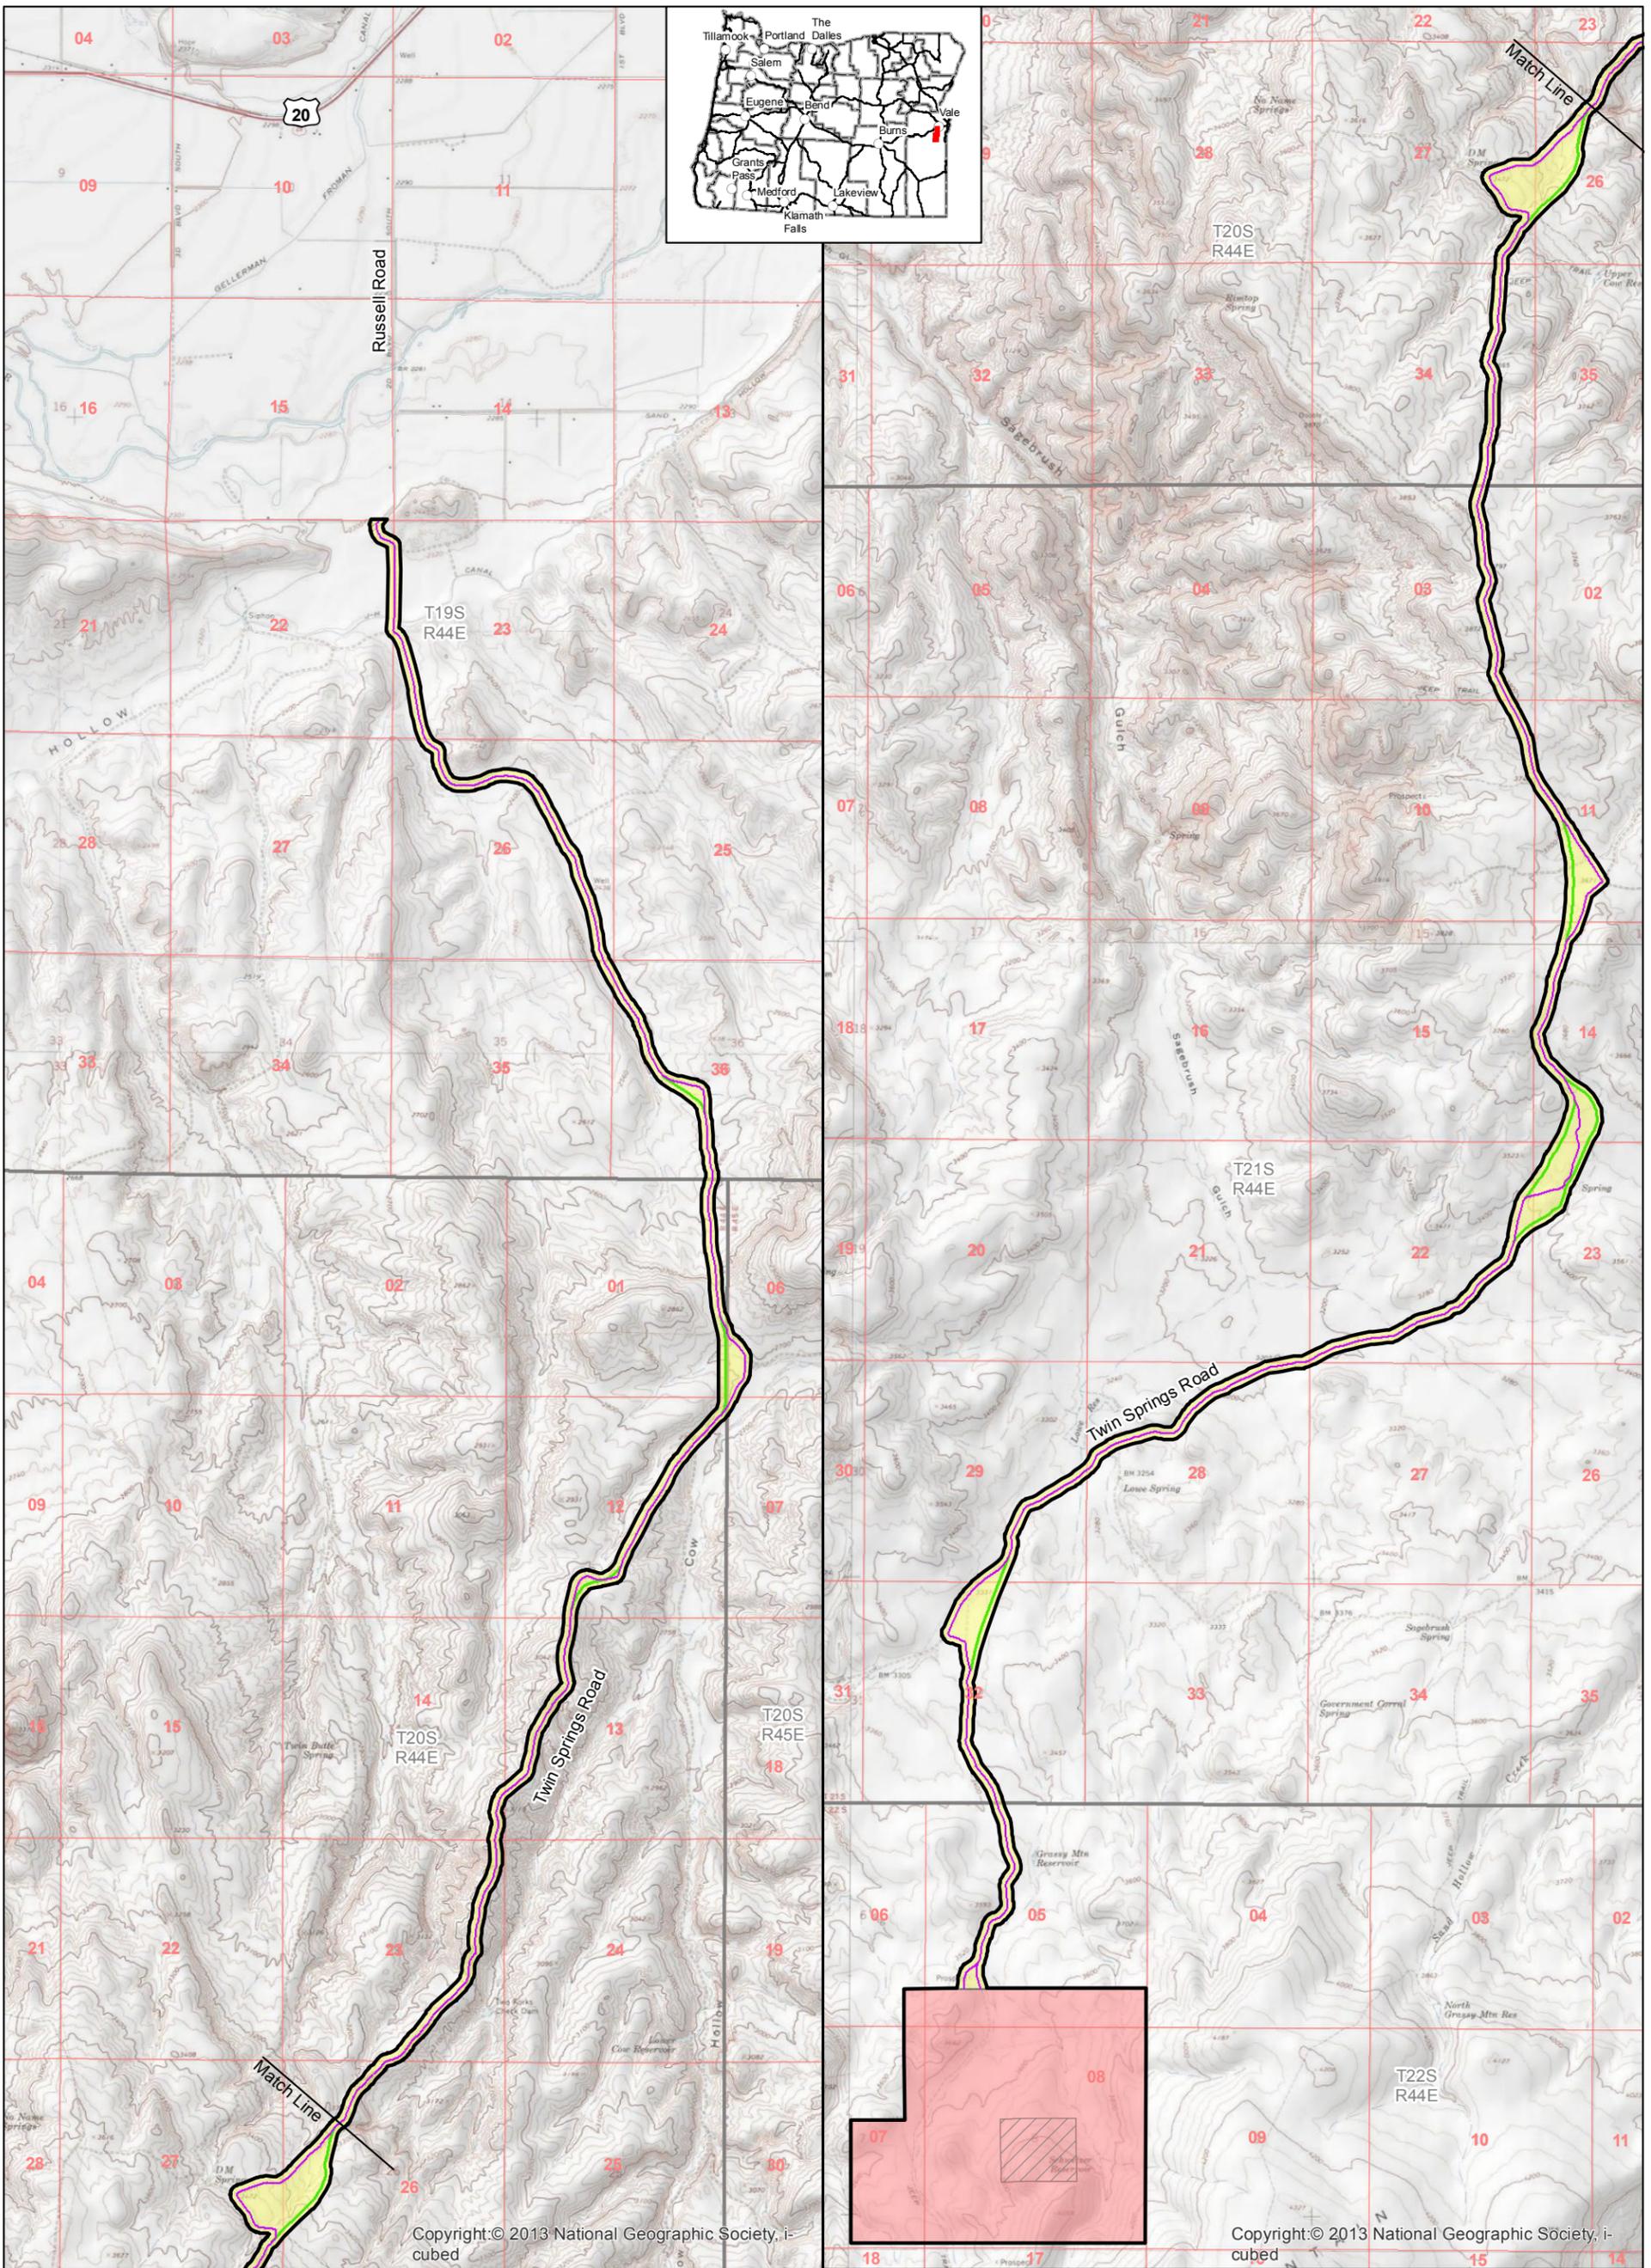
Figure 2

- Permit Area
- Mine and Process Area
- Access Road Area
- Patented Lode Claims
- Proposed Access Road
- Possible Road Realignment

Permit Area Map

The Project is located in Malheur County, Oregon, approximately 22 miles south-southwest of Vale (Figure 1), and consists of two areas: the Mine and Process Area and the Access Road Area (Permit Area) (Figure 2).

The Mine and Process Area is located on three patented lode mining claims and unpatented lode mining claims that cover an estimated 886 acres. These patented and unpatented lode mining claims are part of a larger land position that includes 419 unpatented lode mining claims and nine mill site claims on lands administered by the Bureau of Land Management (BLM) (Figure 2). All proposed mining would occur on the patented claims, with some mine facilities on unpatented claims. The Mine and Process Area is in all or portions of Sections 5 through 8, Township 22 South, Range 44 East (T22S, R44E) (Willamette Meridian).

The Access Road Area is located on public land administered by the BLM, and private land controlled by others (Figure 2). A portion of the Access Road Area is a Malheur County Road named Twin Springs Road. The Access Road Area extends north from the Mine and Process Area to Russell Road, a paved Malheur County Road. The Access Road Area is in portions of Section 5, T22S, R44E, Sections 3, 10, 11, 14, 15, 21 through 23, 28, 29, and 32, T21S, R44E, Sections 1, 12 through 14, 23, 26, 27, and 34, T20S, R44E, Sections 6 and 7, T20S, R45E, and Sections 22, 23, 26, 35, and 36, T19S, R44E (Willamette Meridian). The width of the Access Road Area is 300 feet (150 feet on either side of the access road centerline) to accommodate possible minor widening or re-routing, and a potential powerline adjacent to the access road. There are several areas shown that are significantly wider than 300 feet on the Permit Area Map (Figure 2), which are areas where the final alignment has not yet been determined. The final engineering of the road

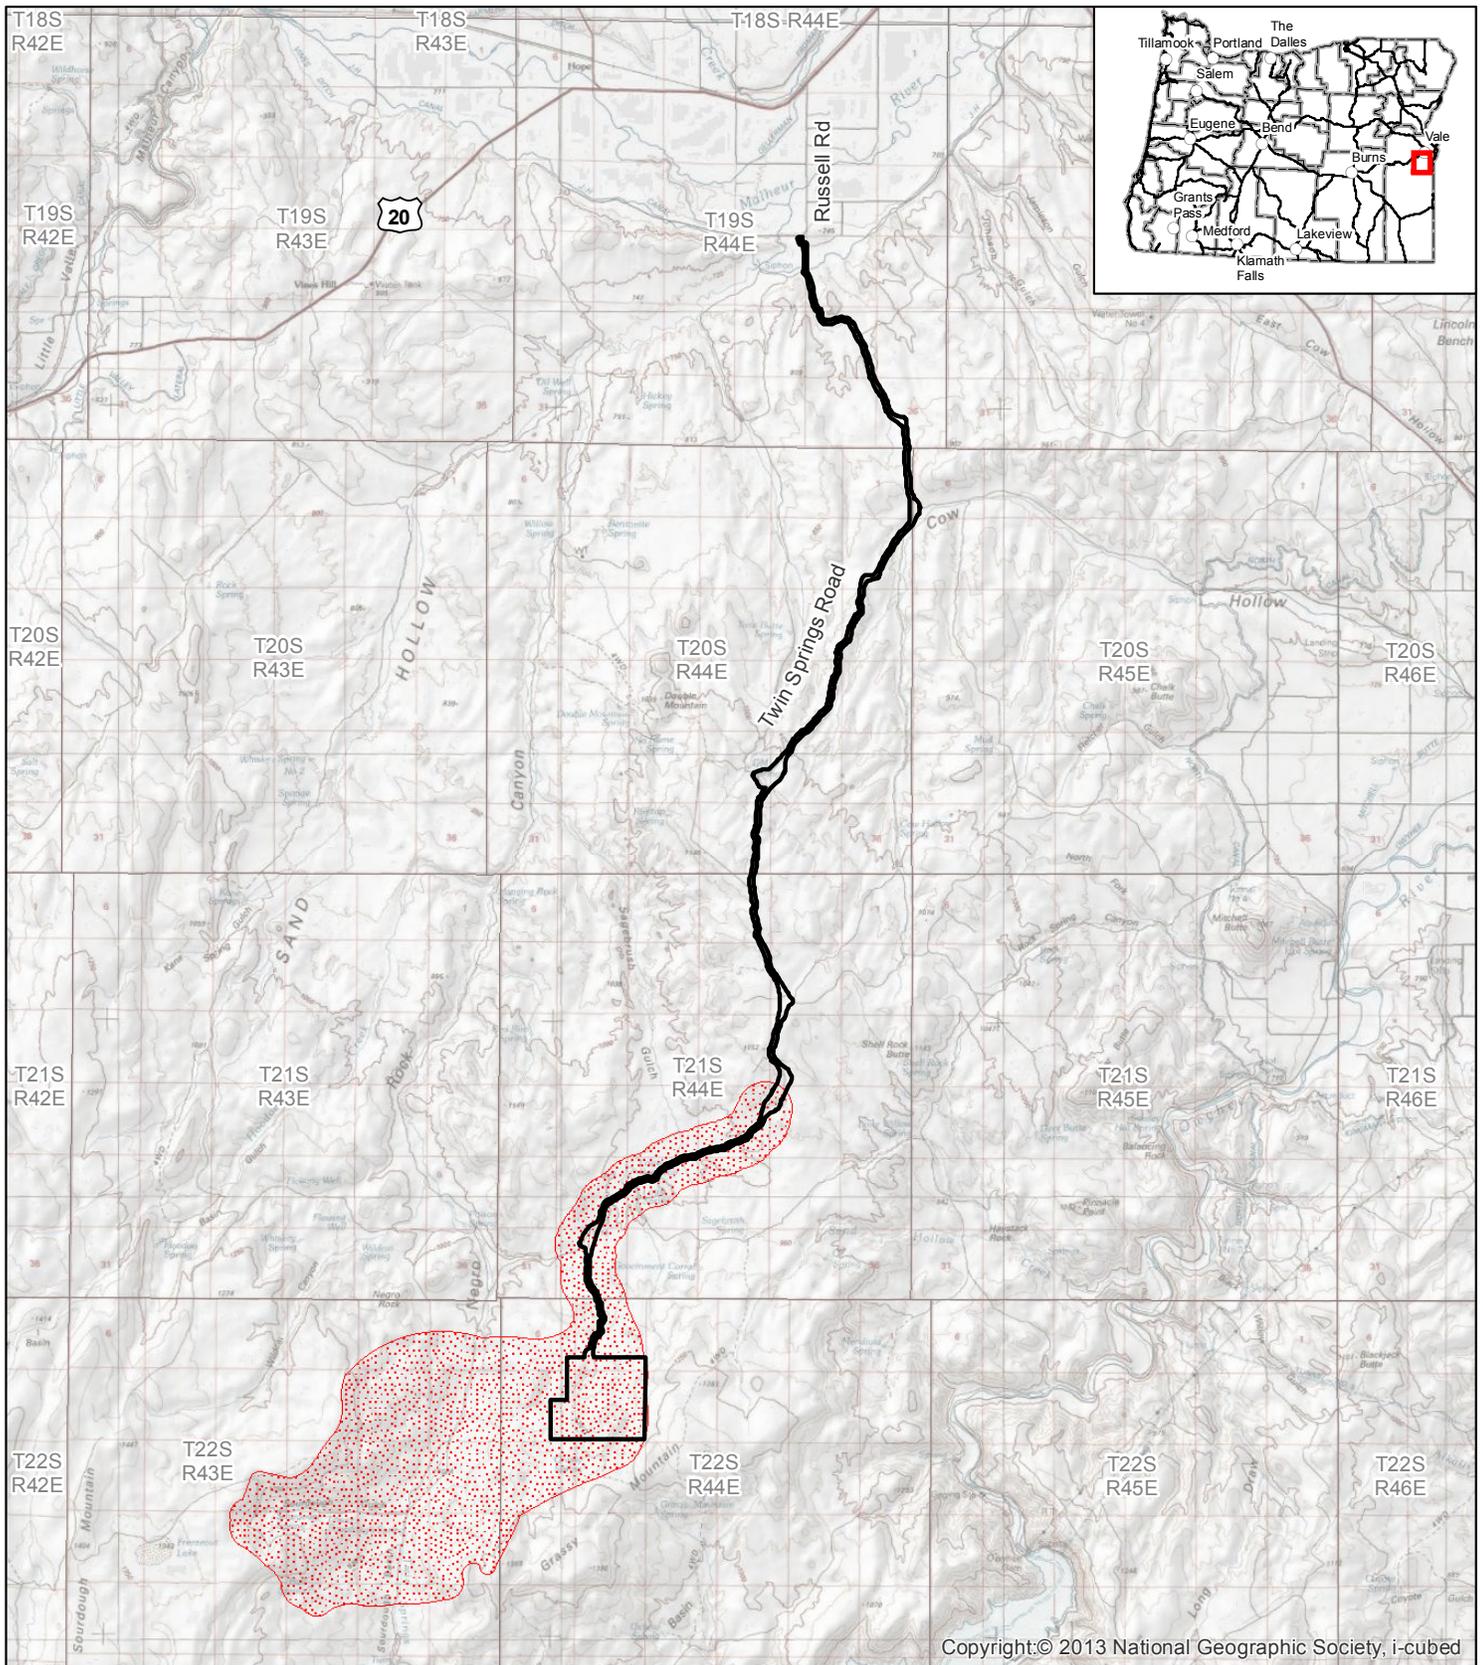
Figure 3

Visual Resources Study Area

will be consistent throughout, and within the Permit Area. The Access Road Area also includes a buffer on either side of the proposed road width for the collection of environmental baseline data. The road corridor will be 40 feet wide, which includes a 24-foot wide road travel width (12 feet on either side of the road centerline), four-foot wide shoulders on each side of the road, minimum one-foot wide ditches on each side of the road, and appropriate cut and fill. The Access Road Area totals approximately 876 acres. The Visual Resources Study Area (Study Area) is shown on Figure 3.

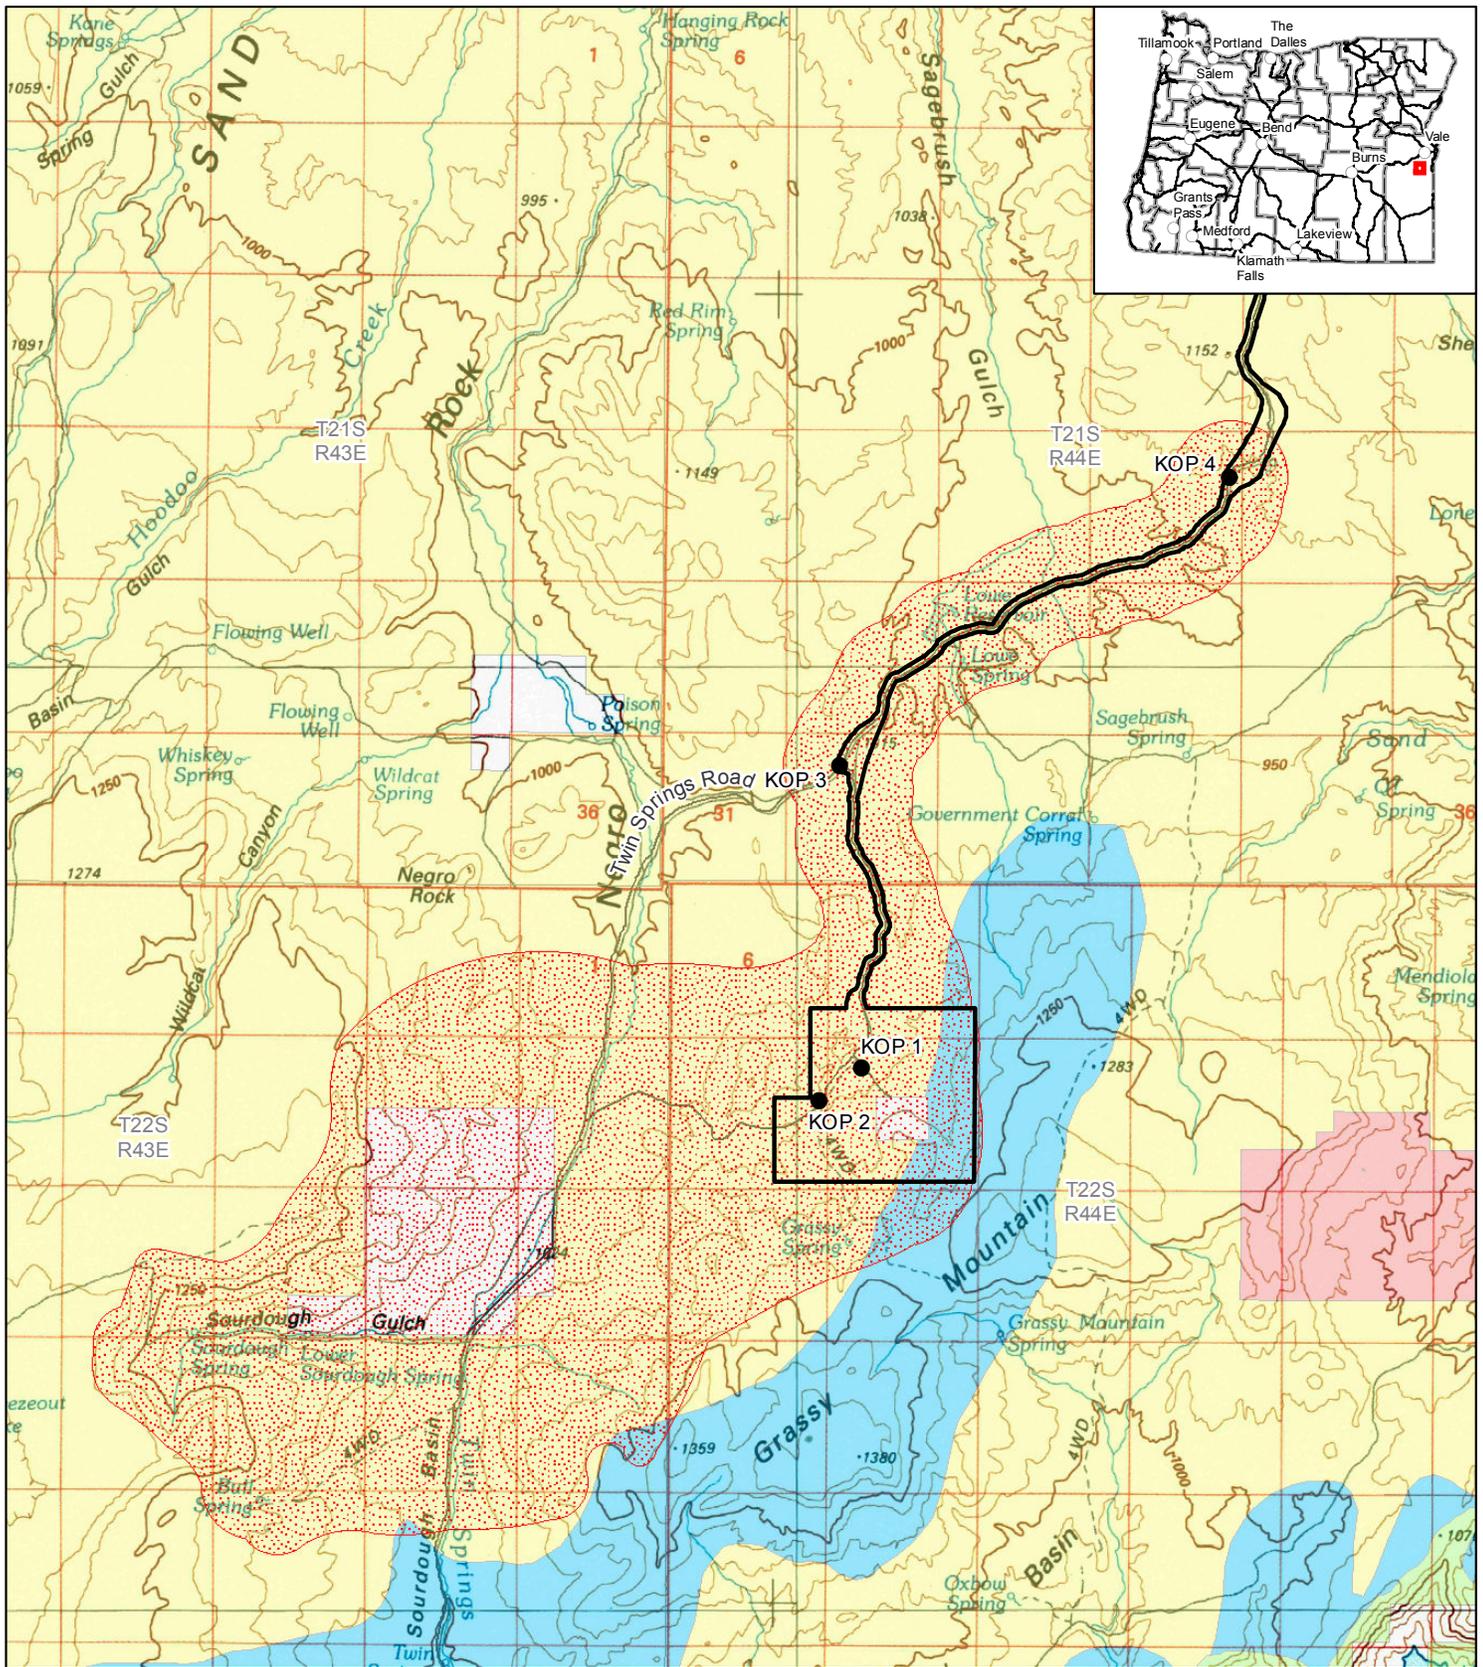
- Visual Resources Management Classes (VRM)**
- VRM 1 - Preserve existing character of landscape
 - VRM 2 - Largely retain the existing character of the landscape
 - VRM 3 - Partially retain the existing character of the landscape
 - VRM 4 - Modification of the character of the landscape is allowed

Visual Resources Management Classes and Key Observation Points

Field investigations were conducted to document the existing landscape conditions in the Study Area during the spring and fall of 2014 and April 2015. Several KOPs were chosen to describe the existing visual elements of the Study Area in the context of form, line, color, and texture associated with the characteristic landscape. BLM Visual Contrast Rating Worksheets for each KOP were completed to ensure that all parameters necessary to characterize the existing conditions were documented. KOPs 5, 6, 7, and 8, as identified in the April 2015 HDR report have been renumbered to KOPs 1, 2, 3, and 4, respectively, for this report (Figure 4).

Four KOPs have been selected to capture views that represent the existing landscape where Project activities are being proposed. The KOPs include views of BLM-administered land that may be used to support future mining activities, as well as the proposed access road corridor, which could be upgraded to provide improved vehicle access to the Project. Each of the four KOPs is given a number designation. The KOPs are briefly described in Table 2 and shown on Figure 4 along with the VRM classes.

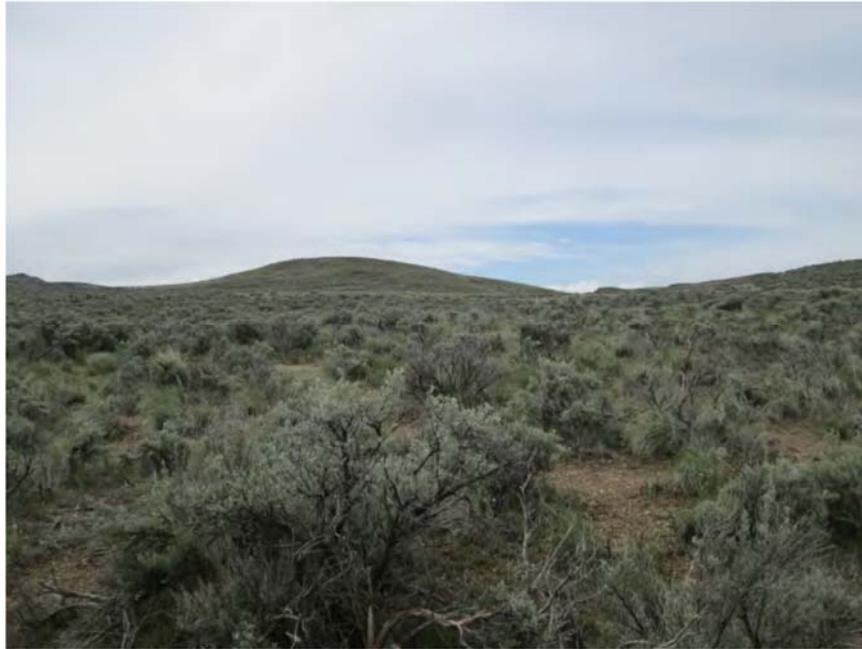
Photo 1: Characteristic Landscape

The landscape within the Study Area is characterized by gently rolling hills, with small rock outcroppings along ridgelines. In general, soils throughout the Study Area are light tan in color. Dark brown rock outcroppings are visible along ridgelines. The Study Area has experienced some disturbance created by various access roads; however, very few man-made structures exist throughout the landscape. The most common structures include fence lines, stock-watering troughs, and transmission lines, which are visible at various locations throughout the Study Area.

Vegetation within the study area is a desert-rangeland type, where sagebrush and grasses are the dominant species. The area has been extensively grazed for many years and invasive cheatgrass dominates much of the landscape. The landscape experiences very little change in color throughout the year. In general, hues of green/gray are typically visible in the sagebrush and rabbitbrush, and the grasses vary between light-yellow/green to light-gold/brown throughout the year. Photo 1 shows the characteristic landscape during spring when there is the most color contrast.

In general, the landscape is devoid of unique water features, has vegetation common to the region, has relatively homogenous color composition, and has large amounts of open space with few unique topographic features.

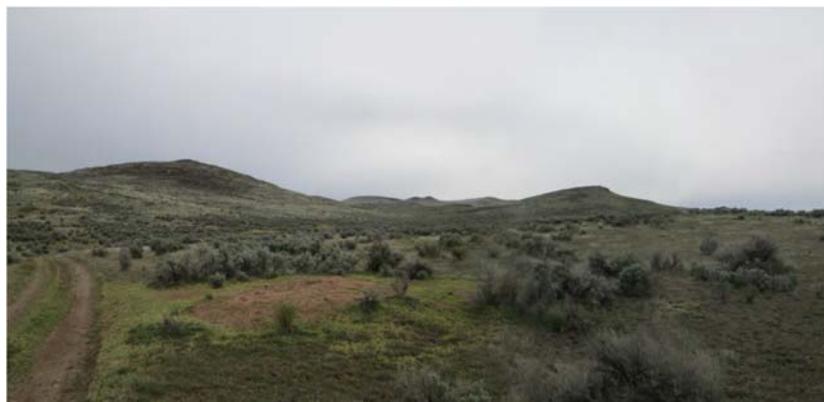
Photo 2: KOP 1

KOP 1 (Photo 2) is located at the end of the Access Road facing south in the Mine and Process Area.

The visible landscape in this area is characterized by gently rolling hills, viewed in the middleground and background. Rock outcroppings are visible along the ridgelines viewed in the middleground, especially at the proposed Mine and Process Area. Soil ranges from tan to brown and rock outcroppings are dark brown in color.

Vegetation at this location consists of a shrub stratum that includes big sagebrush and rabbitbrush. The herbaceous stratum consists of bunchgrasses and cheatgrass, which is dominant across the landscape. The shrub stratum, which is viewed in the foreground and middleground, is gray/green with a fine to medium texture. The herbaceous stratum, which is viewed in the foreground and middleground, is light and varies between green and bright green. In general, the landscape is void of species diversity.

Tire tracks created by the access road add a linear element to the foreground of the viewshed. The texture of the tire tracks contrasts with the adjacent vegetation and undisturbed soil. No other man-made features are visible at this location.

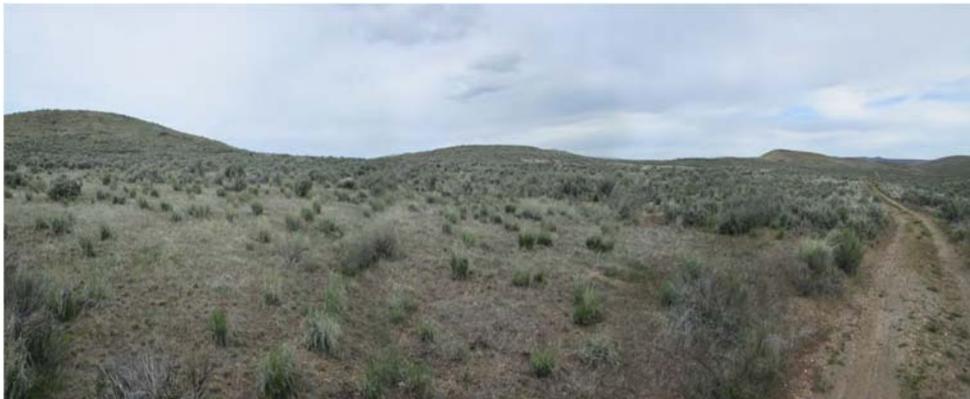
Photo 3: KOP 2

KOP 2 (Photo 3) is located in the western portion of the Mine and Process Area facing northeast.

Similar to KOP 1, the visible landscape from this location is characterized by gently rolling hills, viewed in the middleground and background. Soil colors range from tans to browns with a few dark brown colored rocks scattered throughout the landscape.

Vegetation dominated by sagebrush and bunchgrasses creates a mottled texture throughout the viewshed. The shrub stratum is comprised of big sagebrush and rabbitbrush, while the herbaceous stratum consists of bunchgrasses and cheatgrass. The shrub stratum, viewed in the foreground and middleground, is gray/green with a fine to medium texture. The herbaceous stratum, viewed in the foreground and middleground, is light green in color.

Tire tracks created by the access road add a linear element to landscape as they pass through the viewshed from the foreground before disappearing into the middleground. The texture of the tire tracks contrasts with the adjacent vegetation and undisturbed soil. No other man-made features are visible at KOP 2.

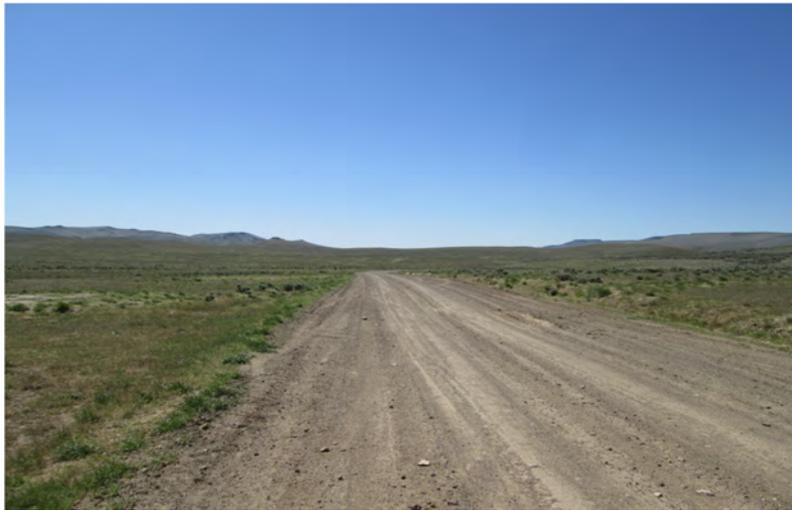
Photo 4: KOP 3

KOP 3 (Photo 4) is located at the intersection of the Access Road Area and Twin Springs Road facing south toward the Mine and Process Area.

The terrain consists of a relatively flat valley bottom. Gently rolling hills are visible in the middleground and background, in the area of the Project. Fine-textured soil throughout the landscape ranges from light tan to brown. Some rock outcroppings are visible in the background and are dark brown in color. Small, light-colored, angular rocks and gravel are present along the access road.

Vegetation viewed in the foreground is relatively homogenous and dominated by grasses, including bluebunch wheatgrass and cheatgrass ranging from green to green/brown in color. Sagebrush in the shrub stratum is sparsely distributed throughout the landscape.

The soil color and texture of the access road contrast with the adjacent undisturbed landscape, especially in the foreground. Views of the roadway diminish as it passes through the middleground to the background toward the Mine and Process Area. Tire tracks in the foreground and middleground introduce a linear element to the natural landscape. No other man-made features are visible from this KOP.

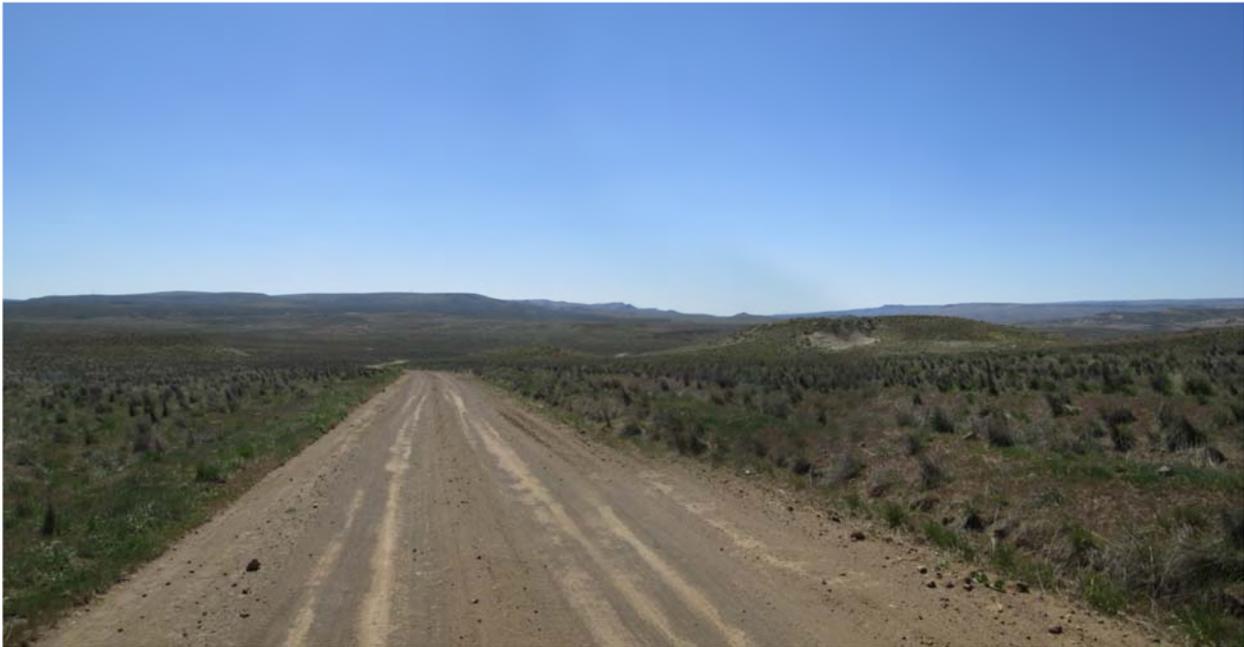
Photo 5: KOP 4

KOP 4 (Photo 5) is located along Twin Springs Road in the northeastern portion of the Study Area facing south toward the Mine and Process Area.

The terrain viewed in the foreground and middleground slopes gently toward the south. Gently rolling hills are visible in the background along the horizon line. Soils range from tan to light brown. Some rock outcroppings are visible in the middleground and background and are dark brown in color. Small angular rocks are present along the edge of the existing road.

Vegetation viewed in the foreground is dominated by grasses, including bluebunch wheatgrass and cheatgrass, which create a mottled, fine texture across the landscape. Sagebrush in the shrub stratum is sparsely distributed throughout the landscape. Varying hues of green are visible throughout the landscape.

The colors and textures created by Twin Springs Road contrast sharply with the adjacent undisturbed landscape, especially in the foreground. Views of the roadway diminish as it passes through the middleground to the background. Tire tracks in the foreground and middleground introduce a linear element to the natural landscape. No other man-made features are visible from this KOP.
