Oregon Department of Geology & Mineral Industries  
800 NE Oregon St, Suite 965  
Portland, OR 97232

# Upper Rogue 3DEP Project Lidar QC Report – August 09, 2017

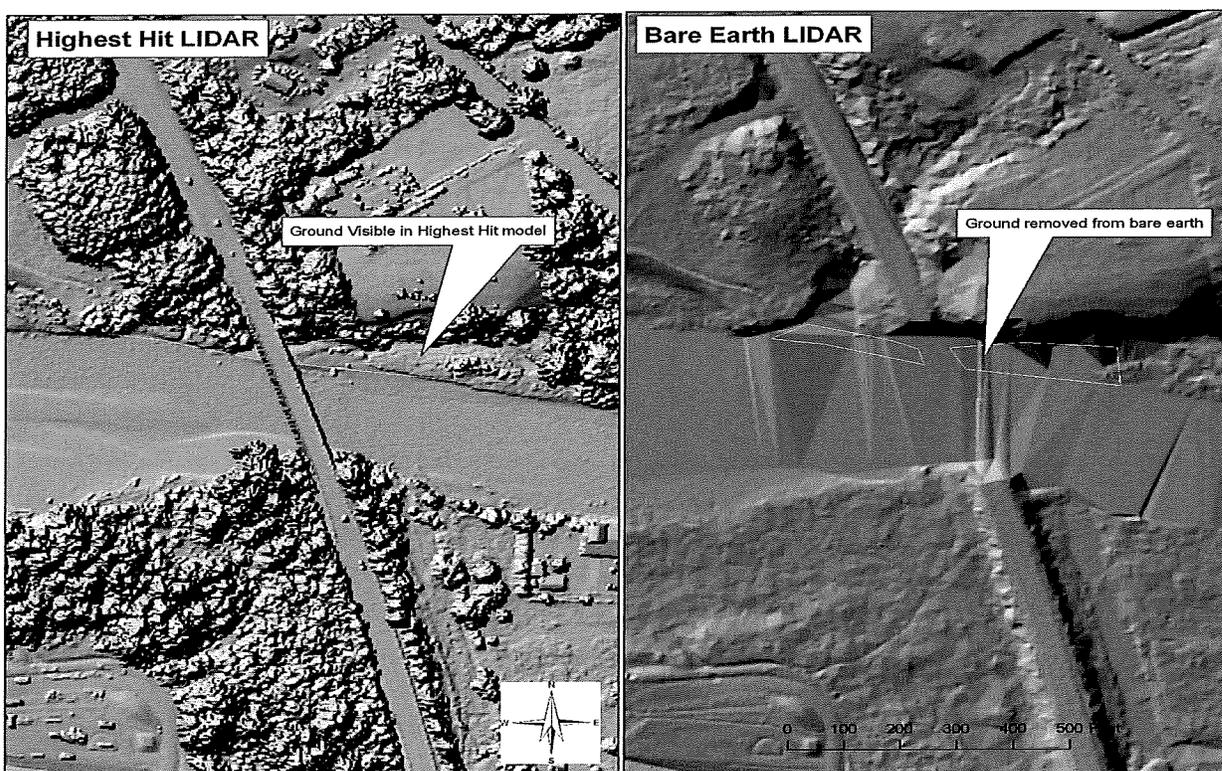
**Figure 6. Example of missing ground in lidar bare earth data. Ground is clearly visible in highest hit model, but has been removed from the bare earth model. This type of classification error is common near water body features.**

Lidar 3ft grids were loaded into ArcGIS™ software for visual analysis. Data were examined through slope and hillshade models of bare-earth returns. Hillshades of the highest hit models were used to identify areas of missing ground (Figure 6). Both bare-earth and highest hit rasters were examined for calibration offsets, tiling artifacts (Figure 7), seam line offsets, pits (Figure 8), and birds.

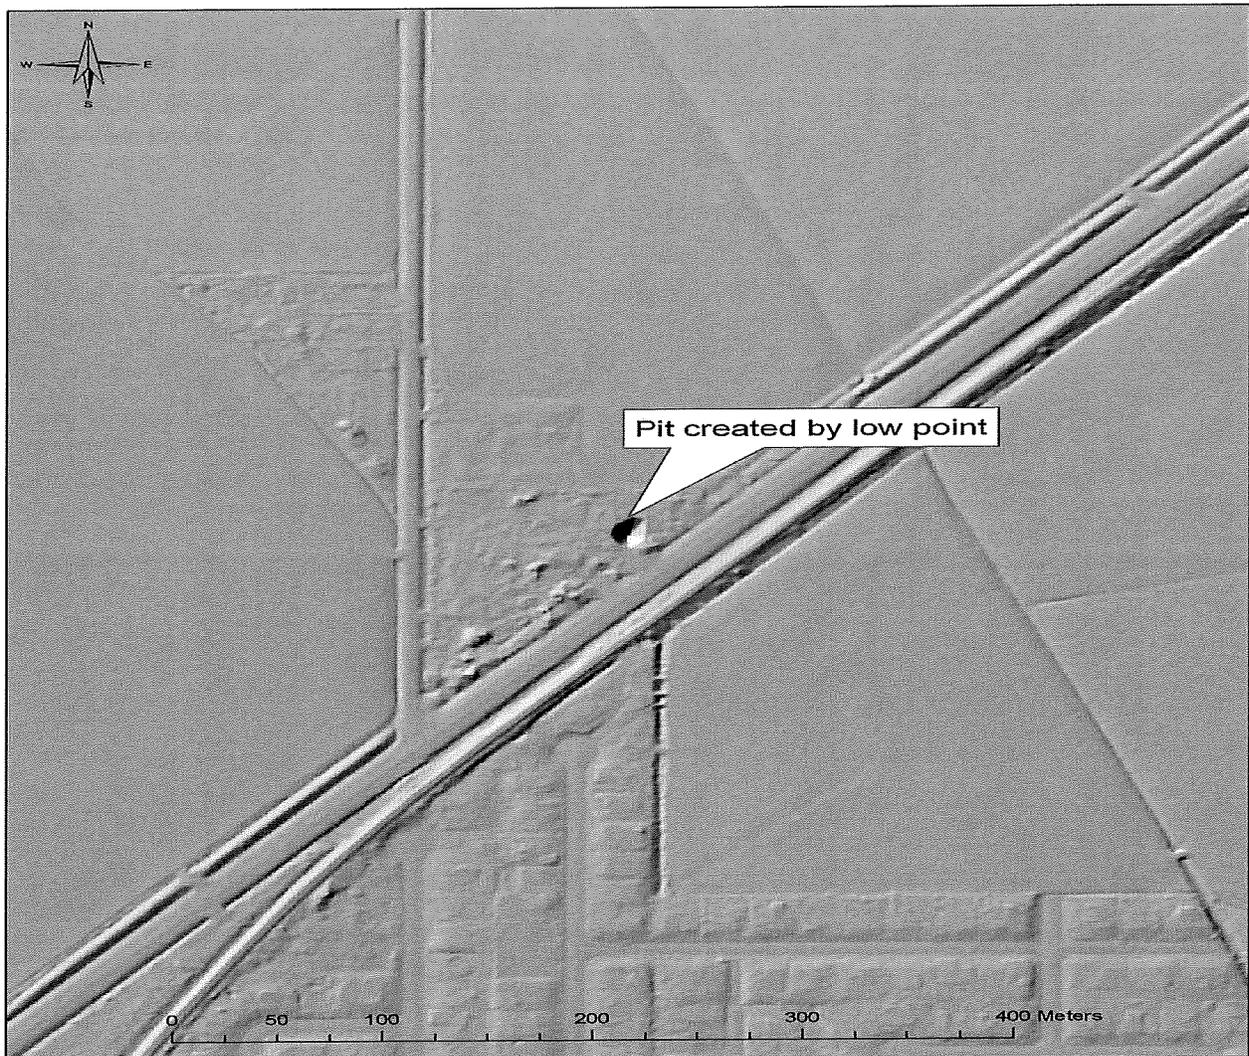
**Figure 8. Example of “Pit” caused by low point in ground model. Pits are caused when standing water absorbs the lidar pulse. Pits are evident in ground model as the lowest point elevation is assigned to the grid cell value. Inversely the pit is not observable in the highest hit model as the highest point elevation is assigned to the grid value.**
