State of Oregon  
Department of Geology and Mineral Industries  
Vicki S. McConnell, State Geologist

**OFR O-04-14**

**ROGUE RIVER STAKEHOLDER PROJECT  
PHASE 2**

**COMPLETION REPORT AND YEAR ONE  
MONITORING REPORT**

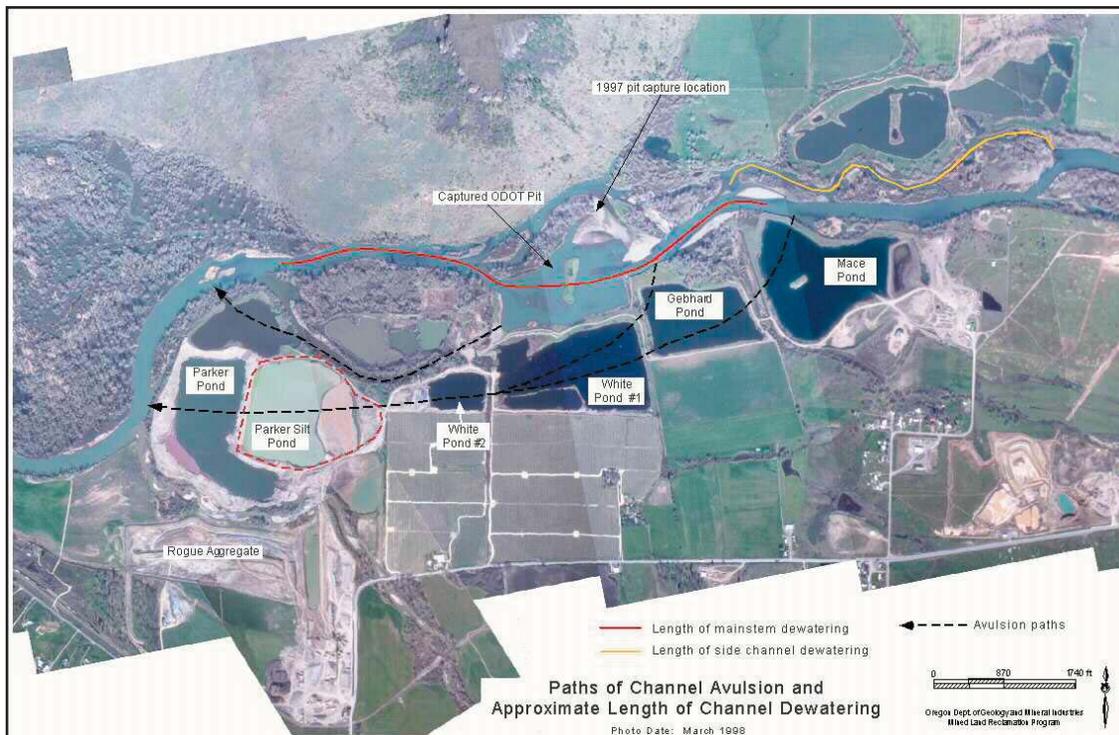
Figure 1.1. Potential Avulsion Paths.

velocities resulted in a permanent redirection of the Rogue River into the ODOT pond. After the flood waters receded and temporary emergency mitigation work was completed, it became clear that additional ponds were at risk from the post-capture accelerated stream erosion rates. Following a review of environmental options, it was determined that the Rogue River channel could not be returned to its pre-1997 stream course. The Rogue River's current channel instability would have to be addressed without further channelization. The Stakeholders proposed a geomorphic solution that would allow the dynamic Rogue River to adjust within its meander belt width and would reconnect the river to its adjacent flood-plain and partially abandoned meanders without the disastrous consequences of further pit capture.

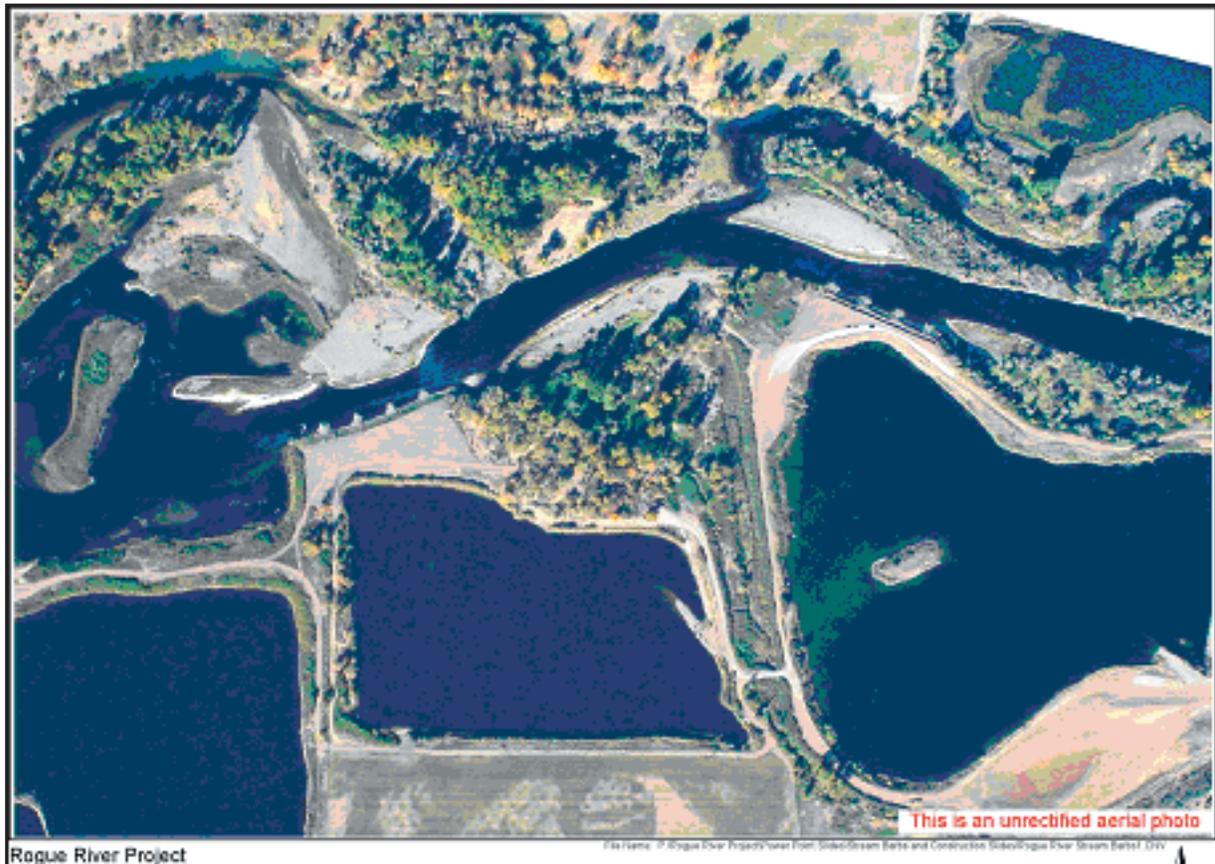
Figure 1.2. Phase 2 Stream Barbs and Bank Stabilization (Prepared by Vaughn Balzer).

- placing a series of four stream barbs at two locations at high risk for channel avulsion into floodplain ponds
- planting 1500 trees and 500 shrubs
- establishing hundreds of willow stakes and 100 feet of willow bundles rootwad placement at each barb
- burial of live cottonwood trees to provide bio-technical bank stability at key locations
- placing erosion mats on resloped channel banks

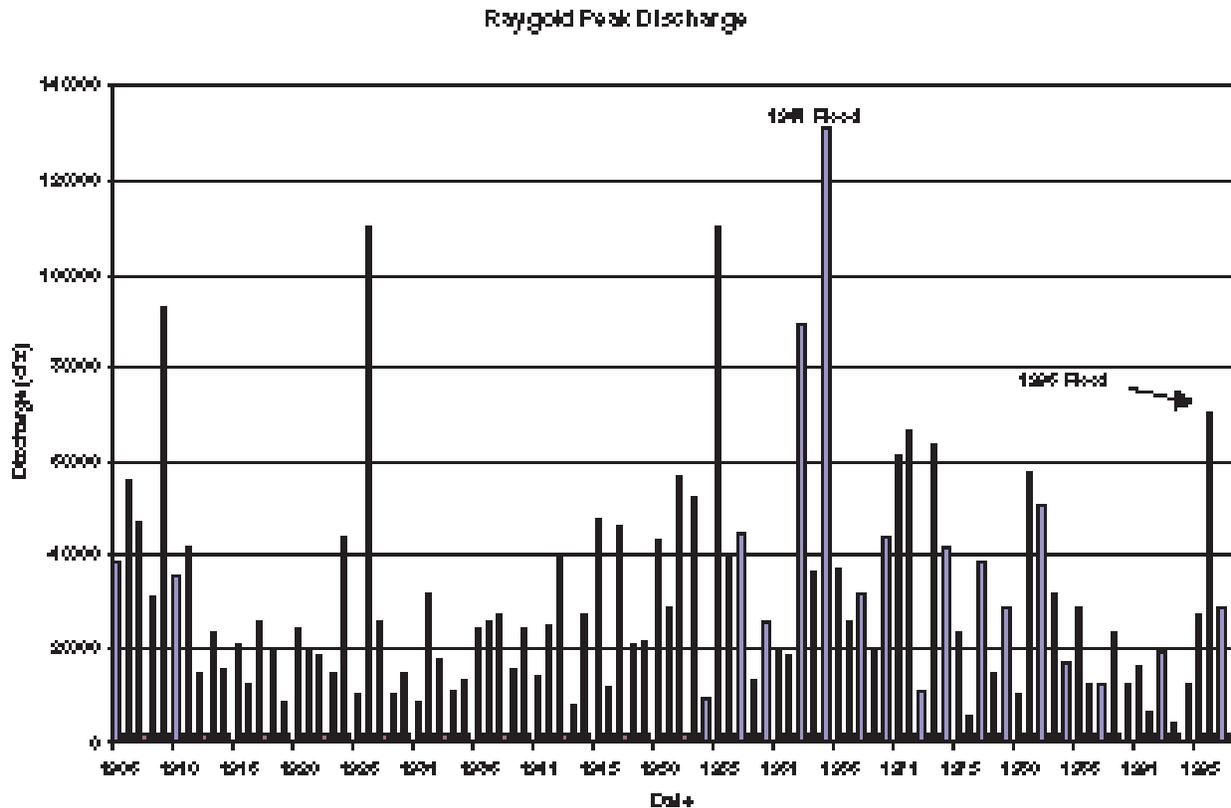
Figure 1.3. Peak Flows.

Figure 1.3 illustrates annual peak flows at the nearest river gauge from 1906 to 1997. This gage is located about two miles downstream. The 1996 flood was the sixth largest recorded flood event. The stakeholders considered the costs and benefits of various flood return periods including

the 100-year storm and concluded that the design flood for the project should be able to pass an event similar to the 1997 flood without incurring damage to the proposed structures.

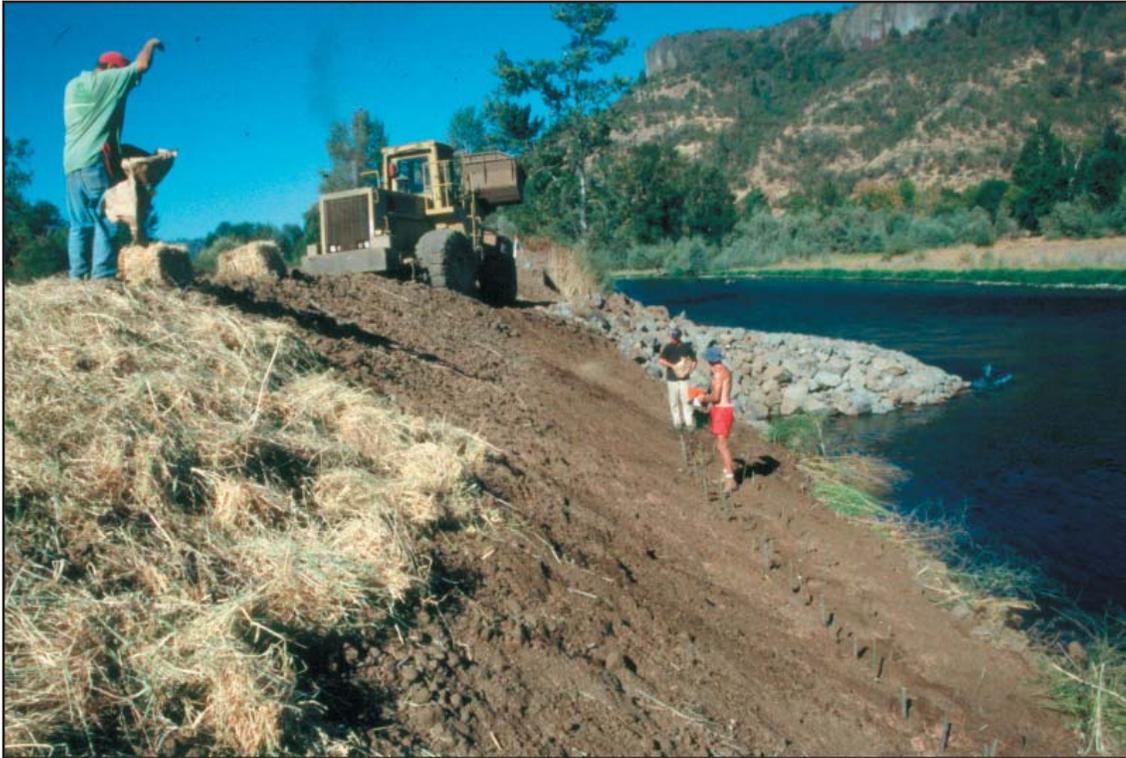
**Mace Site: Willow staking, seeding and mulching**

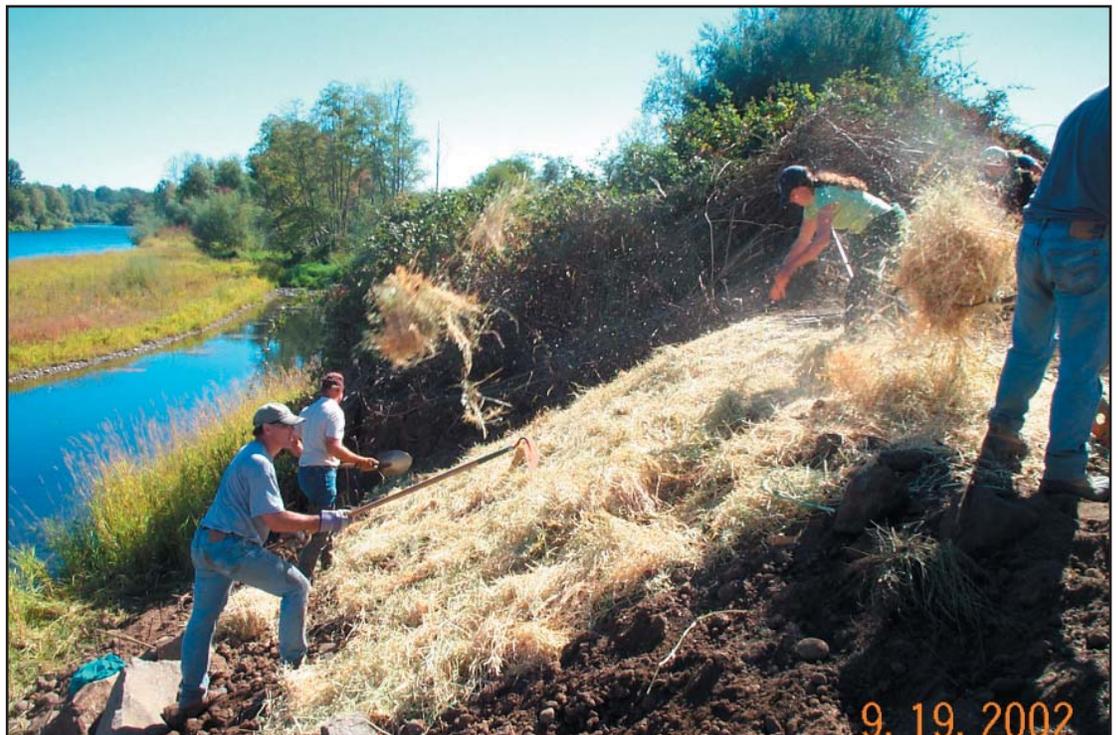
**Mace Site: Willow staking, seeding and mulching**

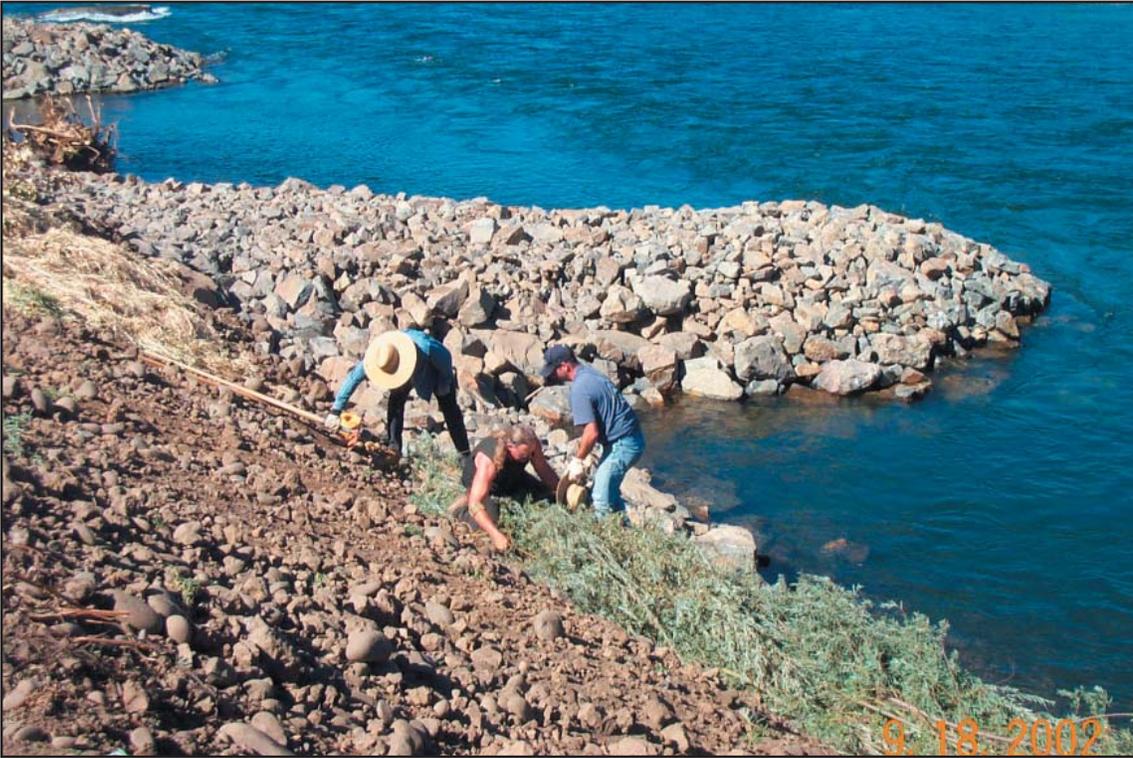
Gebhard Site: Construction of willow bundles.

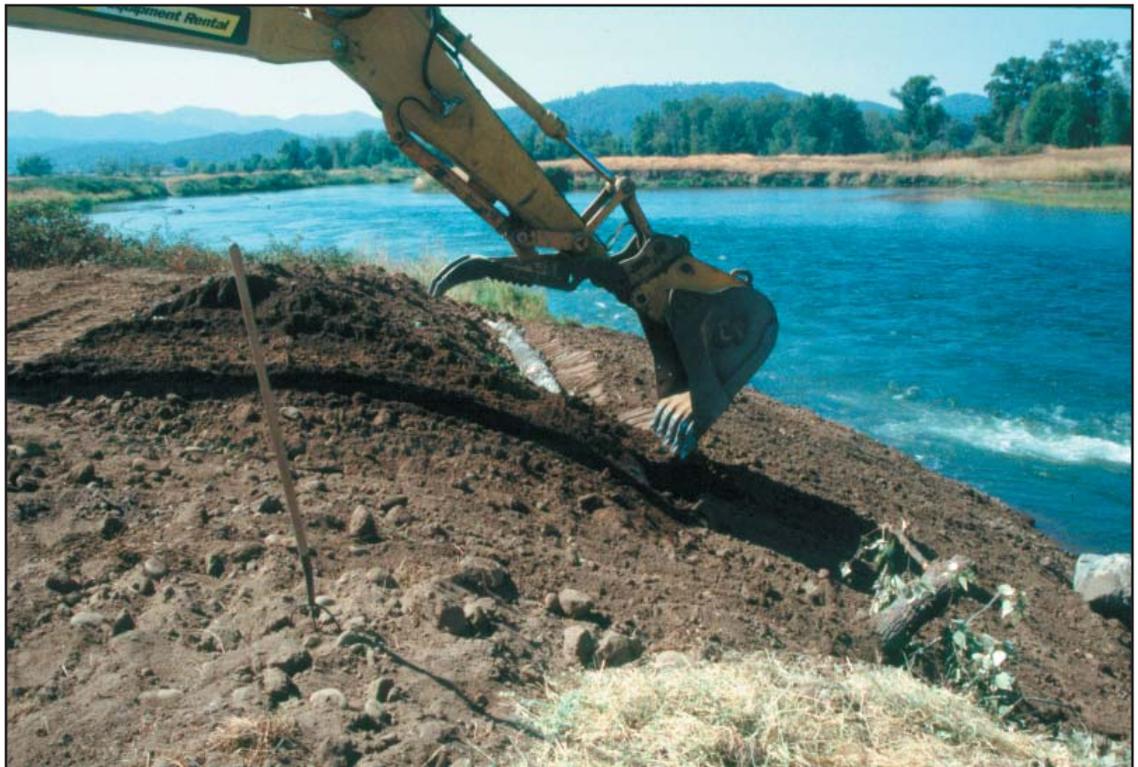
Gebhard Site: Biotechnical bank stabilization by burial of live cottonwood trees.

Live cottonwood trees were buried in the resloped river banks in the fills above each barb and at a few locations between the barbs. The cotton-

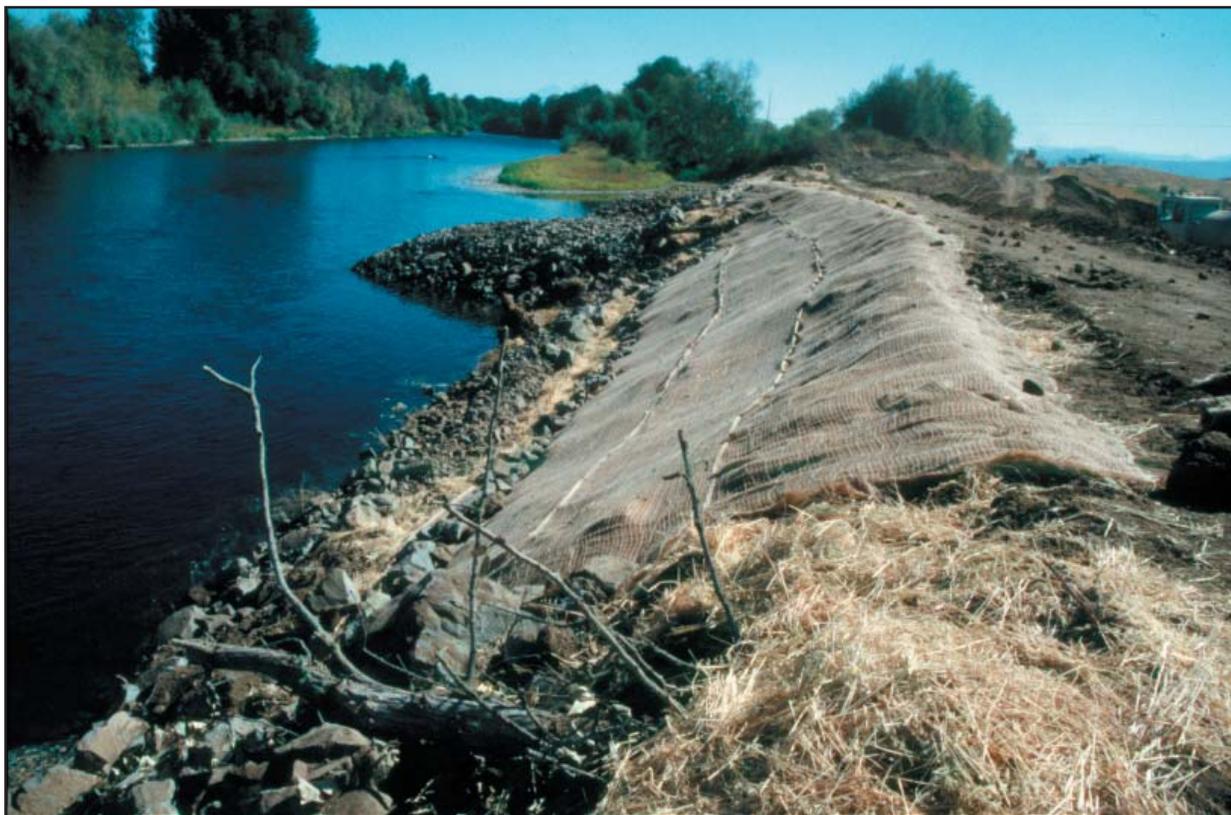
**Mace Site: After willow staking, seeding, and placement of erosion matting.**

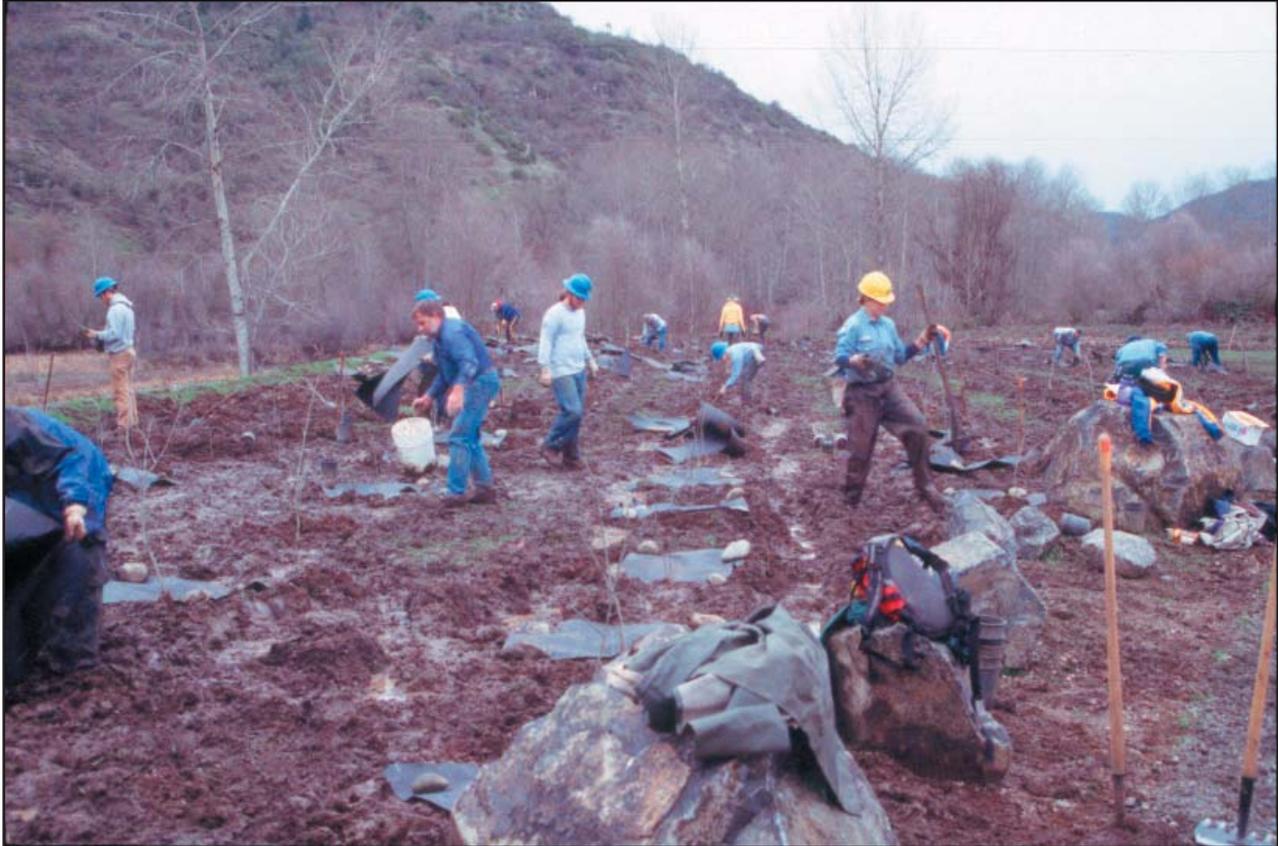
**Mace Site: Tree and shrub planting.**

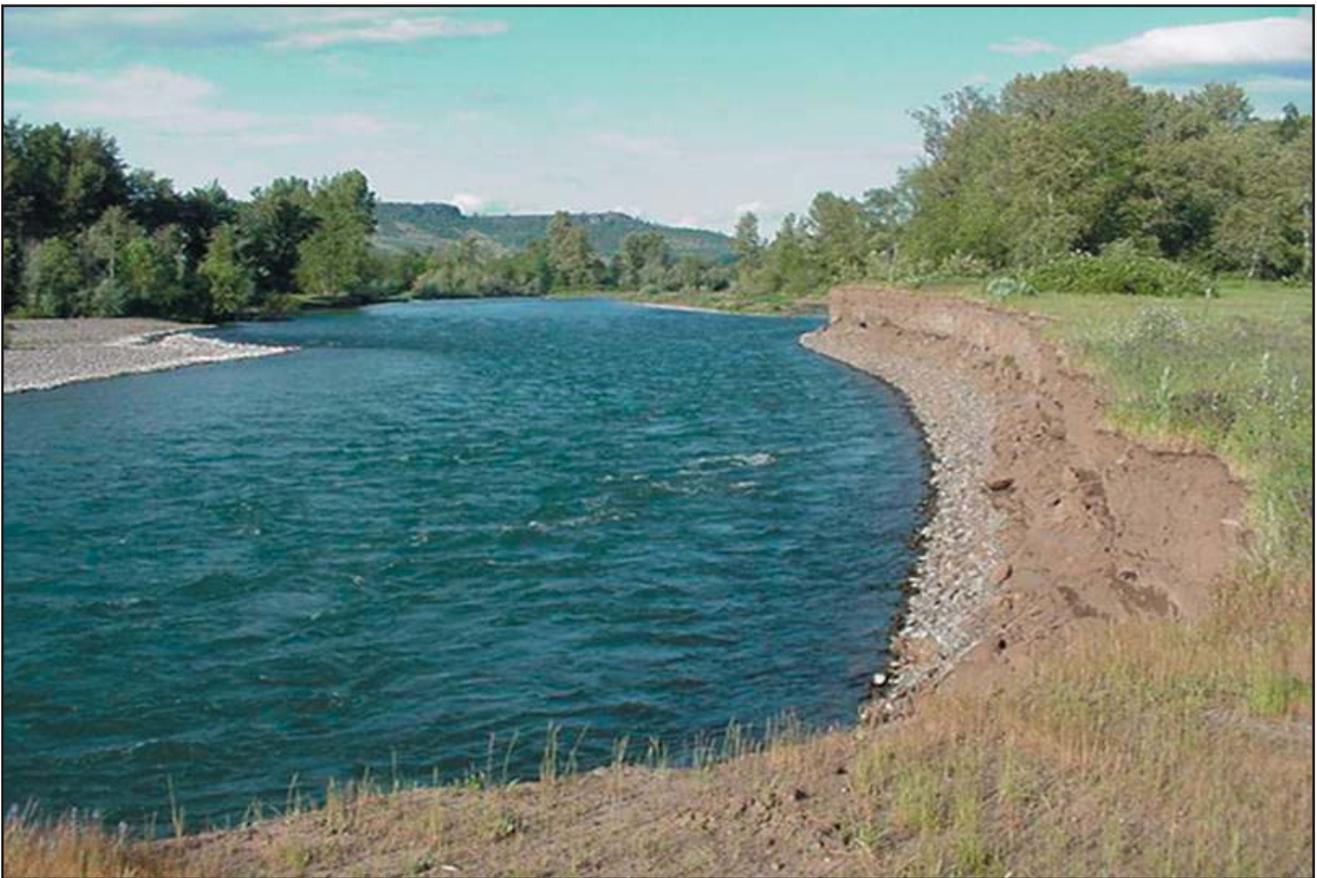
Gebhard Bank – Pre-construction photo at upstream view photo point. 2000

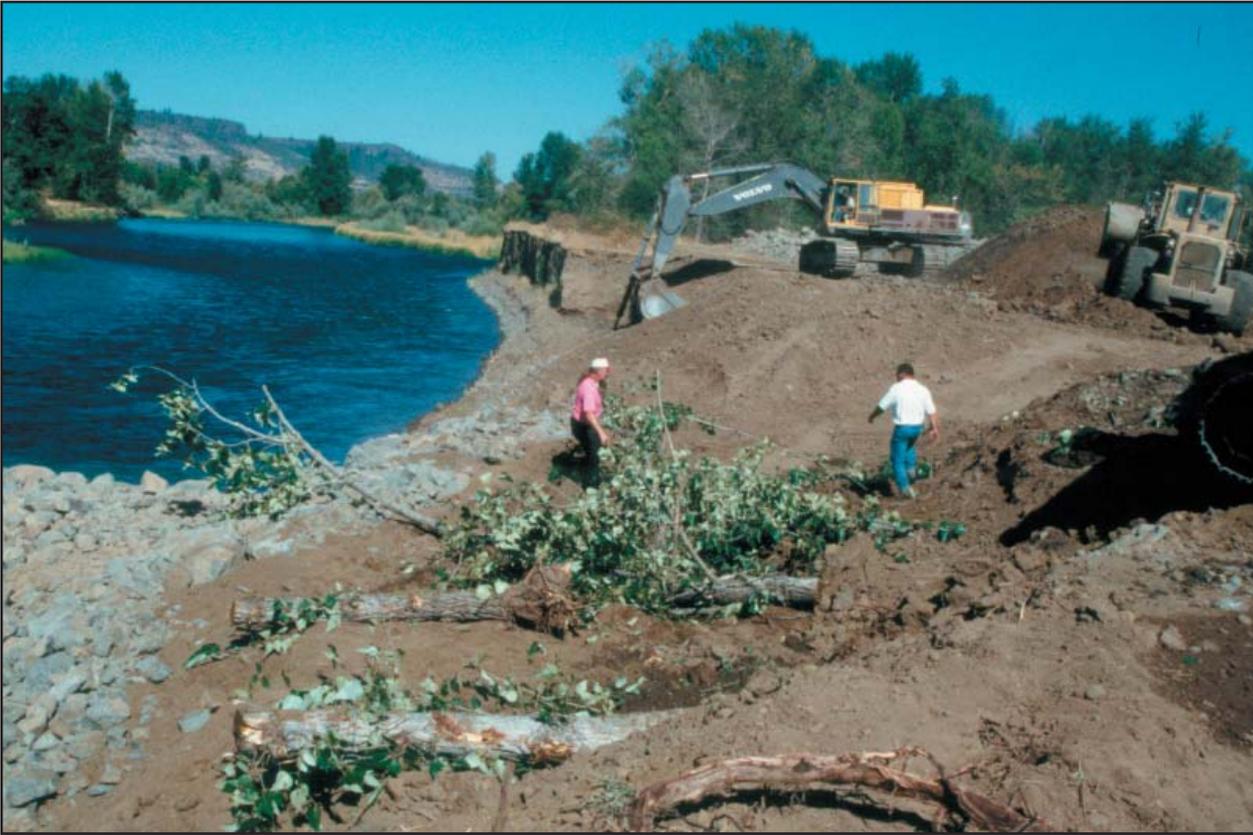
Gebhard Bank - Burial of live cottonwood trees in fill at Barb 2. September 2002

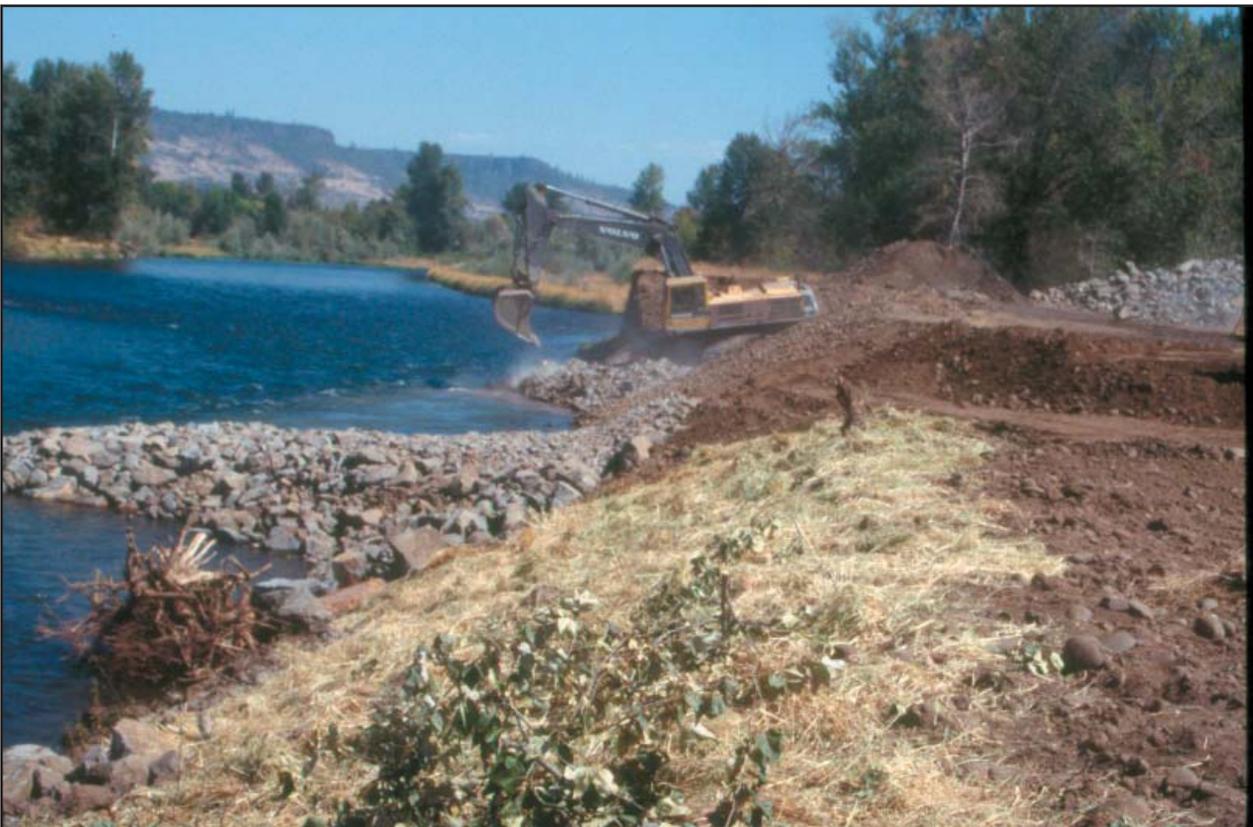
Gebhard Bank - Upstream view of placing rock for Barb 4. September 2002

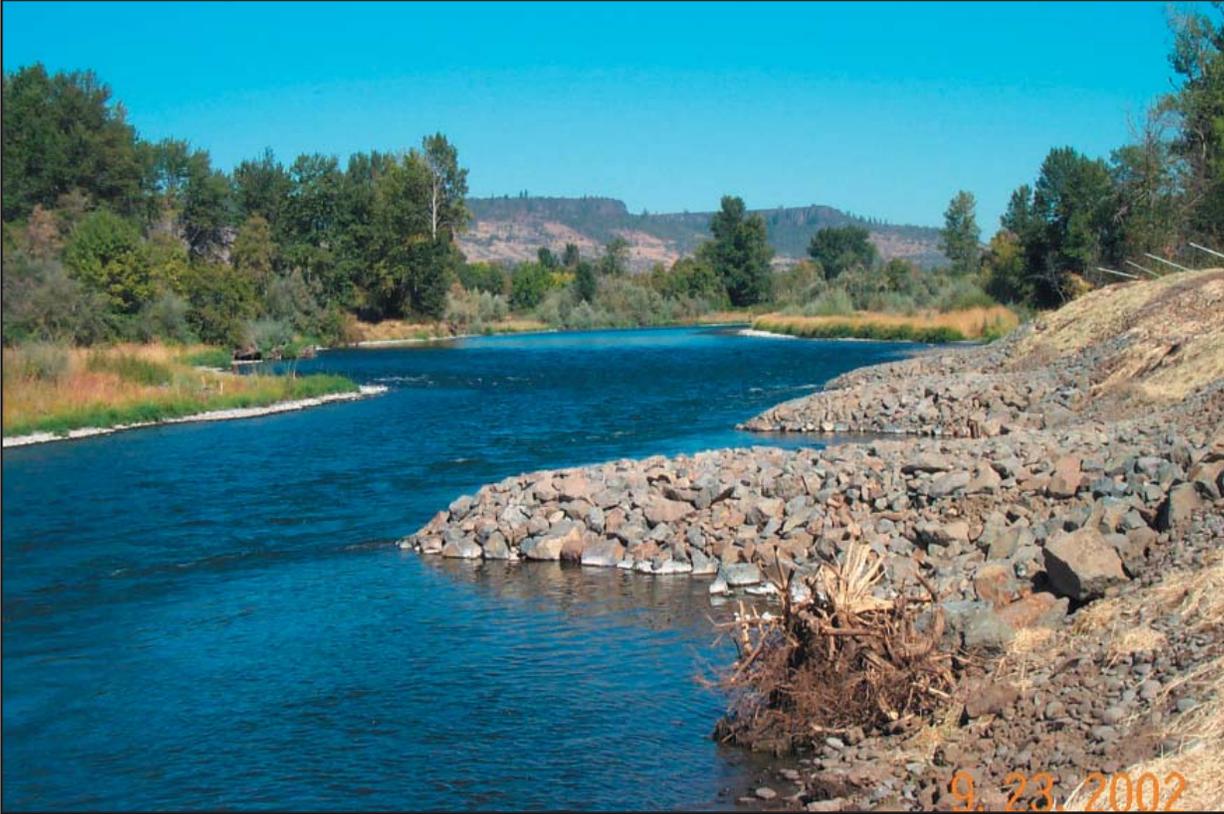
Gebhard Bank - Upstream view after completion of the stream barbs. September 2002

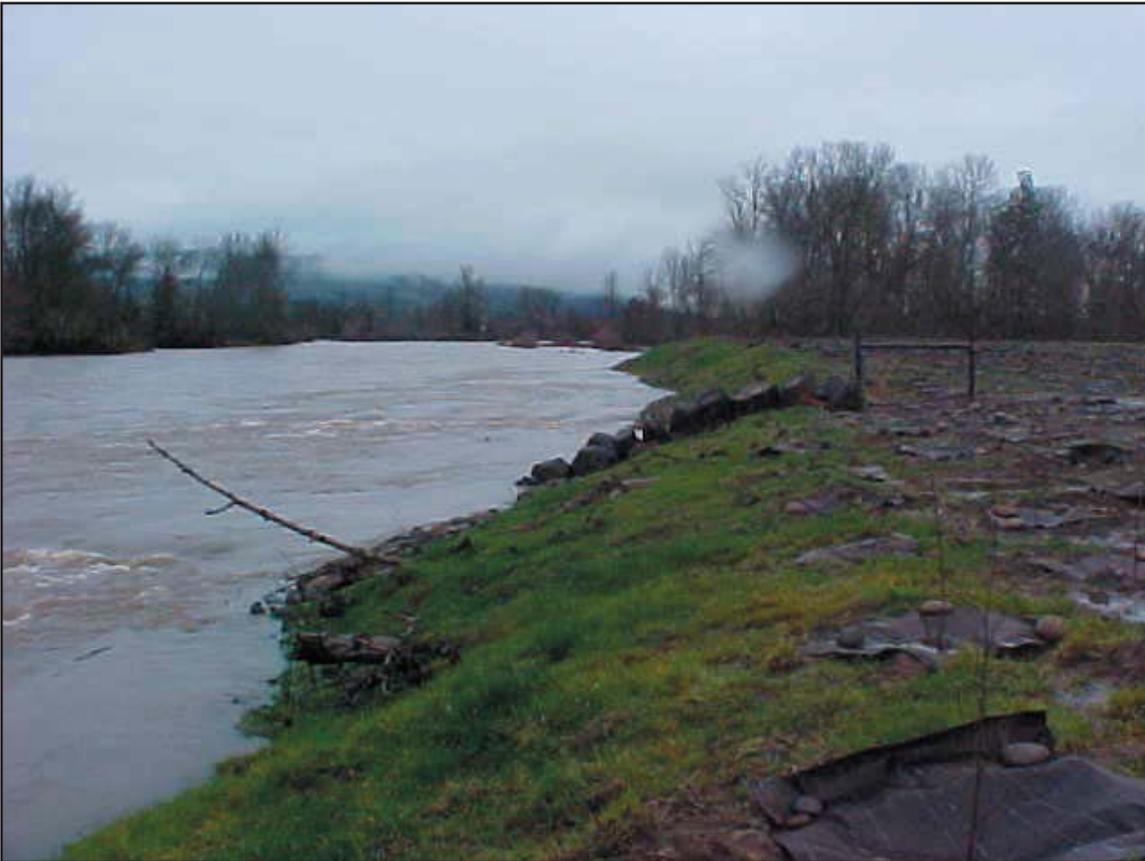
Gebhard Bank - From upstream view photo point during December 2002 high water (barbs submerged).

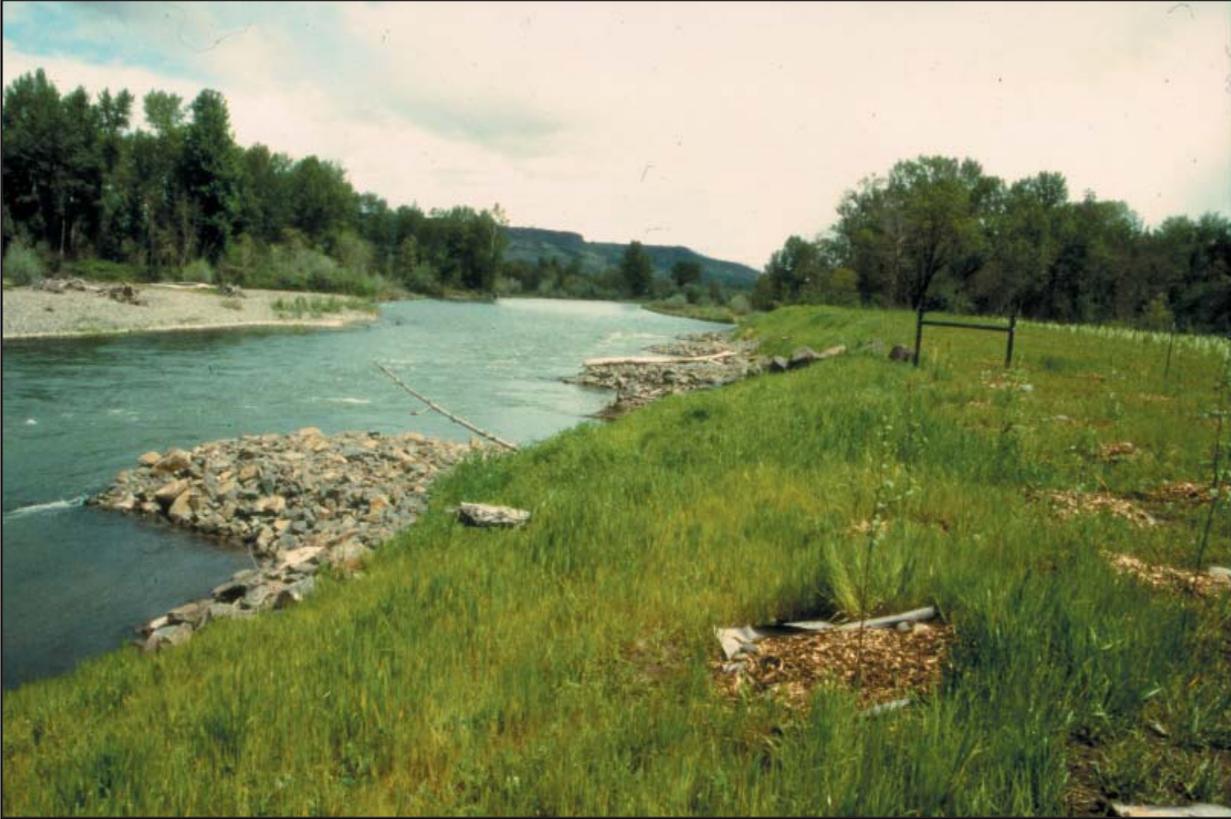
**Gebhard Site  
- Upstream  
view after  
mulching tree  
basins. April  
2003**

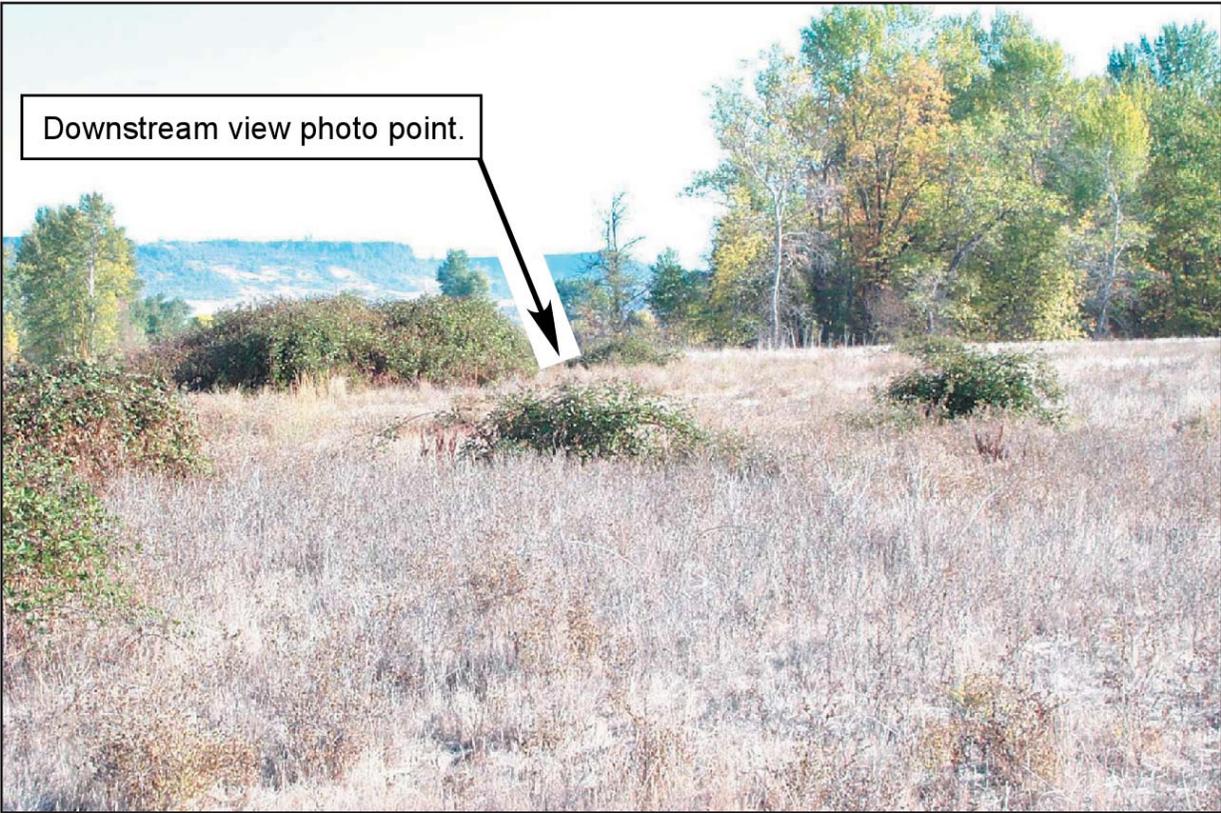
Downstream view photo point.

**Gebhard Terrace - Prior to  
construction  
and riparian  
plantings: star  
thistles and  
blackberries.  
August 2001**

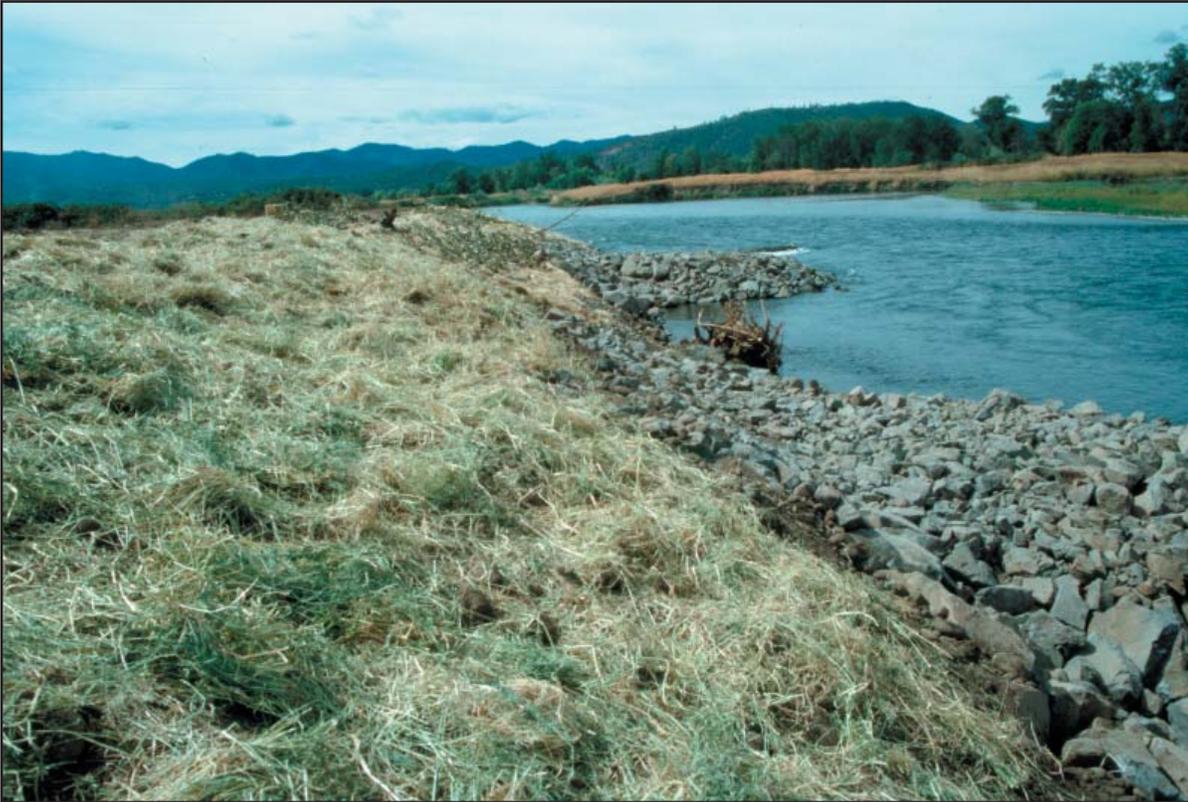
Gebhard Bank  
- Downstream  
view after seed-  
ing and mulch-  
ing. September  
2003

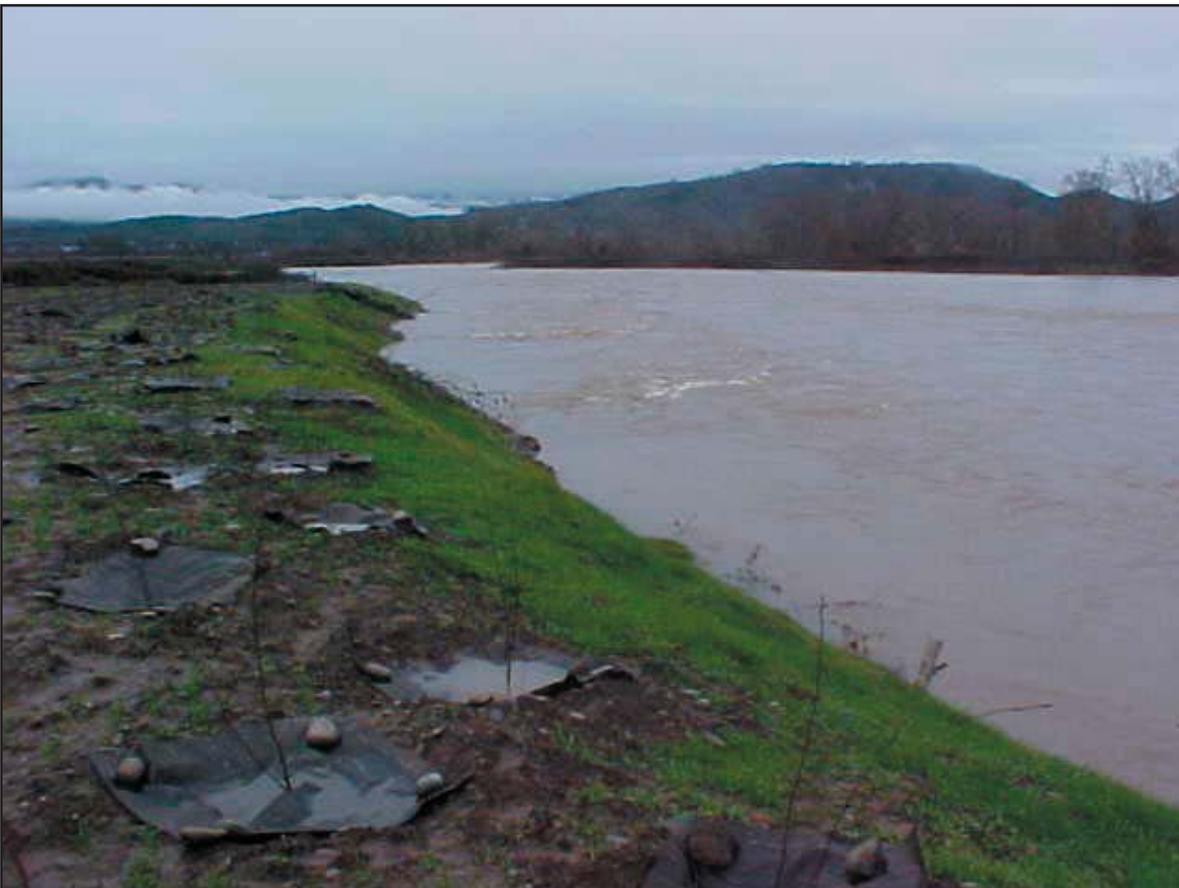
Gebhard Bank  
- Downstream  
view during  
December 2002  
high water (barbs  
submerged).

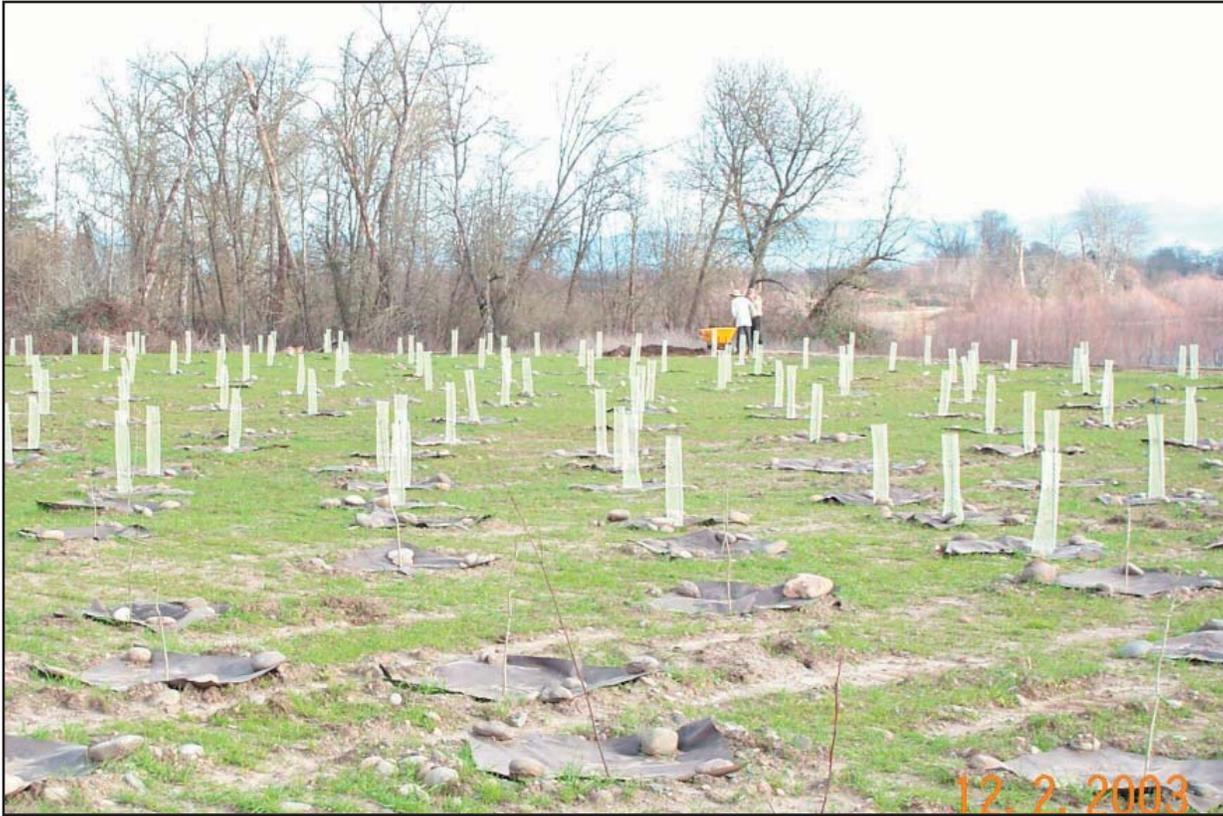
Gebhard Terrace - Establishing plant protectors on maple plugs. February 2002

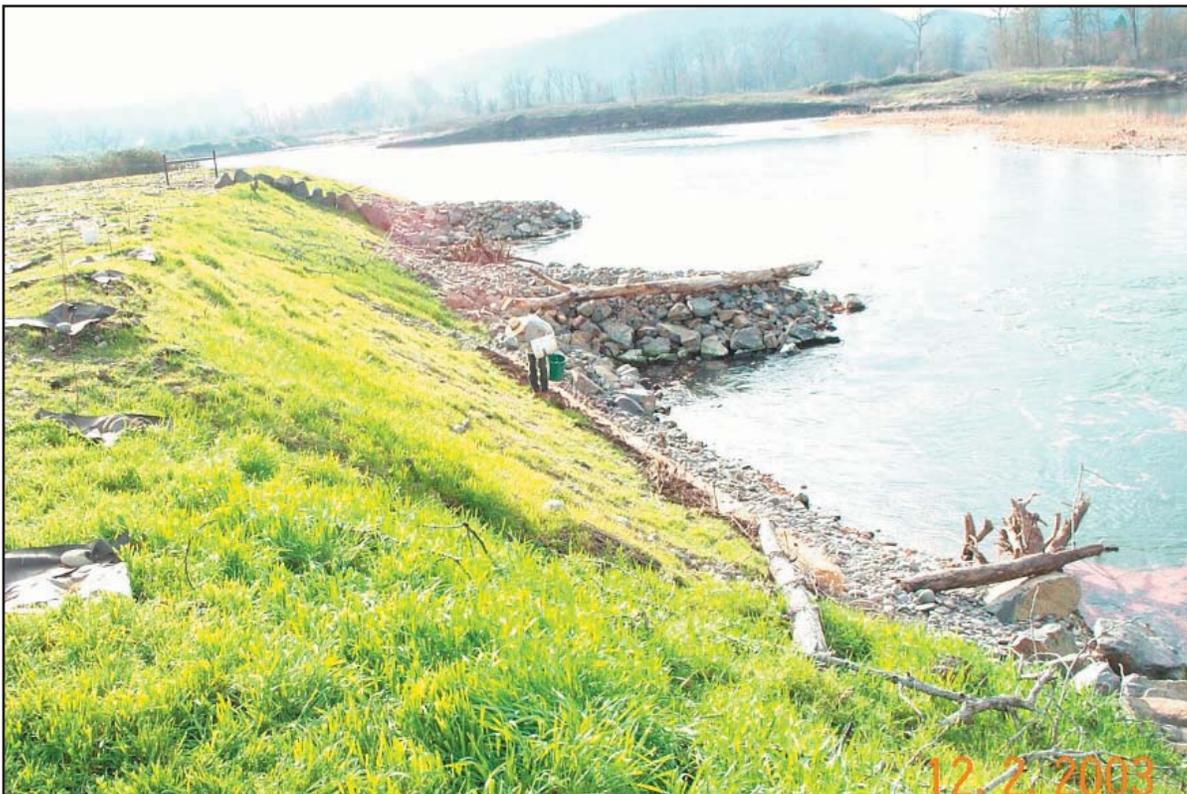
Gebhard Bank - Downstream view of bank and bars. Hauling soil to re-cover willow bundles. Note: LWD rafted in during December high water. February 2003

February: Re-cover willow bundles with soil and straw exposed during the December 2002 high-water event.

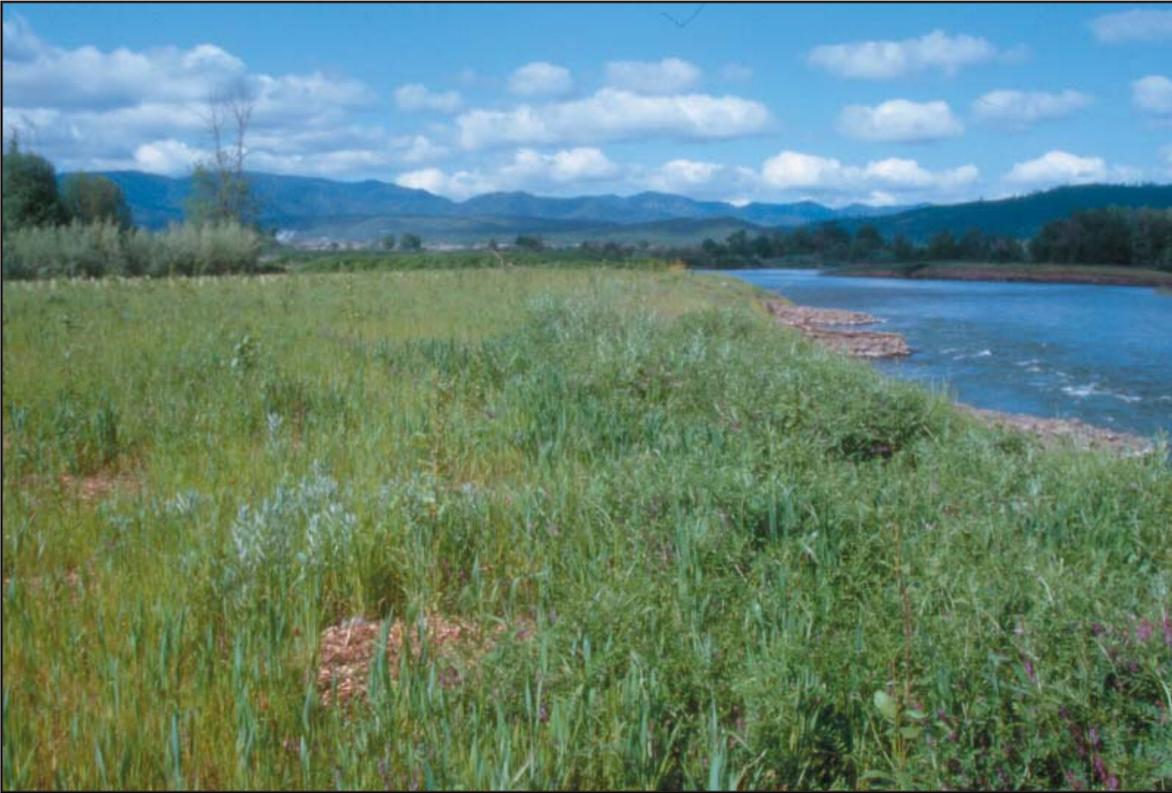
**Gebhard Bank –  
Downstream view  
of riparian plant-  
ings from photo  
point, mulch pile  
around ash tree in  
foreground. June  
2003**

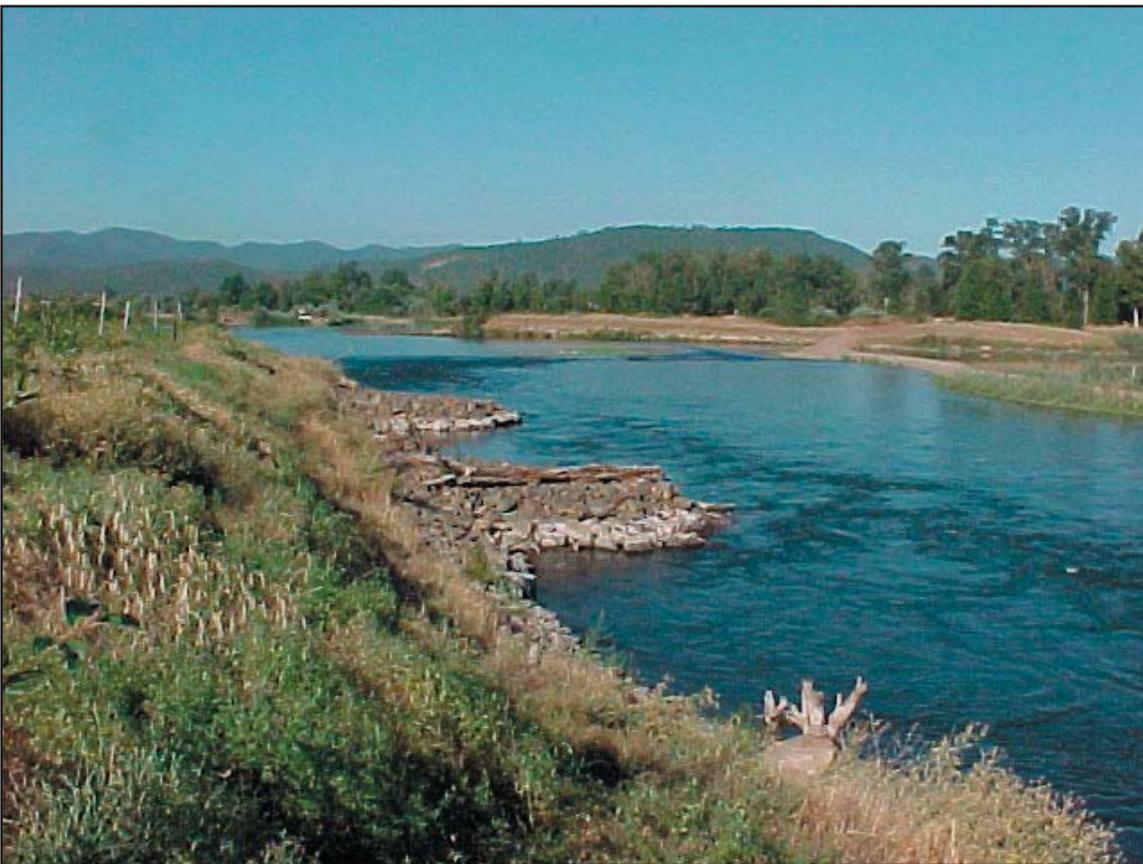
**Gebhard Bank  
- Downstream view  
of bank and barbs.  
September 2003**
