State of Oregon  
Department of Geology and Mineral Industries  
Vicki S. McConnell, State Geologist

**OFR O-04-14**

**ROGUE RIVER STAKEHOLDER PROJECT  
PHASE 2**

**COMPLETION REPORT AND YEAR ONE  
MONITORING REPORT**

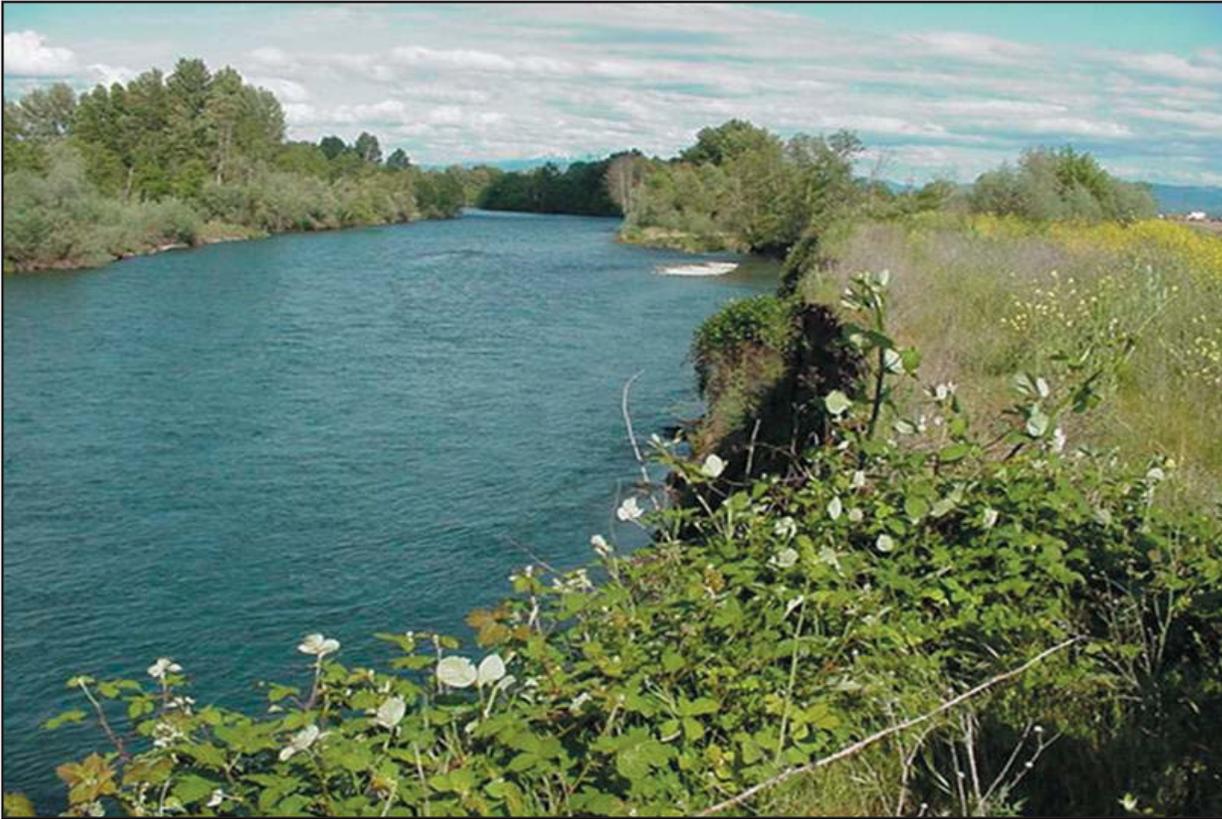
Mace Bank -  
Pre-construction  
upstream  
view. 2000

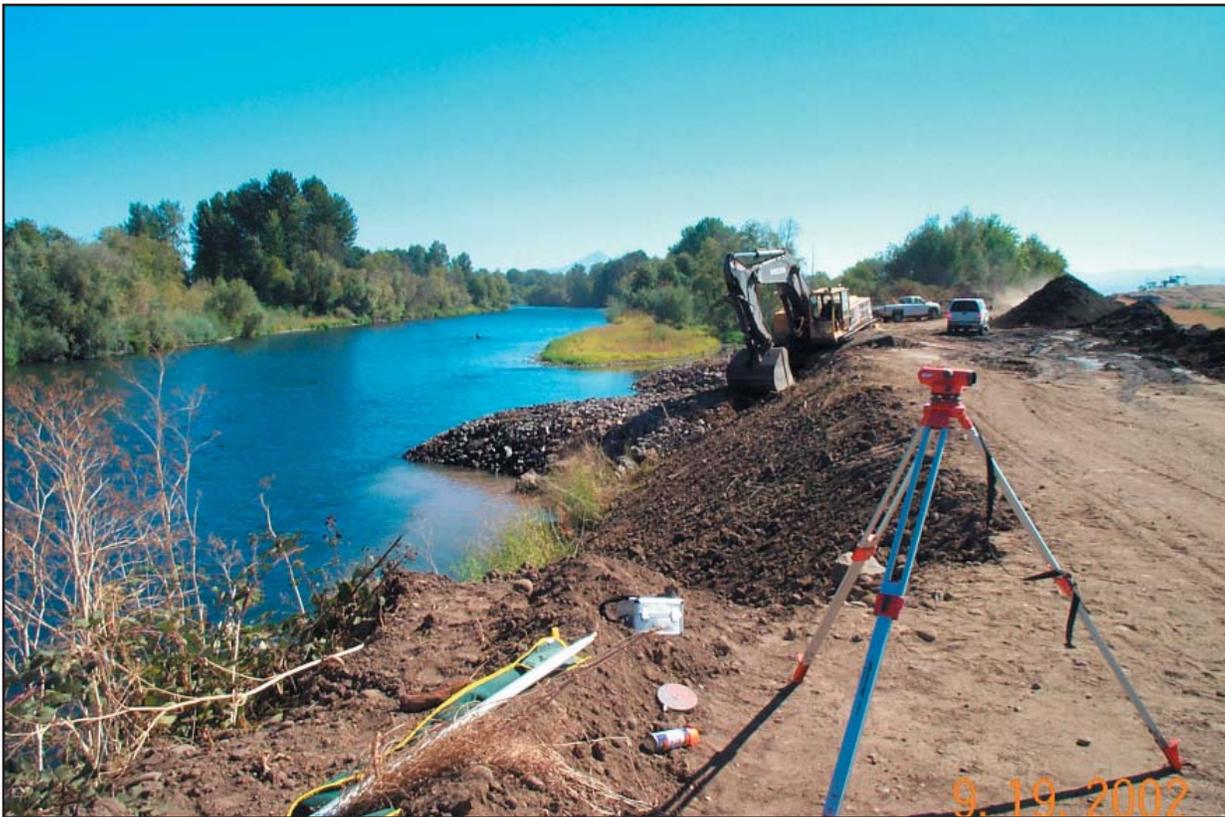
Mace Bank  
- Upstream  
view during  
root wad  
placement,  
note turbidity  
plume along  
bank down-  
stream of the  
barb. September  
2002

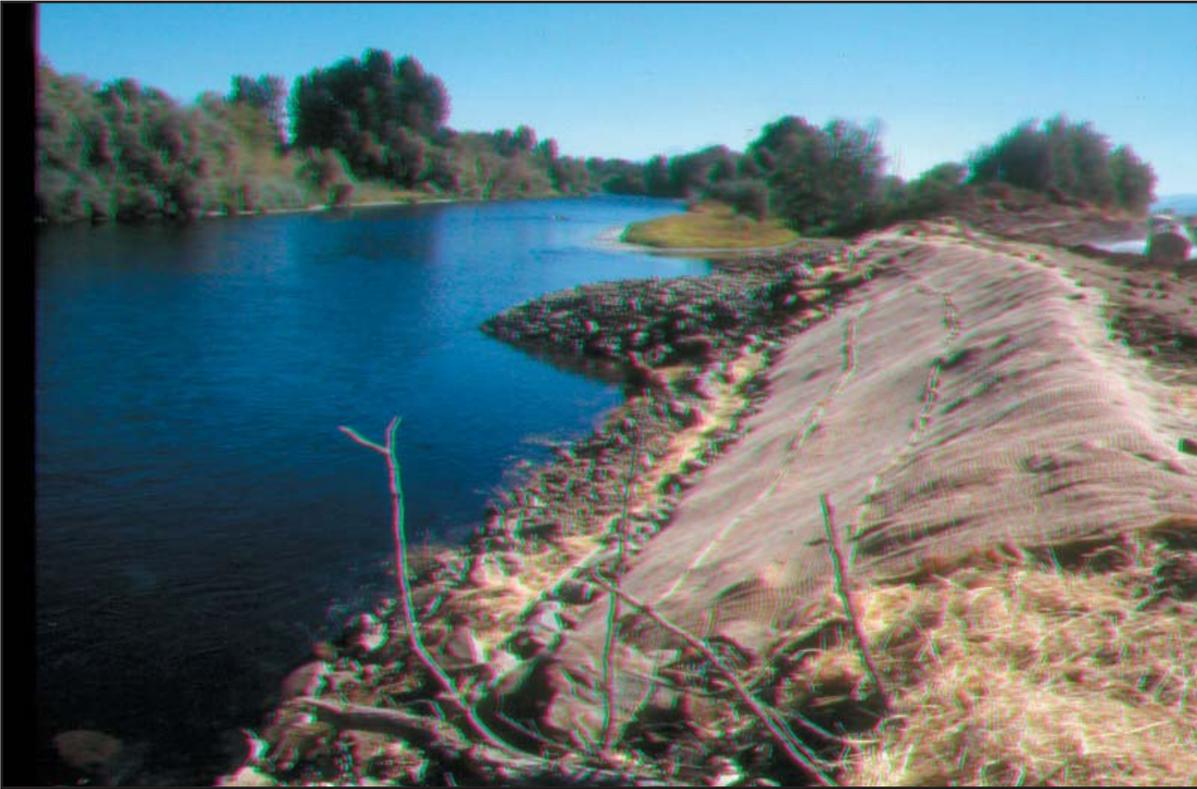
**Mace Bank –  
Upstream view  
after seeding,  
mulching, and  
placing erosion  
mats. September  
2002**

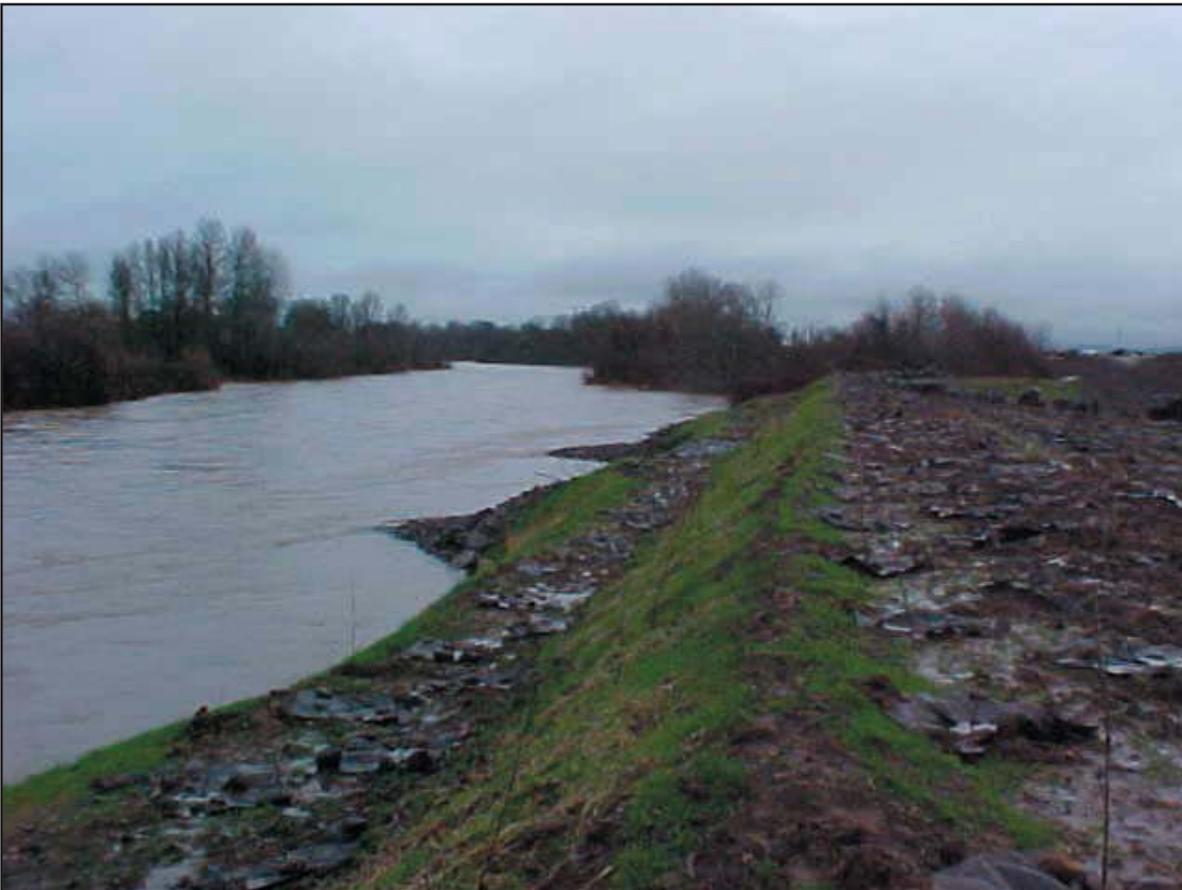
**Mace Site – Barbs  
partially sub-  
merged during  
high water on 12-  
28-02; taken from  
upstream view  
photo point.**

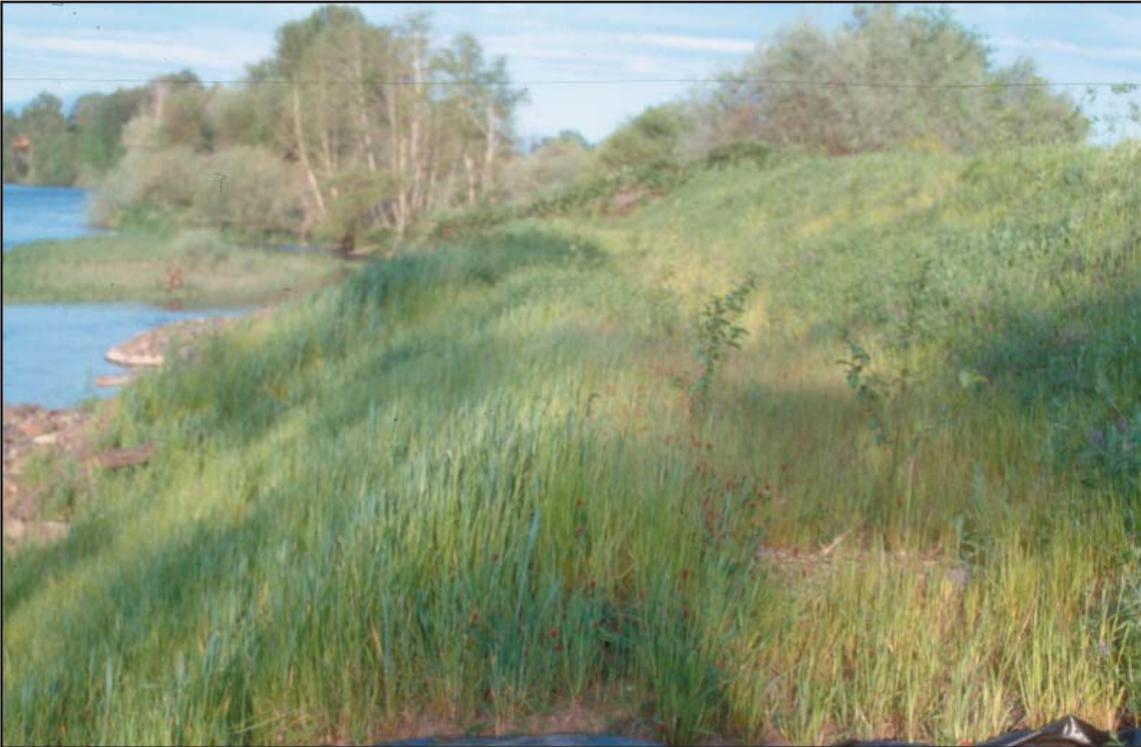
**Mace Bank - Upstream view, white alder trees in foreground. April 2003**

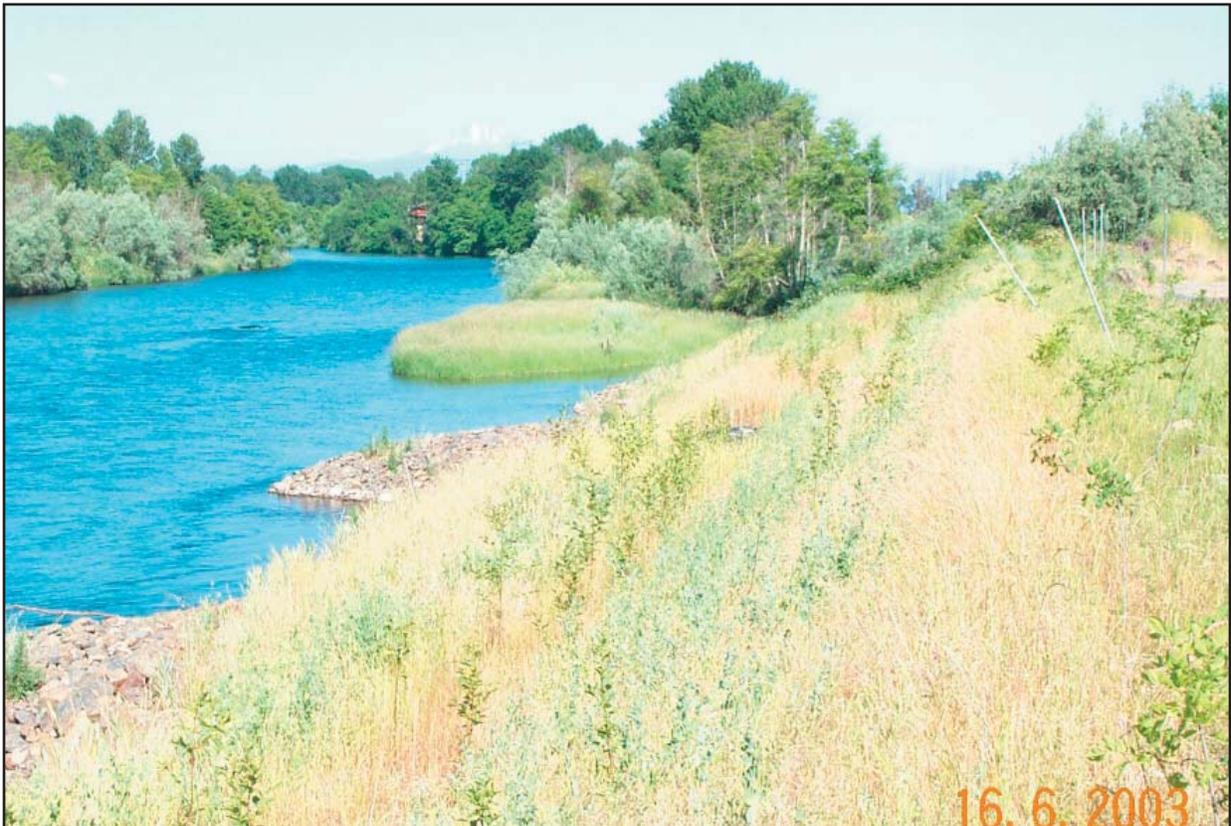
**Mace Bank - Upstream view, white alders on lower terrace; irrigation risers and Oregon ash trees on upper terrace. June 2003**

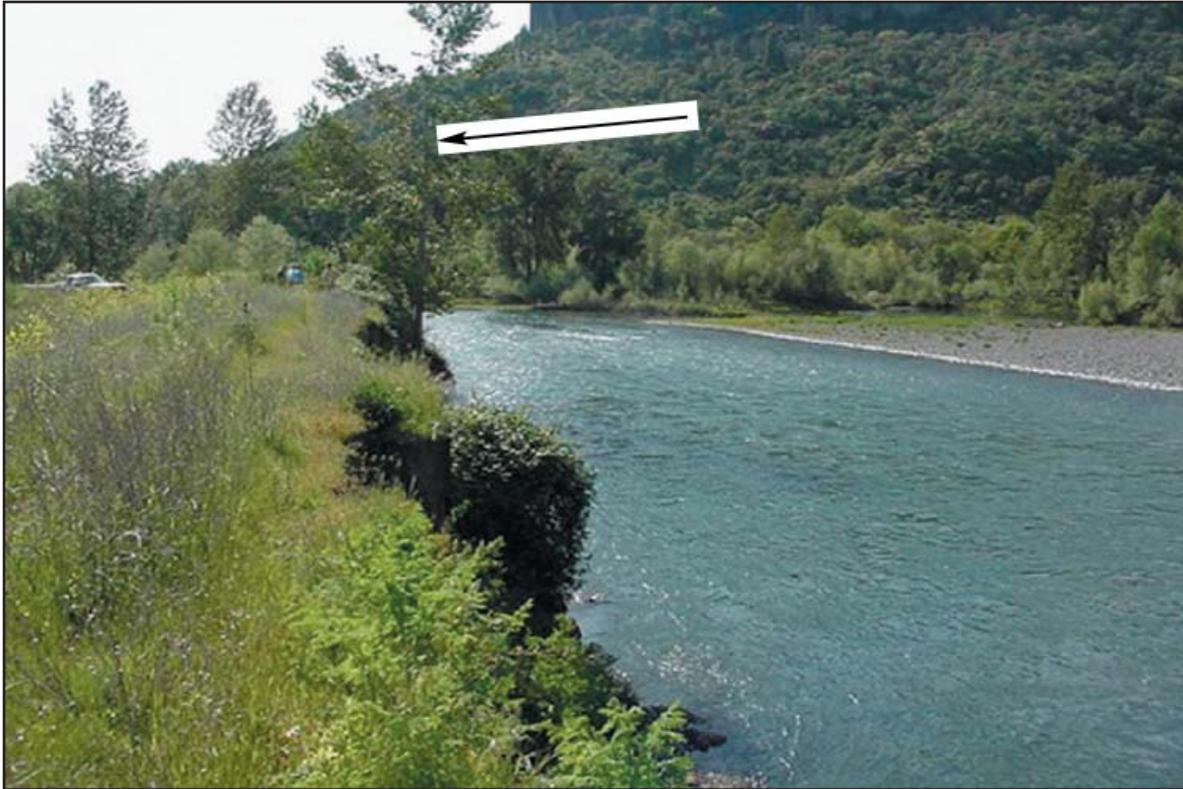
Mace Bank - Pre-construction downstream view. Note cottonwood tree on bank to the right of the stakeholders.

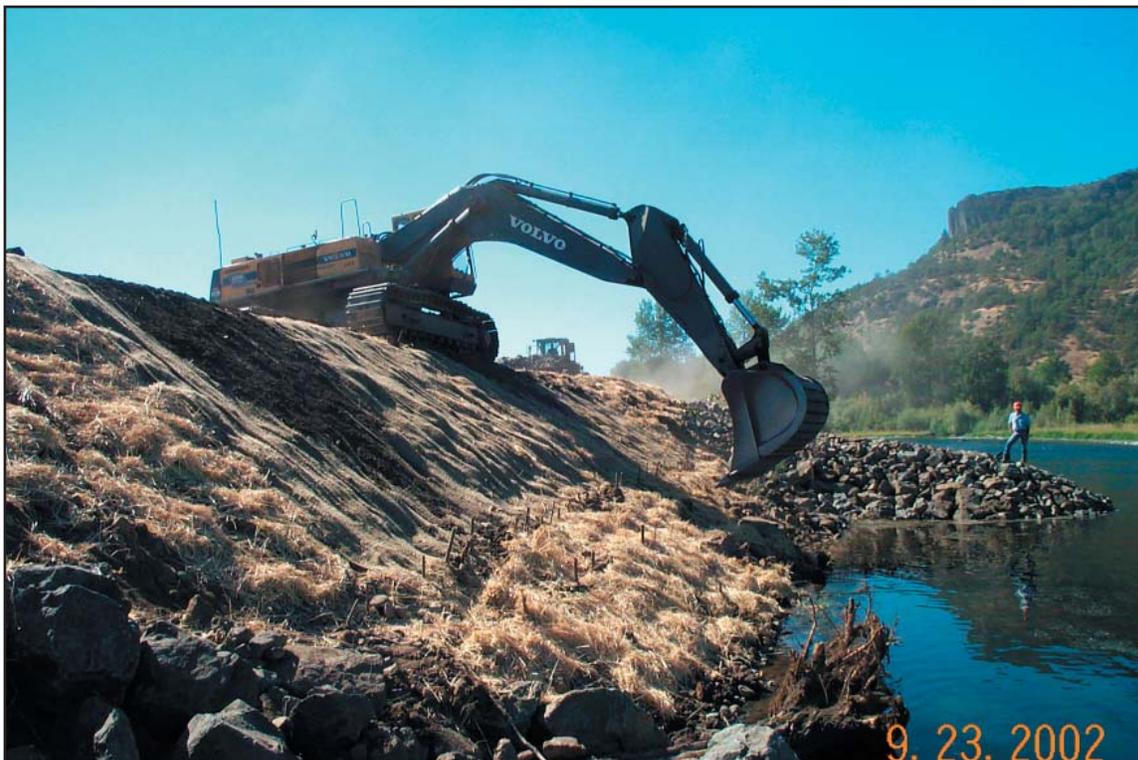
Mace Site - Downstream view-placing anchor rocks on root wad. September 2002

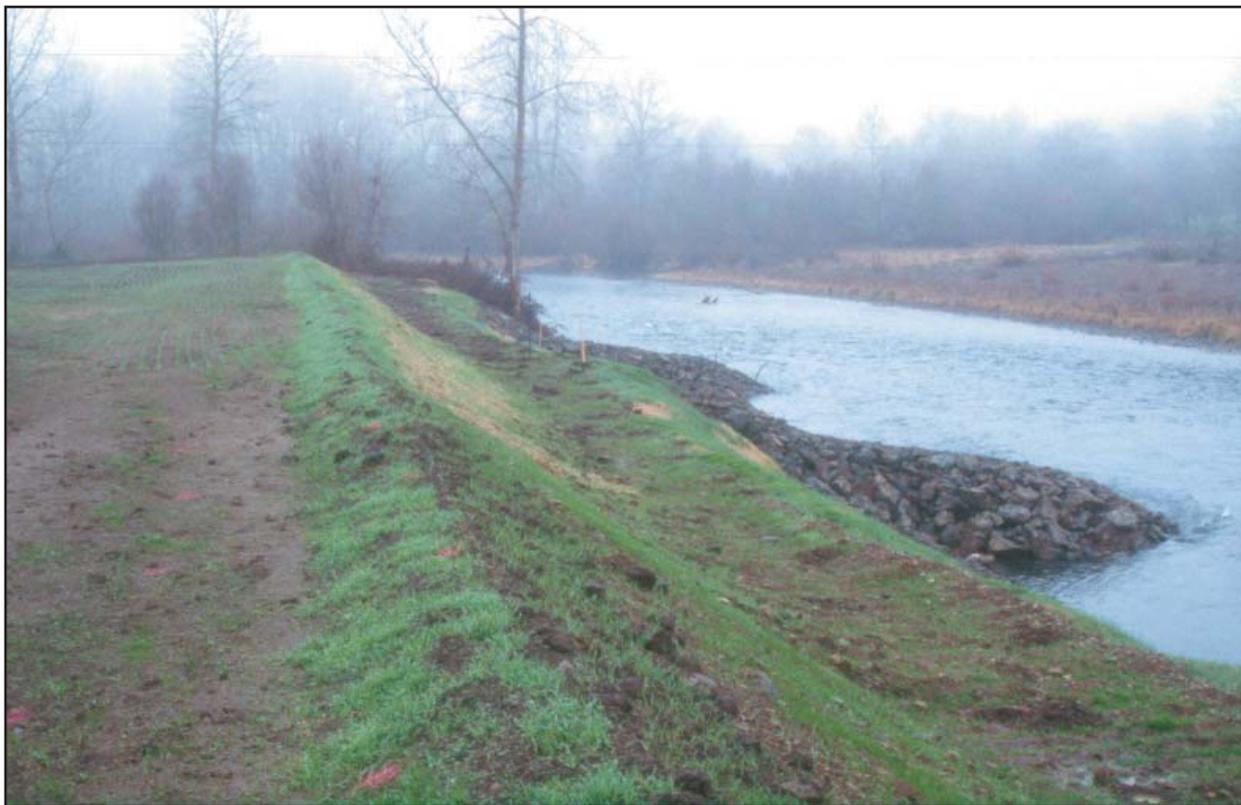
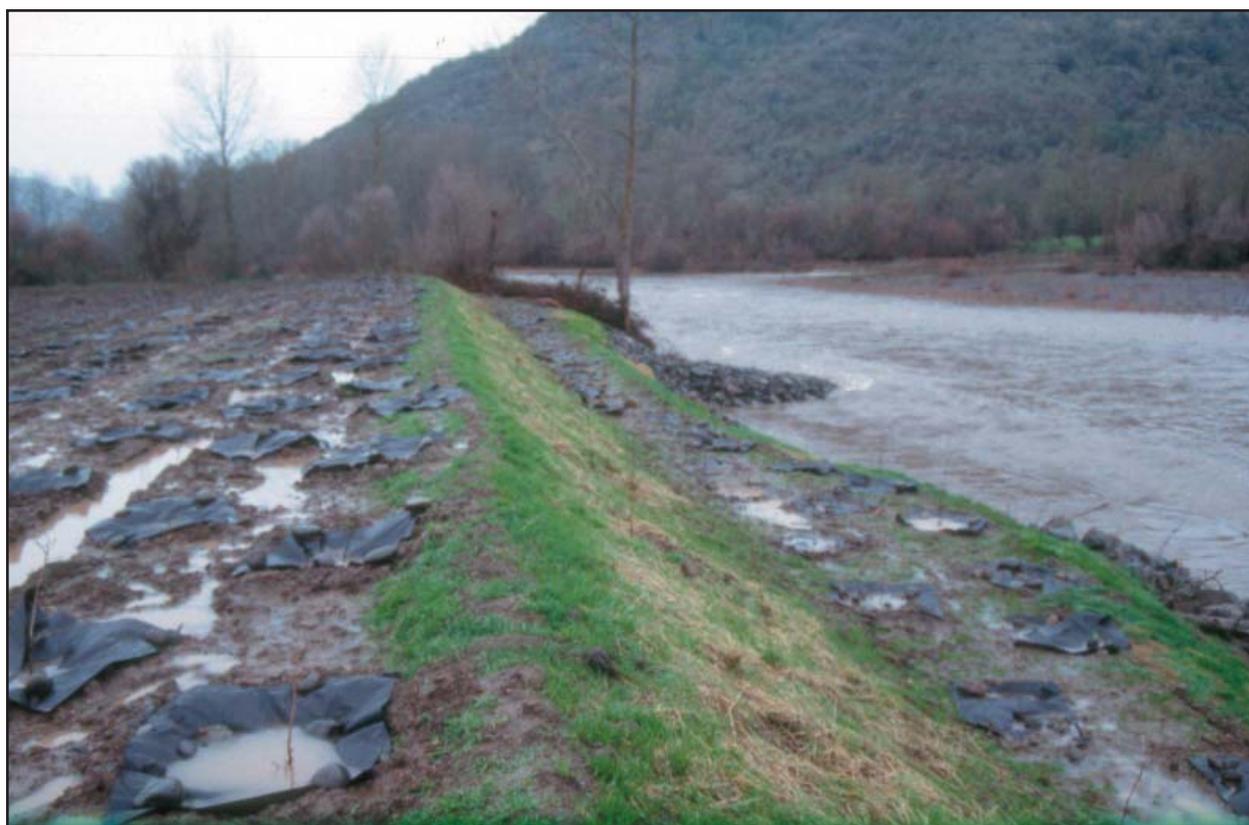
Mace Site.  
Fall 2002

Mace Site - After tree planting. Winter 2003

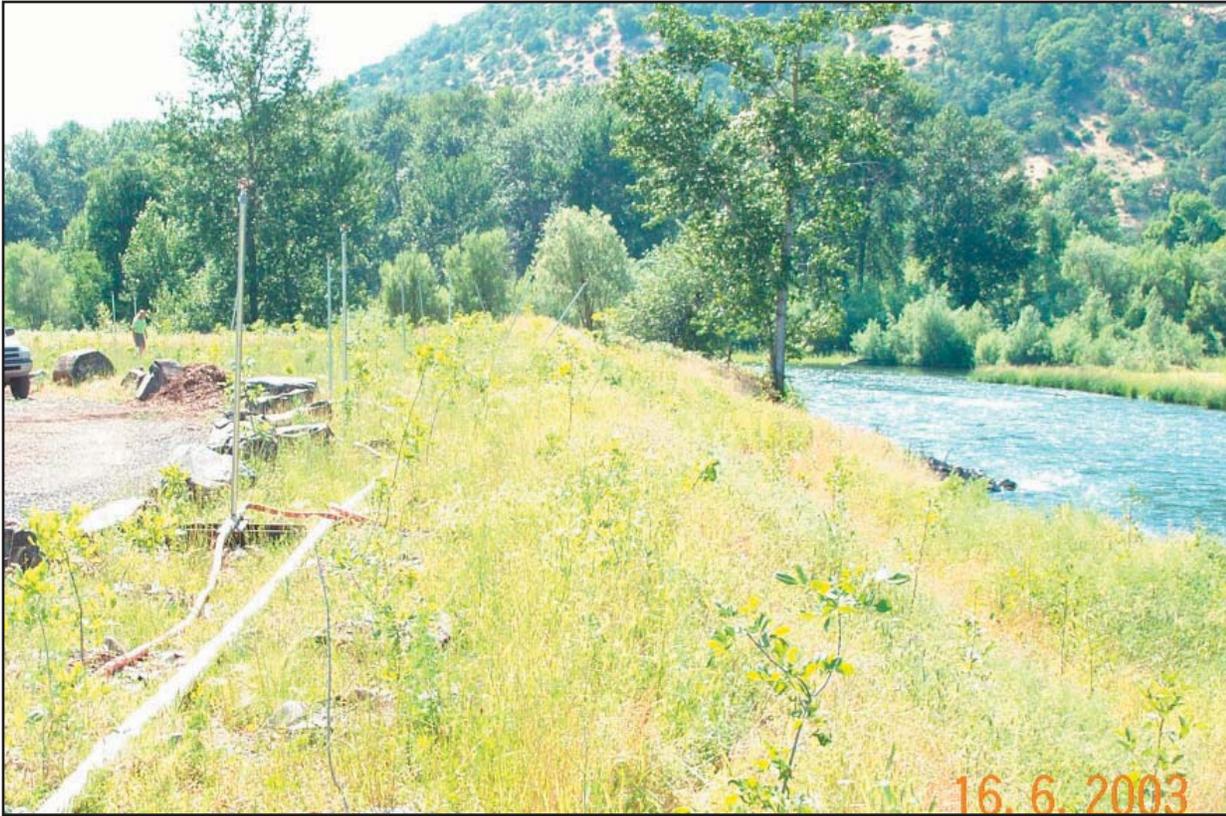
Mace Site - Riparian plantings on upper terrace and irrigation risers. June 2003

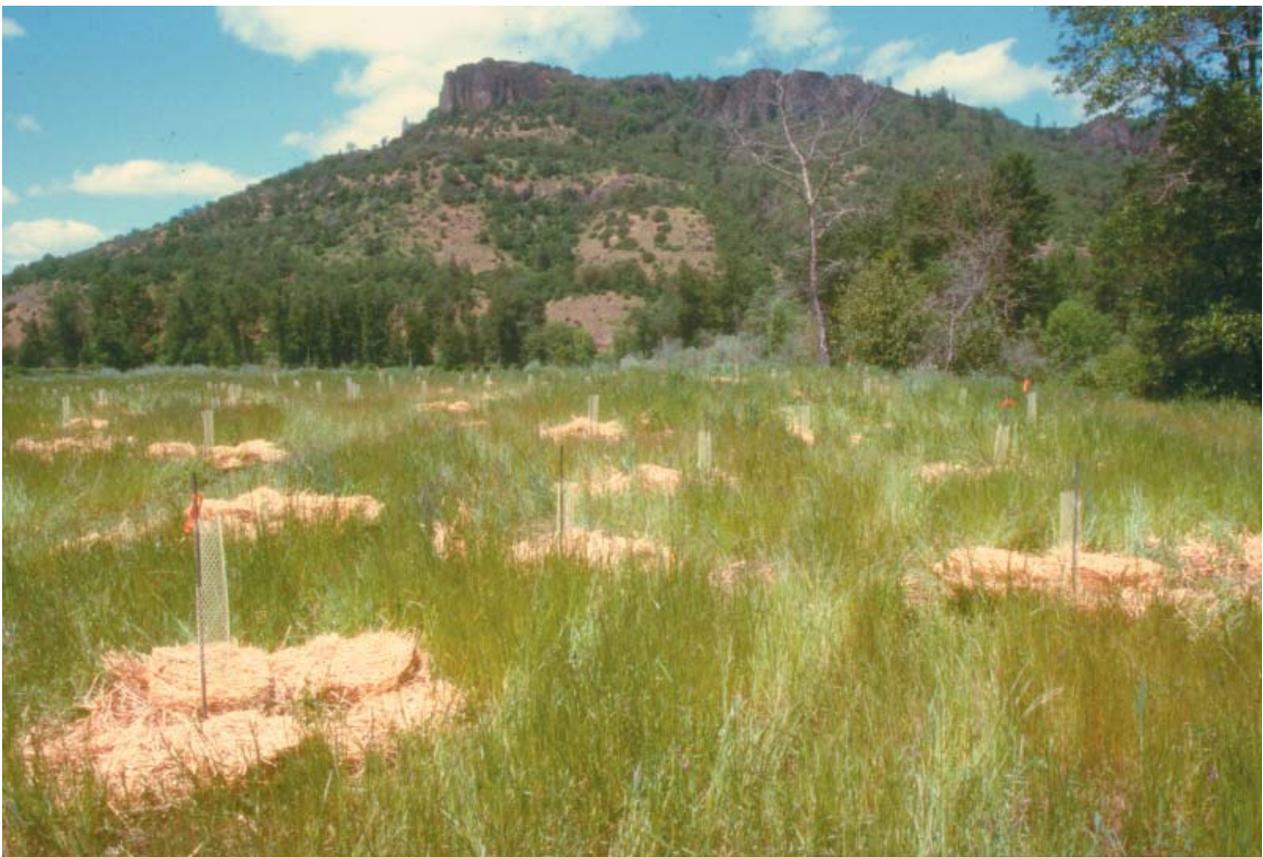
**Gebhard Site – Straw mulch around maple seedlings. May 2002**

April: All trees and shrubs were weeded and then mulched with wood chips donated by Jackson County. About 5 cubic feet of woodchips were placed around each tree and shrub. Work was completed by volunteers from Rogue Aggregates, High Bank Rock Products, John's Repair, Parisi and Parisi, Wilsonville Concrete, Rogue Flyfishers, Jackson County SWCD, Crater High School Ecology Lab students, a Bear Creek Watershed Council member, ODFW, Jackson County, and DOGAMI. Volunteer labor totaled 148 hours.

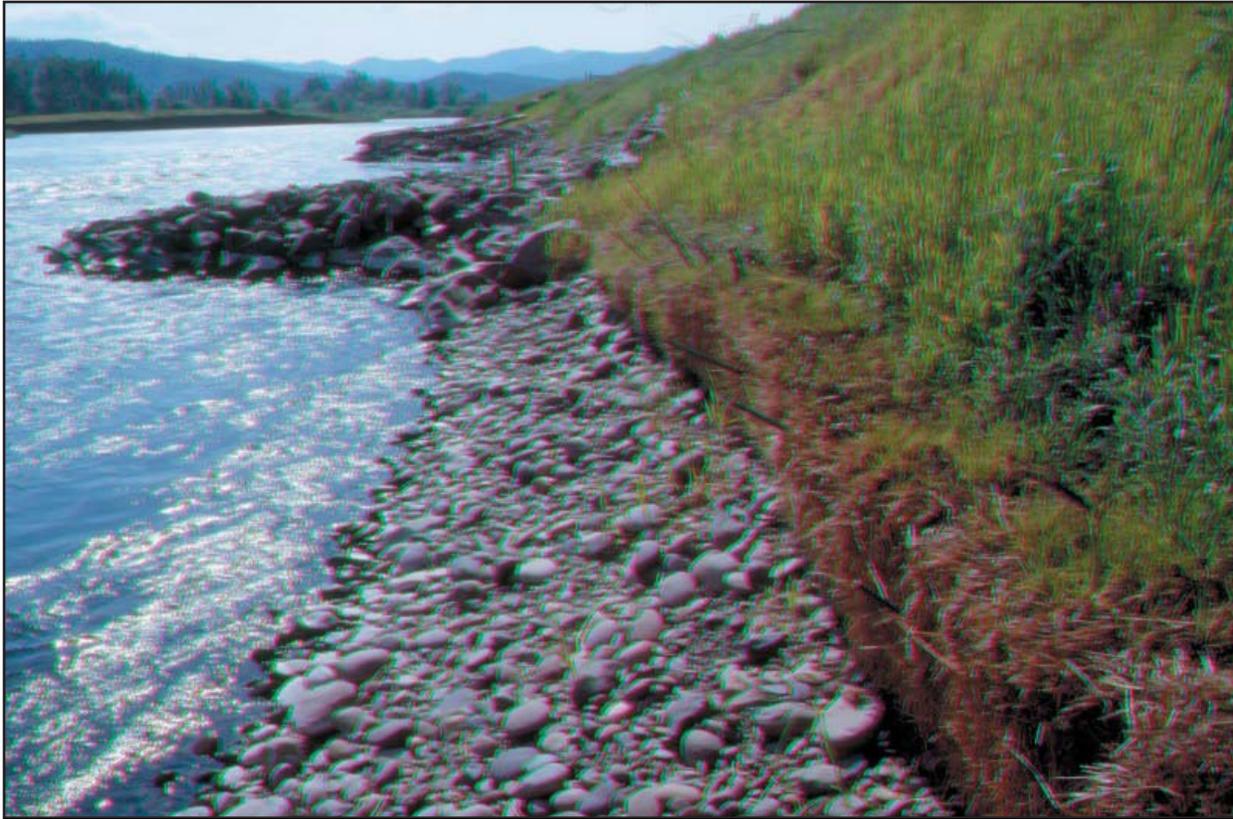
Monitoring after the December high water and again in late spring, documented minor amounts of sediment input at the Gebhard bank. This occurred between all of the barbs. At and below ordinary high water, channel bank velocities during the 27,500 cfs event were sufficient to mobilize fine sediments left after bank re-sloping. The winnowing of the sand and silt fines off the resloped bank but with no transport of gravels, suggests the stream barbs were effective in reducing velocity flows against the bank. In terms of material transported, 10 to 20 yards (or about 20 to 40 tons) were eroded at the Gebhard site. This small amount of erosion did not result in changing the shape of the bank. Areas above ordinary high water were not affected (see following photo). Subsequent monitoring after the December event found sand and silt deposits, along with organic debris and LWD, in between the barbs.

**Gebhard Site – Erosion of fine sediments between Barbs 2 and 3. Vertical bank above the gravels is formed by hay bales staked in place with rebar. April 2002**

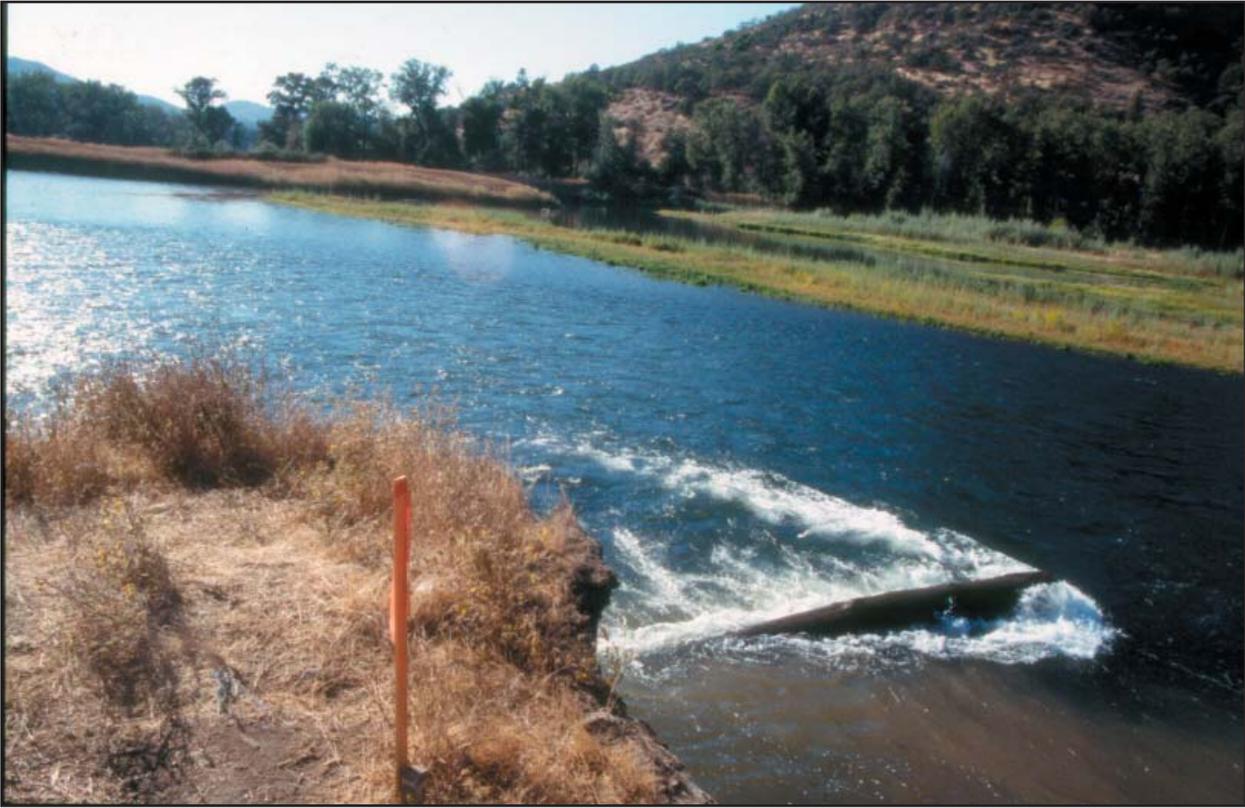
The most significant change to the reshaped banks occurred downstream of the Barb 1 at the Gebhard site. At this location, a cottonwood log partially buried in the bank was not disturbed during barb construction. The stakeholders and boaters who asked that we remove it recognized this as a problem for bank stability. The presence of the log prevented the placement of the downstream apron for Barb 1 during construction. The log deflected flow towards the bank during the December 2002 high water. It was dislodged by high velocity flows during December or January.

Gebhard Bank - Prior to Phase 2 construction showing log embedded in eroding

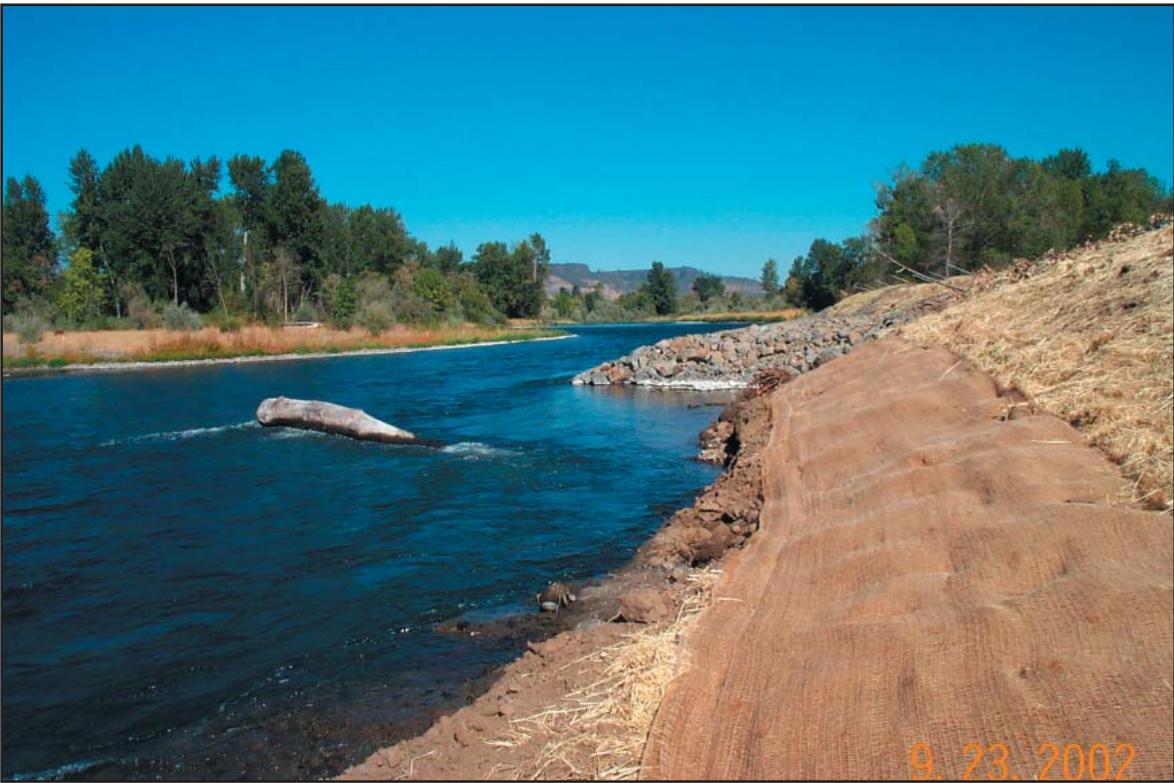
This resulted in the most significant amount of bank erosion that the project experienced. The reshaped bank eroded vertically for a distance of about 40 to 50 feet where the flow enters the captured ODOT pond. This caused a sediment input of approximately 800 to 1000 tons.

Gebhard Bank - Barb 1. Erosion mat proved to be ineffective in protecting bank against high velocity flows deflected by log embedded in bank. September 2002

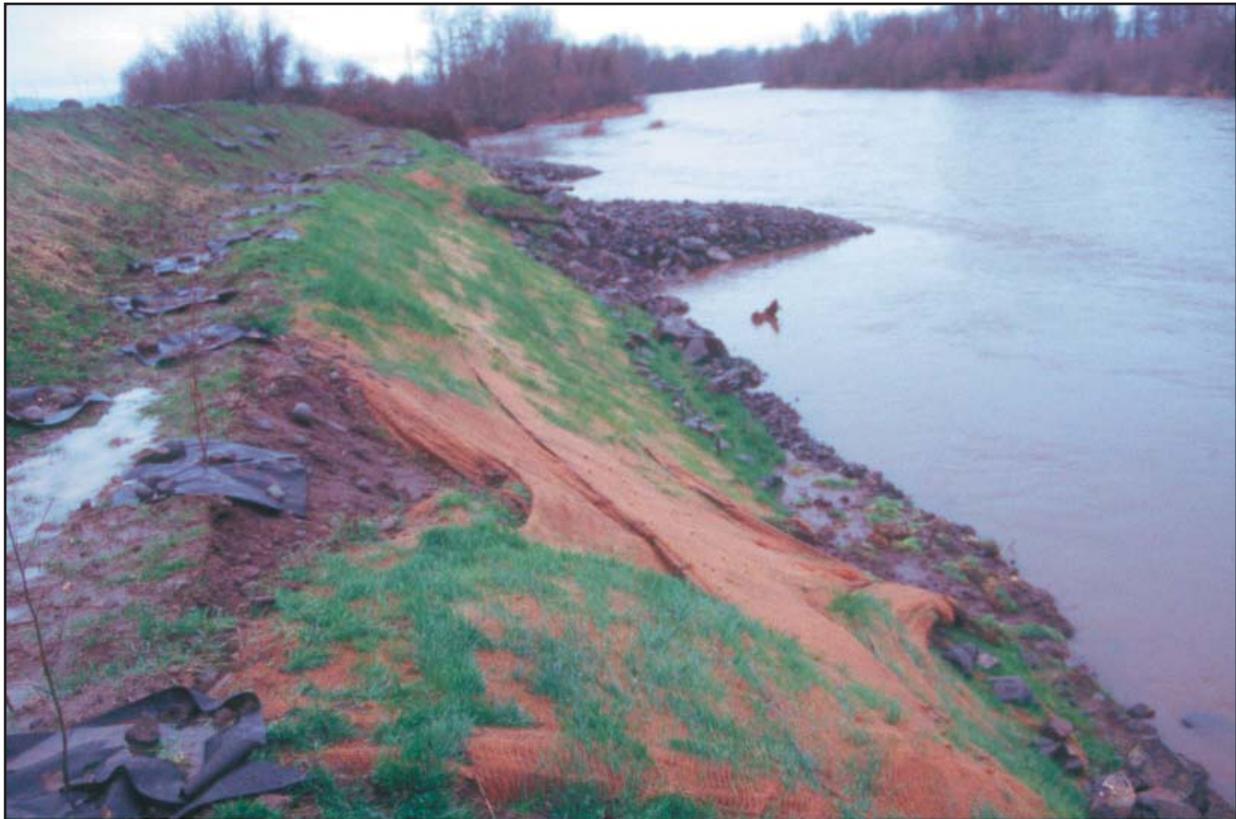
At the Mace bank, the high water did not initiate any changes to the channel bank line; however, at two locations, several cubic yards of fill near the head of Barb 2 collapsed and slumped down the bank. Part of this material entered the channel. The total sediment input was about one ton. This area was covered with plastic sheeting in

Mace Bank - Showing blowout area prior to covering with plastic sheeting. December 2002

December 2002. The problem was not caused by river flooding; it was caused by precipitation runoff concentrating in one spot on a narrow terrace created for tree establishment. It could have been avoided by spot checking the area with a level during construction. During April 2003, 95 containerized willows were planted in and around the blowout areas followed by mulching with straw.

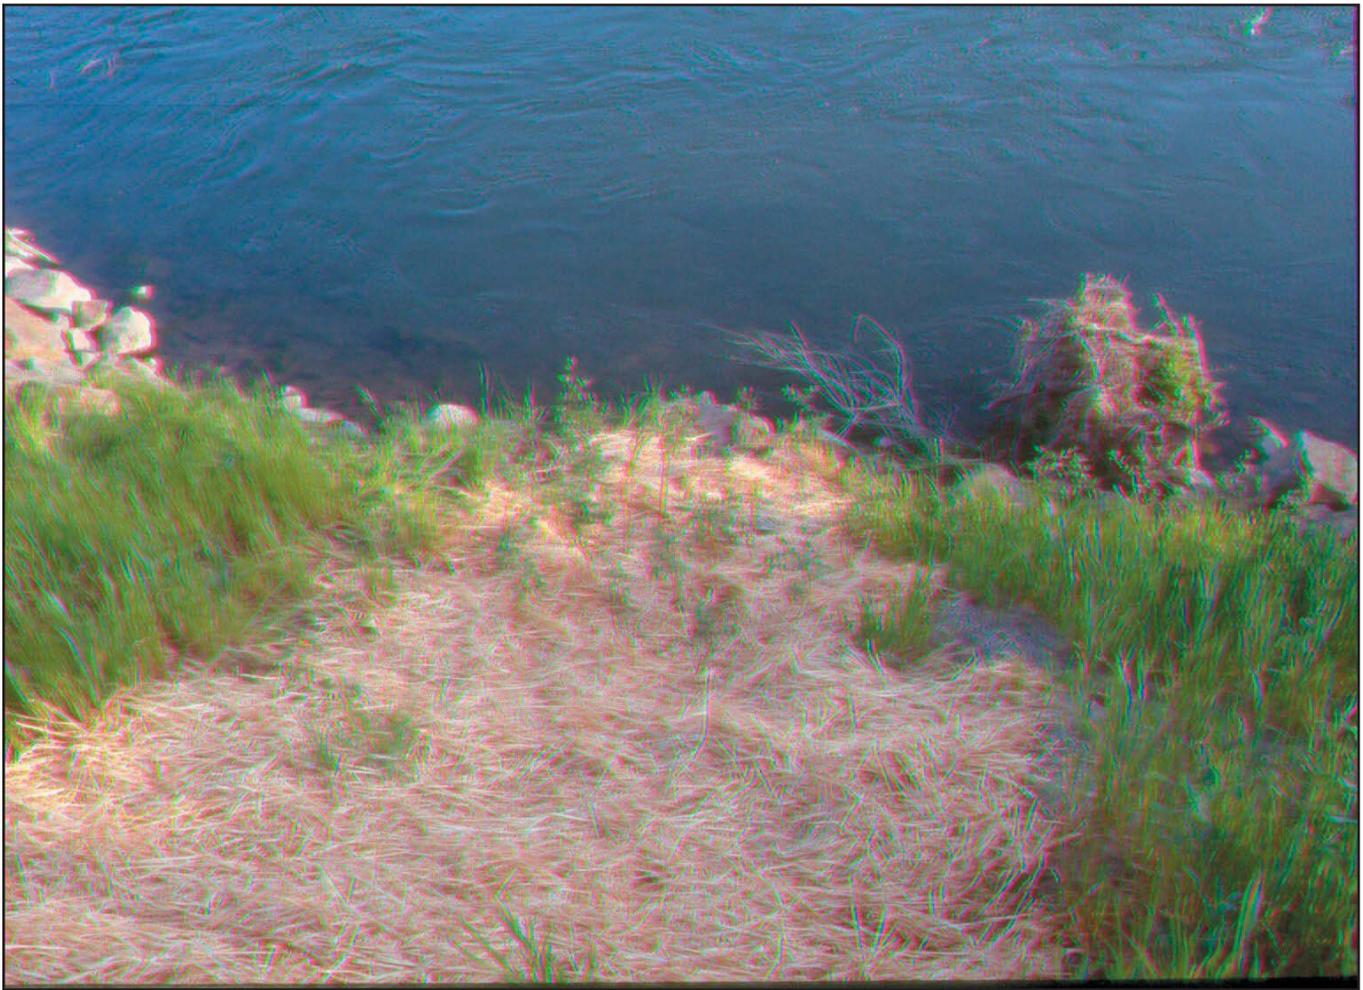
Mace Site - Blowout after planting containerized willows and applying mulch. May 2002

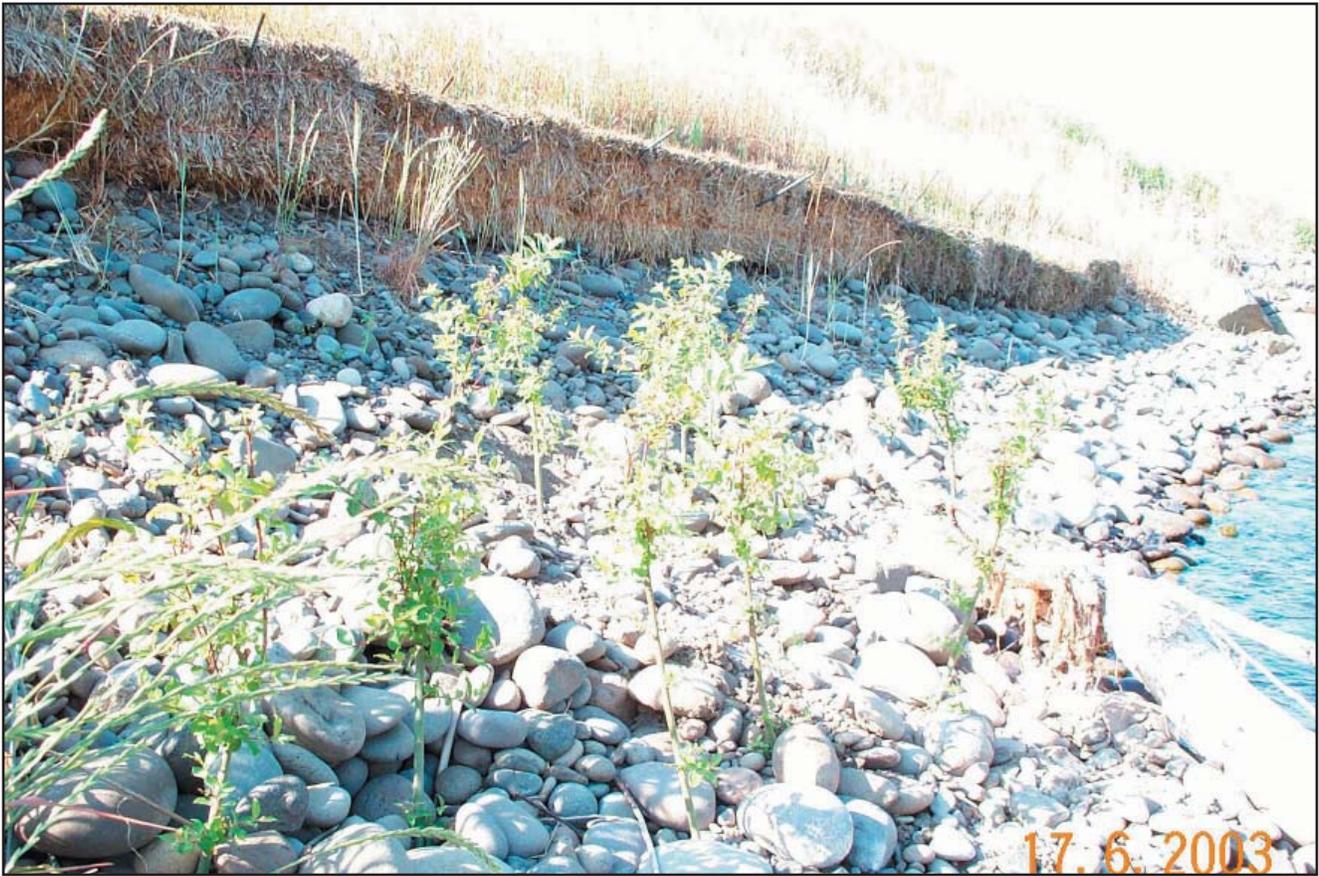
reasons for this; they were uncovered by high water during December 2002 and then covered again in February 2003 by the stakeholders using straw bales and soil. The shallow depth makes them vulnerable to desiccation and irrigation start-up may have been too late for them. Containerized willows were placed where the bundles failed. They were planted during the spring and summer of 2003.

**Gebhard Site - Containerized willows planted below failed willow bundle. June 2003**
