State of Oregon  
Department of Geology and Mineral Industries  
Vicki S. McConnell, State Geologist

**OFR O-04-14**

**ROGUE RIVER STAKEHOLDER PROJECT  
PHASE 2**

**COMPLETION REPORT AND YEAR ONE  
MONITORING REPORT**

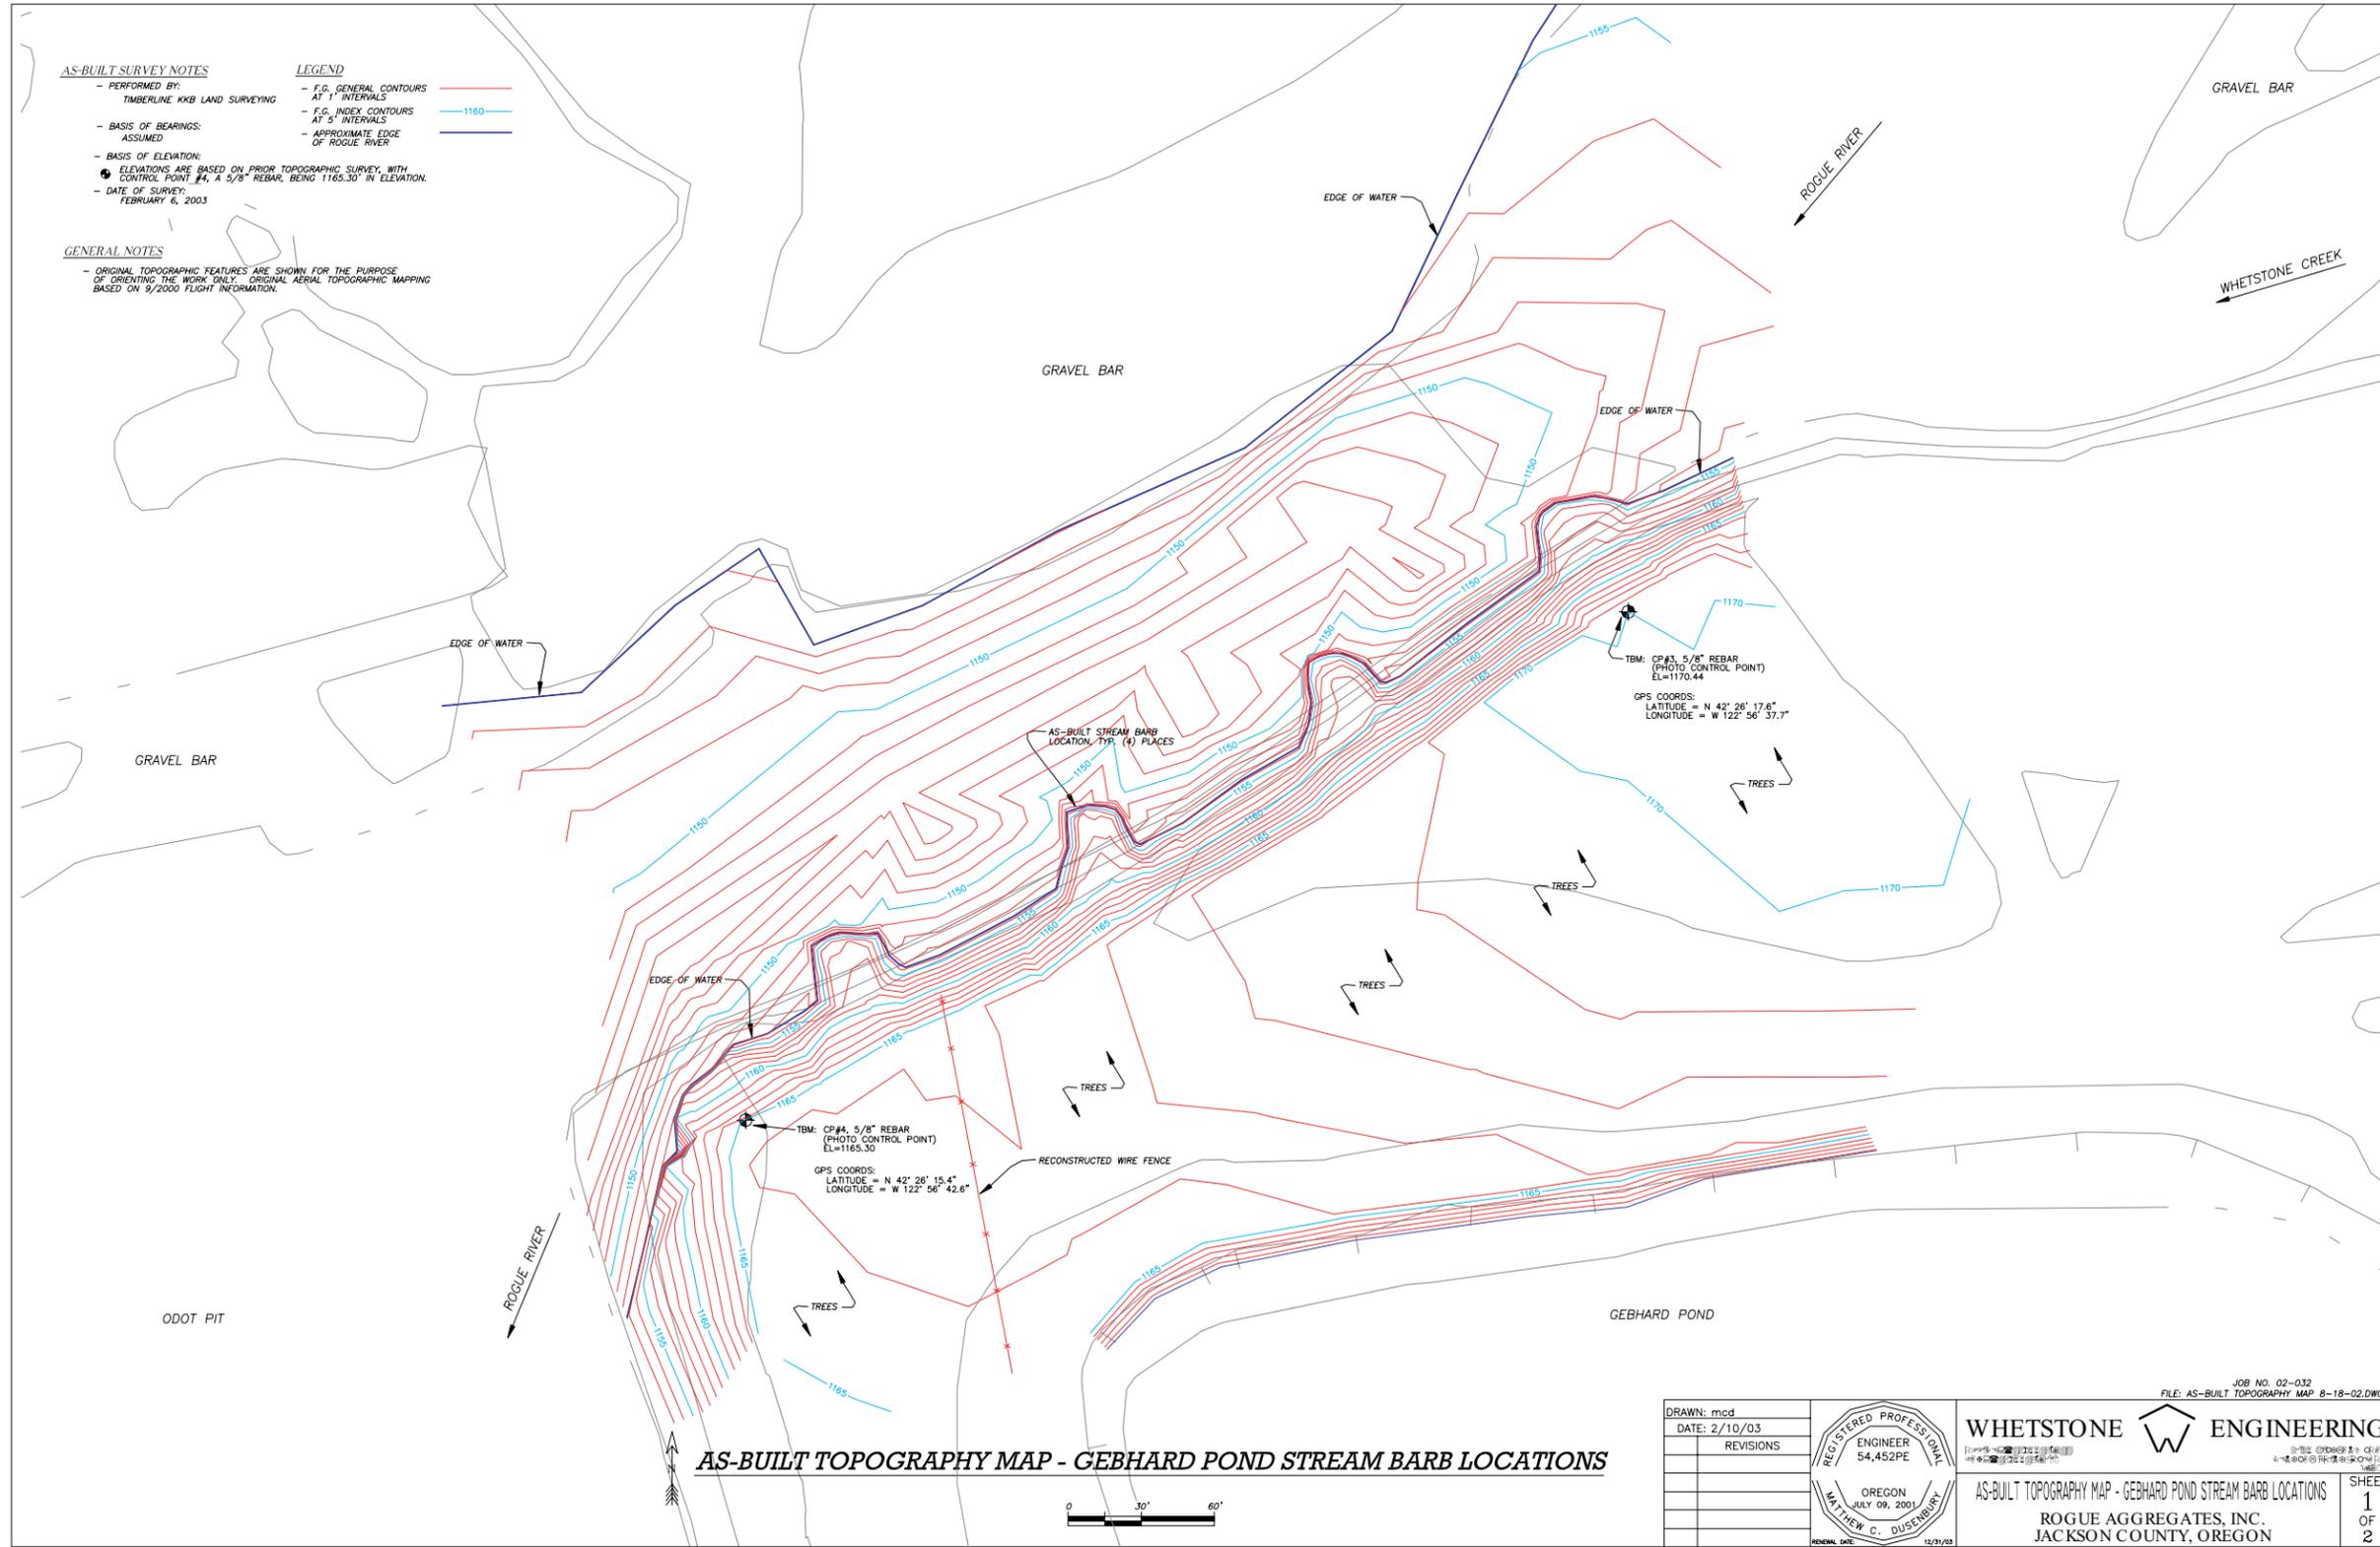
# Appendix A – Gebhard As-Built Topography Barb Locations and Bank Reshaping

DRAWN: mcd		JOB NO. 02-032	
DATE: 2/10/03		FILE: AS-BUILT TOPOGRAPHY MAP 8-18-02.DWG	
REVISIONS			
		<b>WHETSTONE ENGINEERING</b> AS-BUILT TOPOGRAPHY MAP - GEBHARD POND STREAM BARB LOCATIONS ROGUE AGGREGATES, INC. JACKSON COUNTY, OREGON	
		SHEET 1 OF 2
