Crescent RFPD

FEMA 154 Rapid Visual Screening Score Card

Crescent-Odell Lakes RFPD

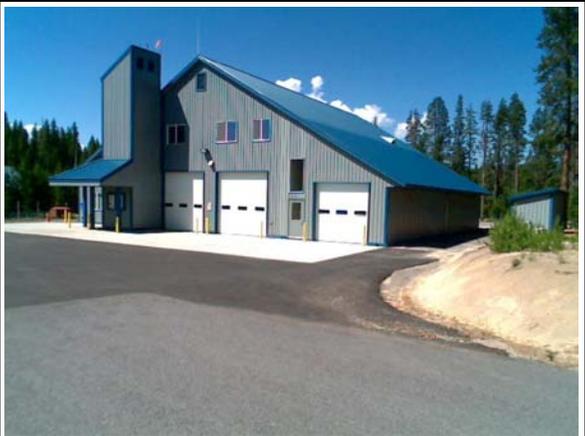
Enrollment	Year Built (Field Verified)	Year Built (Alt. Source)	Est. Decade Built
			1990
Total Area (square ft)	Number of Stories	Basement	Pounding Potential
	2	No	No

Plan Irregularities	Vertical Irregularities
Reentrant Corners: Other	Steps in Elevation View: Single Change
None	None
None	None

Falling Hazards	Poor Conditions
None	None
None	None
None	None

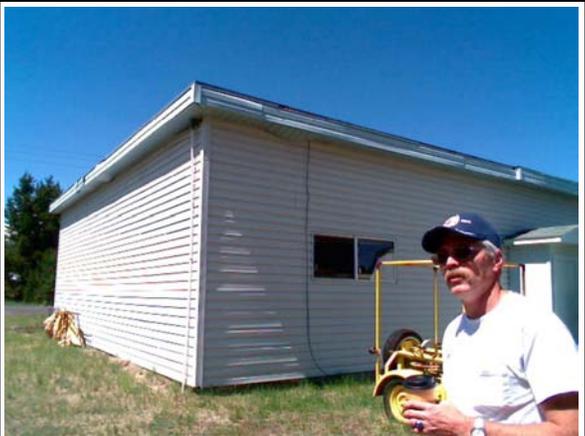
Enrollment	Year Built (Field Verified)	Year Built (Alt. Source)	Est. Decade Built
			1970
Total Area (square ft)	Number of Stories	Basement	Pounding Potential
	1	No	No

Plan Irregularities	Vertical Irregularities
None	None
None	None
None	None

Falling Hazards	Poor Conditions
None	None
None	None
None	None
