Building Type	County	
School	Union	
Street		
1400 Birch St		
City	State	Zip
Elgin	OR	97827
Latitude		Longitude
45.56282		117.92379
Tracking Code		Inspection Date
RVS in 2006		8/4/2006

FEMA 154 Rapid Visual Screening Score Card

Elgin High School

Elgin SD 23

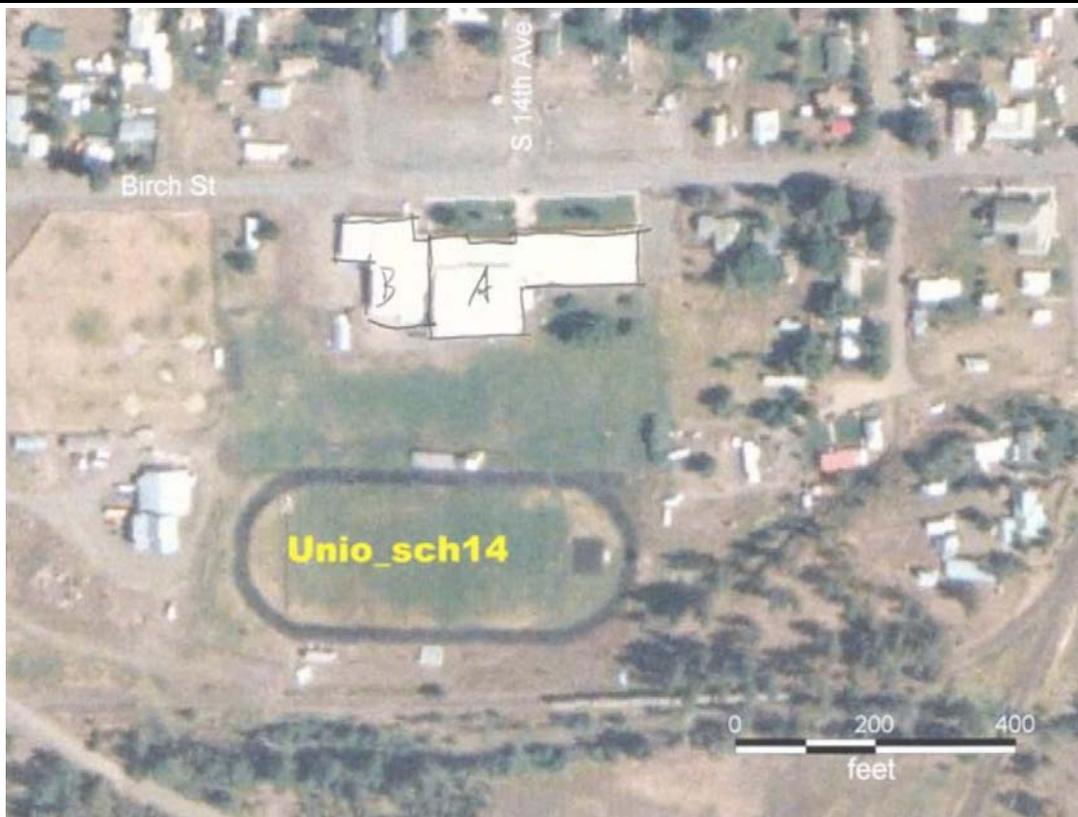
Enrollment	Year Built (Field Verified)	Year Built (Alt. Source)	Est. Decade Built
139		1957	1950
Total Area (square ft)	Number of Stories	Basement	Pounding Potential
40000	1	No	No

Plan Irregularities	Vertical Irregularities
Reentrant Corners: Other	Steps in Elevation View: 2 to 3 Changes
Reentrant Corners: Other	Steps in Elevation View: Single Change (Adjacent Building/Entity)
None	None

Falling Hazards	Poor Conditions
None	None
None	None
None	None

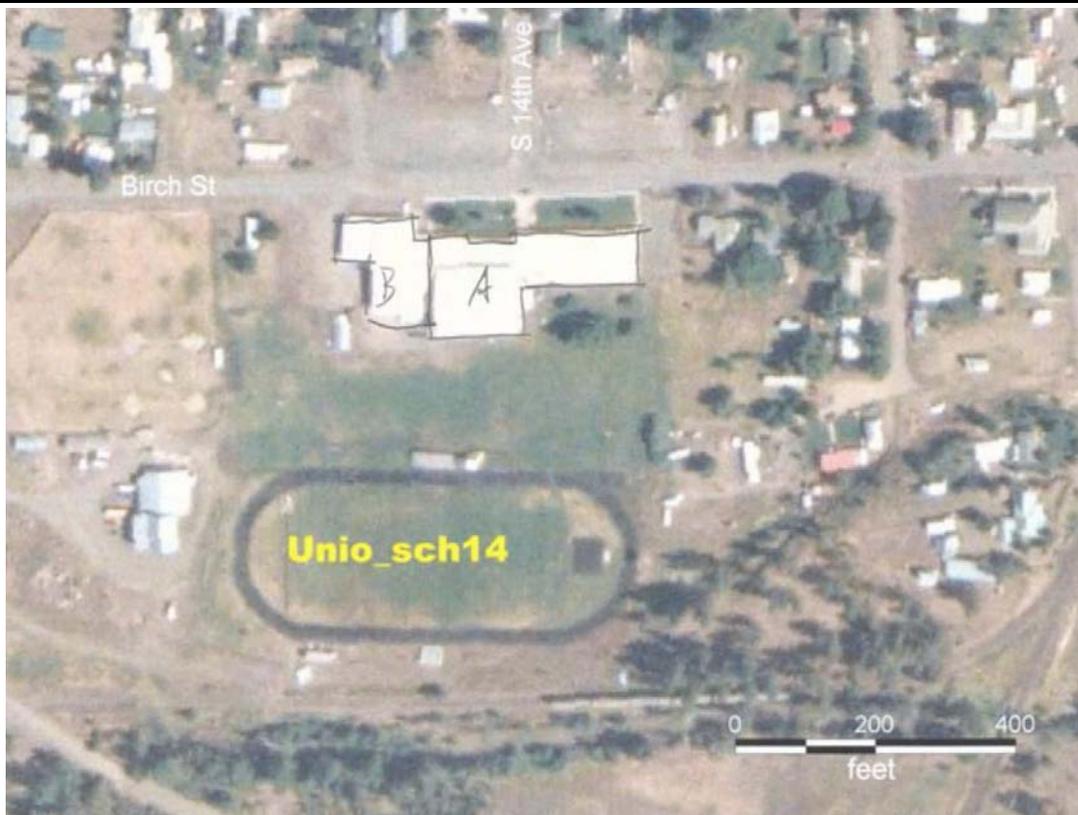
Enrollment	Year Built (Field Verified)	Year Built (Alt. Source)	Est. Decade Built
139		1957	1960
Total Area (square ft)	Number of Stories	Basement	Pounding Potential
40000	1	No	No

Plan Irregularities	Vertical Irregularities
Reentrant Corners: L Shaped	Steps in Elevation View: Single Change
Reentrant Corners: Other	Steps in Elevation View: Single Change (Adjacent Building/Entity)
None	None

Falling Hazards	Poor Conditions
None	None
None	None
None	None
